23rd World Gas Conference, Amsterdam 2006

Integrity Management for old Pipeline System

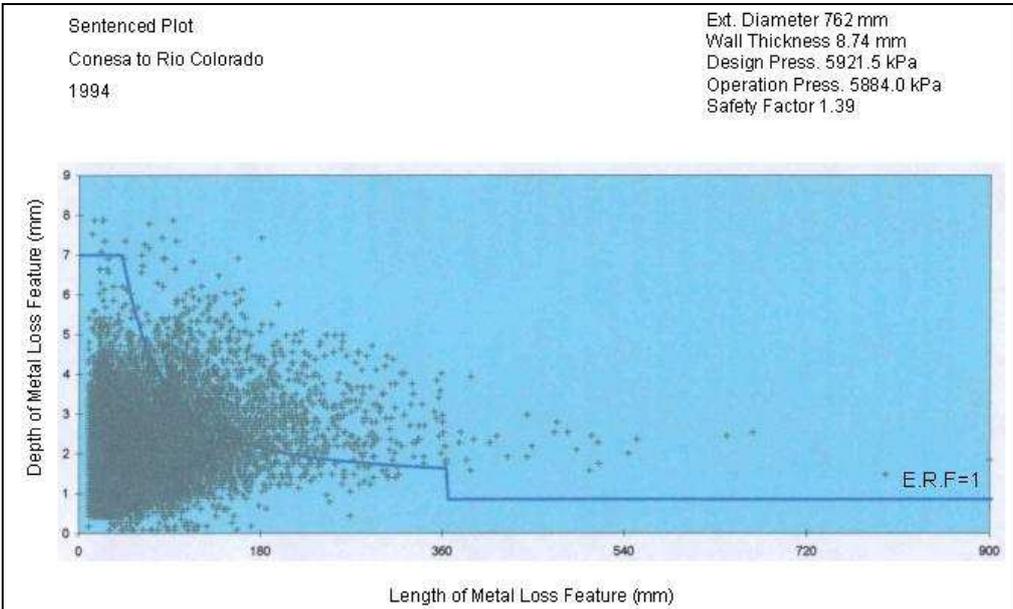
Figure 2: 1994 ILI Results (ASME B31G Curve)

To illustrate this, Figure 2 shows the ASME B31G curves of the 148 km long sections Conesa – Colorado, in which the inspection tool recorded over 27.000 defects due to metal loss.

Most pipelines presented overall corrosion, with many severe defects, including defects along the transversal welding. This information had not been detected by low resolution tools, or even by some of the so-called second- generation tools.

The performance of the in-line inspections and the obtained results initiated a Repairs Program, which comprised pipeline replacements, and installation of full circumvallation reinforcements.

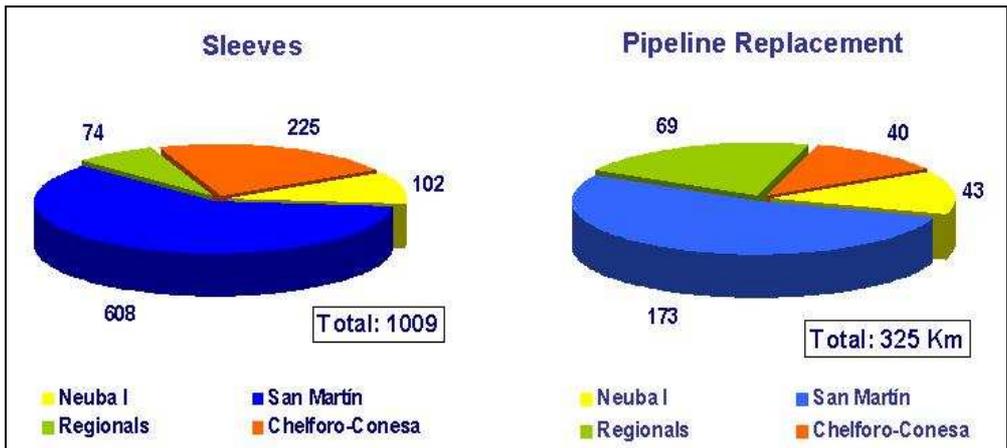
Figure 3: Maintenance Tasks made by TGS

Figure 3 shows the replacements and installed sleeves conducted by TGS.

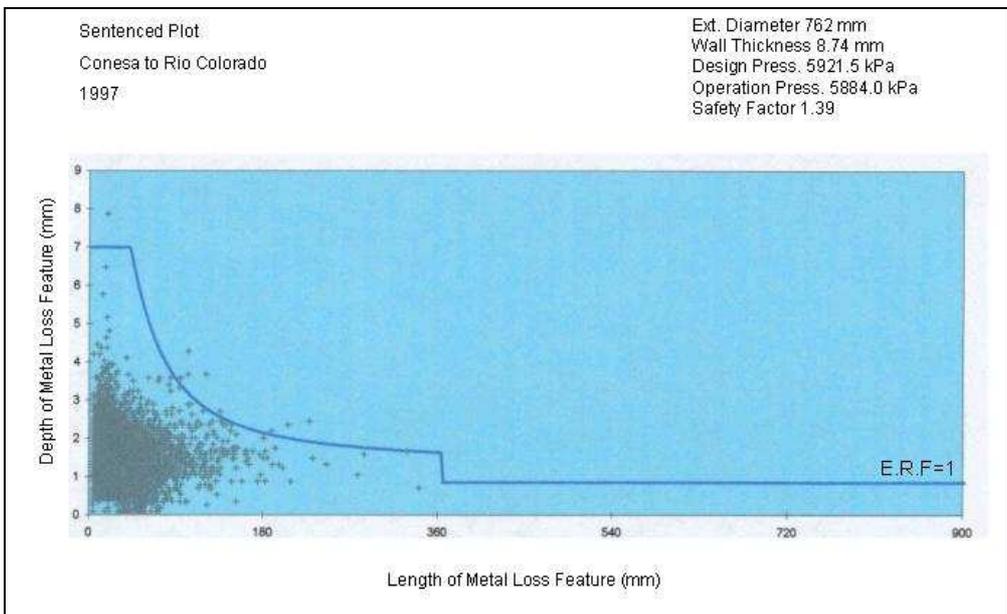
Figure 4: 1997 ILI Results (ASME B31G Curve)

Further to the performed program - and in line with the outlined monitoring methodologies- three years after the first in-line inspection, a second running of the in-line inspection tools was carried out. The results obtained showed the improvement achieved by the Integrity Plan implemented in 1997. Figures 4 and 5 show the state of the defects for the section Conesa - Colorado in the second and third running. Afterwards we continued with five-year inspection intervals.

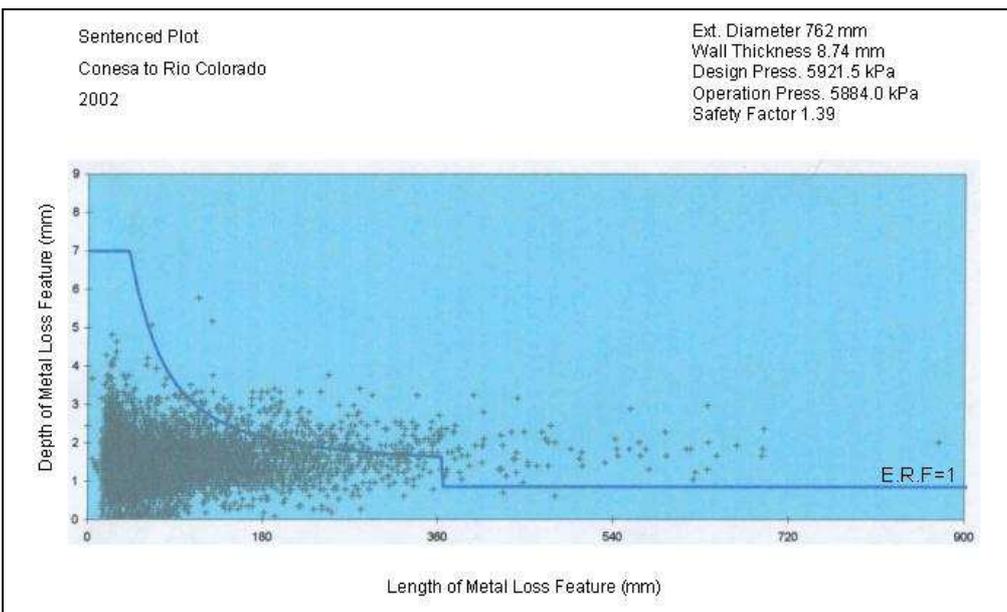
Figure 5: 2002 ILI Results (ASME B31G Curve)

The results of the several in-line inspections carried out indicated that in a first stage the massive advance of the external corrosion was constrained. However the last in-line inspection pointed out at a new increase in the threat of external corrosion. This led to the implementation of new analysis, such as the assessment of corrosion speed rates.

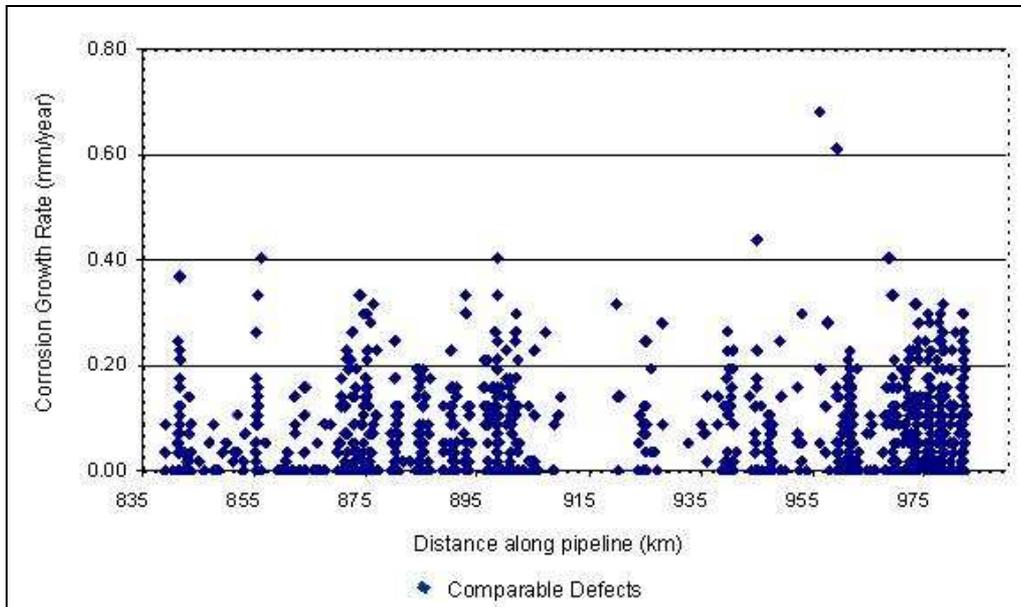
Figure 6: Corrosion Rates

To determine corrosion rates, in 2002 the existing inspection reports were compared, relating the recorded defect depth differences to the time intervals between one inspection and the other (Figure 6). This calculation involved an error, characteristic of defect sizing. On the other hand, for the comparison of this kind of defects, many variables should have been normalized, (odometry, orientation) .

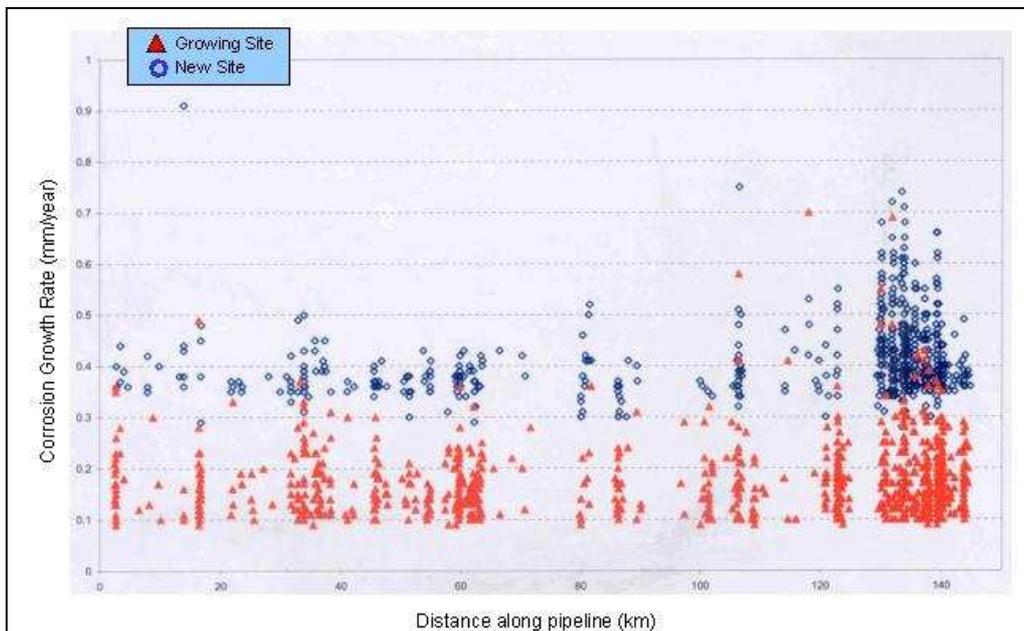
Figure 7: RunCom Analysis

In order to avoid measurement obstacles, we chose a new method to determine corrosion speed rates, known as RunCom (Figure 7). This new method, supplied by in-line inspection personnel, consists in the comparison of tool runnings, not considering the quantified values, but directly the magnetic signals of the running tool. Thus, the obstacles involved in the previous method would be avoided and it would be easier to discriminate new defects from the ones which were growing. This discrimination was not possible in the previous method as there was no certainty when determining whether a defect was new or not.

The results of these new surveys facilitate the monitoring of these defects, and their discrimination between active and non-active faults by following their evolution in time. This allowed us to minimize the threat attack field.

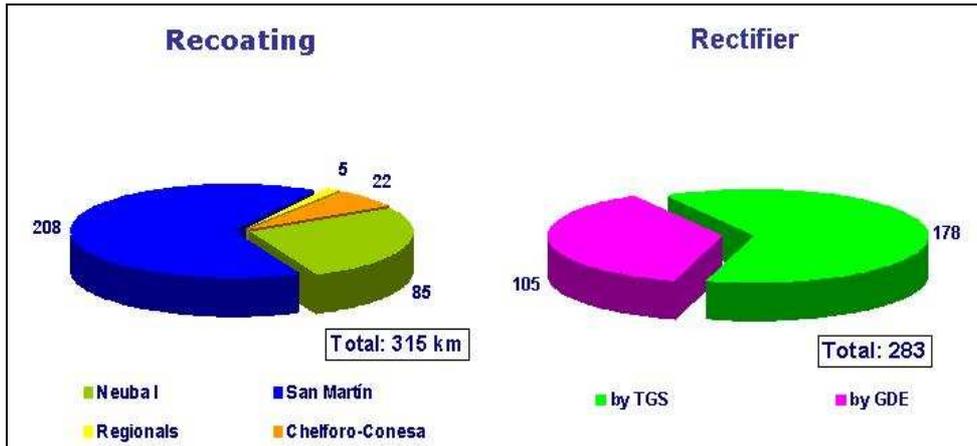
Figure 8: Recoating and New Rectifiers installed by TGS

The main cause of this was the bad condition of the original asphalt coating, which had to be replaced to improve the cathodic protection system and to hold back the advance of corrosion detected in the last in-line inspection.

Figure 8 shows the Recoating executed to date, and the quantity of cathodic protection equipments installed by TGS. Up to this date, we recorded 315 km of coating change and installed 178 cathodic protection units.

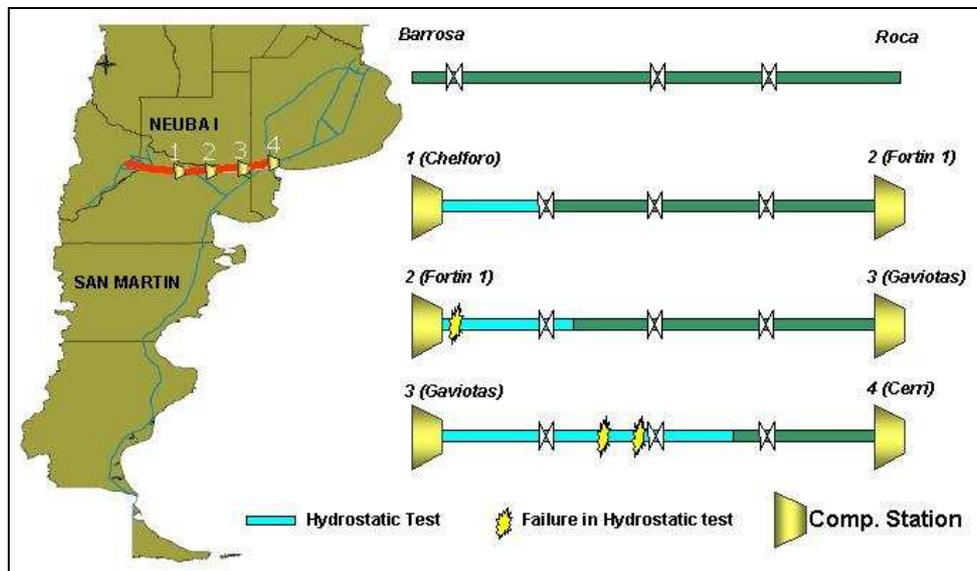
Figure 9: Hydrostatic Tests made by TGS

The first inspection methodology used by TGS to identify and mitigate SCC was the application of hydrostatic test on the pipelines affected by the SCC ruptures. The areas selected in the Neuba I Pipeline comprised the compressor plants discharge areas, which combined the most unfavorable conditions in connection with SCC susceptibility. Three sections were affected by this testing (Figure 9).

Performed hydrostatic test totaled an extension of 134 kilometers with the outcome of three (3) cases of SCC at the discharge of the Compressor Plants in Gaviotas (2) and Fortín Uno (1).
