Assessment of the condition of underground collector lines

situated inside the technological complexes of
underground storage facilities

Underground gas storage Lab

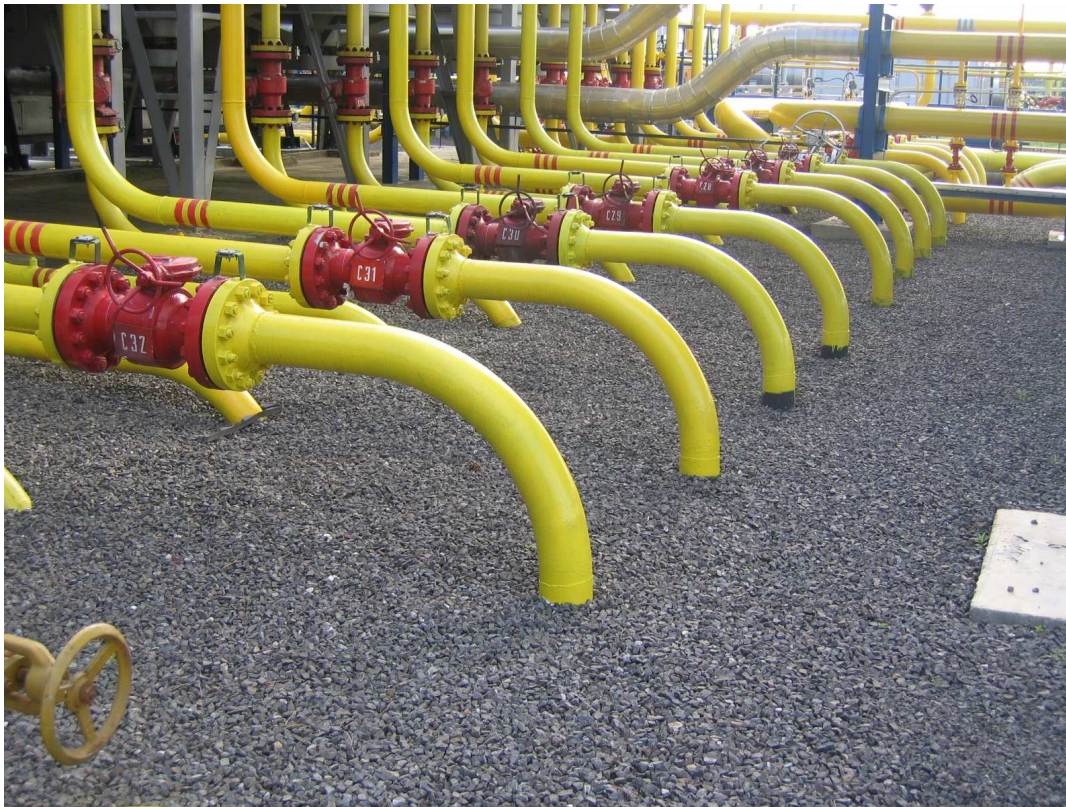
Inspection of collectors K 102, K 103

K 102

Nominal diameter 700 mm

Length 57 m

K 103

Length 26 m

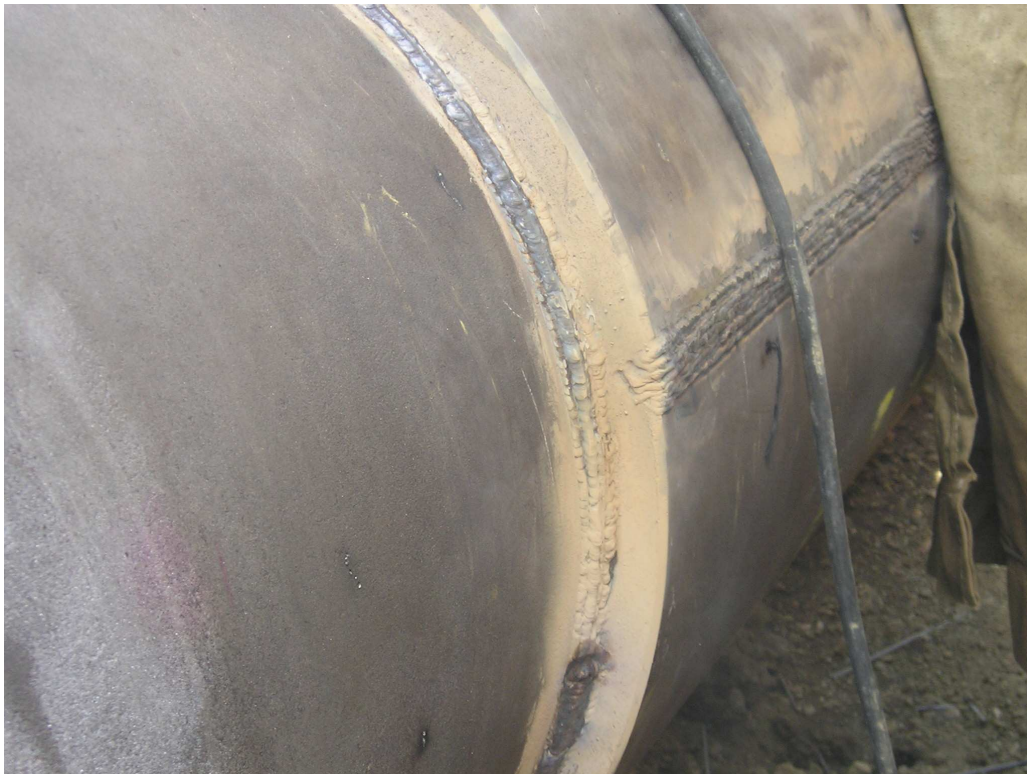
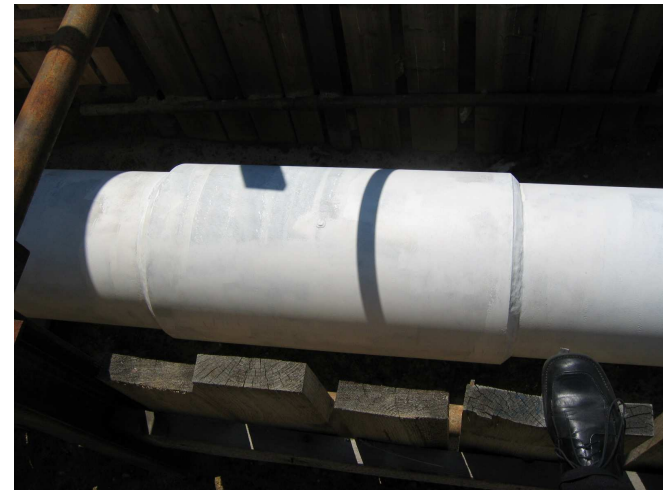
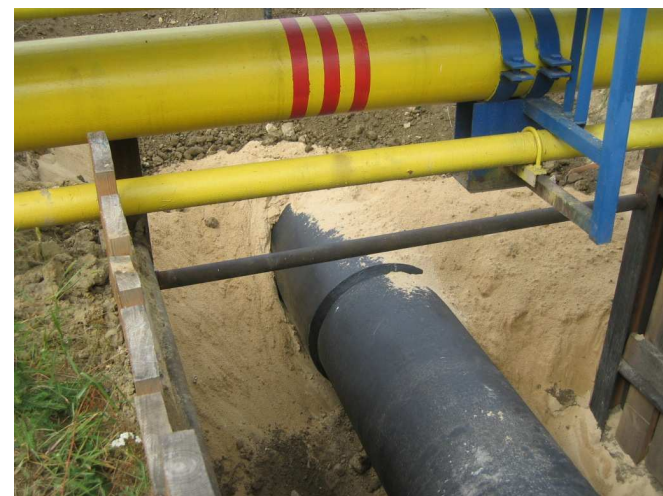
Repairing of collectors K 102, K 103

- **No serious defects were revealed**
- Only lamination defects (mill defects), originating from manufacturing process were found
- There were no relevant indications of internal and external corrosion
- There was not an immediate risk for safety of operation
- However, lamination parts were reinforced by installation of ‘hot sleeves’
- **Based on simulation, safe operation forecasted until year 2025**
- The next inspection with assessment planned 2025

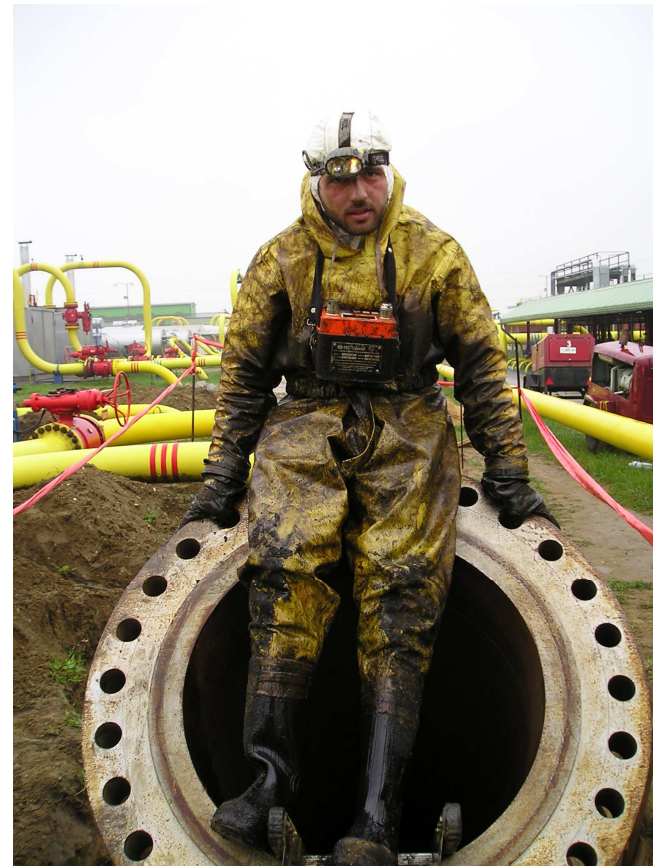
Inspection of collectors K 100, K 101

K 100

Nominal diameter 700 mm

Length 136 m

K 101

Length 105 m

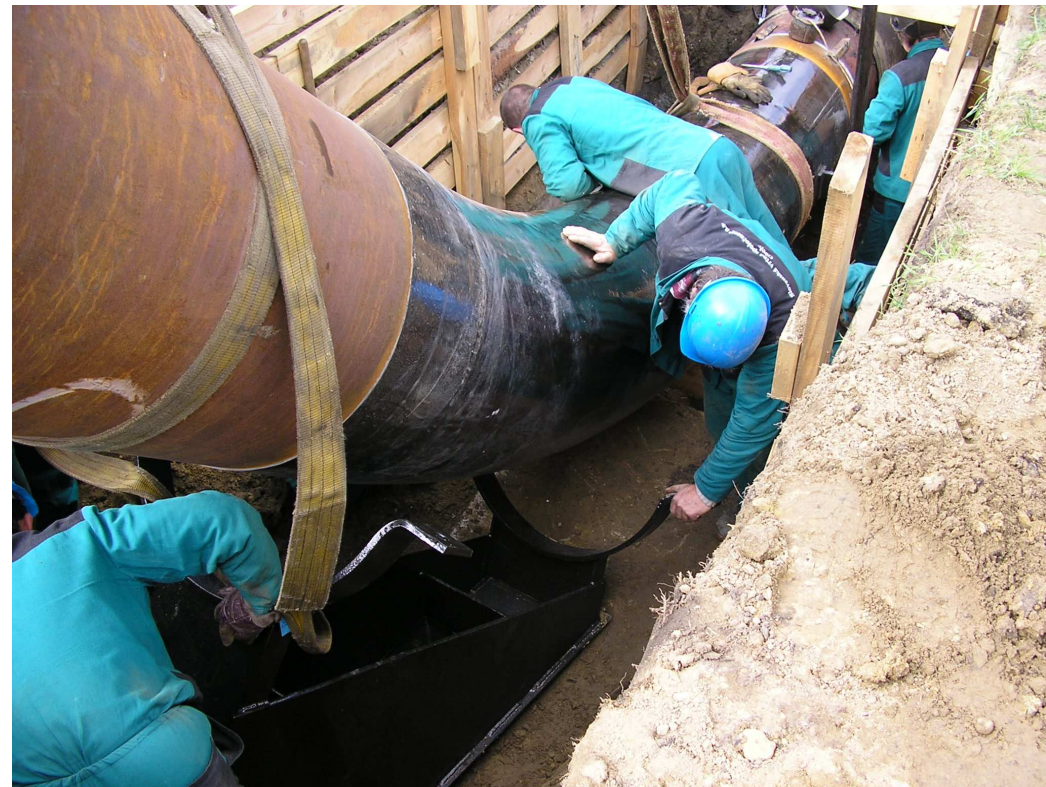
Inspection of collectors K 100, K 101

- Excavation and preparation for bends' installation
- Inspection of all off-takes
- Material shop preparation
- Modifications of collectors' entries
- Ultrasonic in-line inspection by an external company

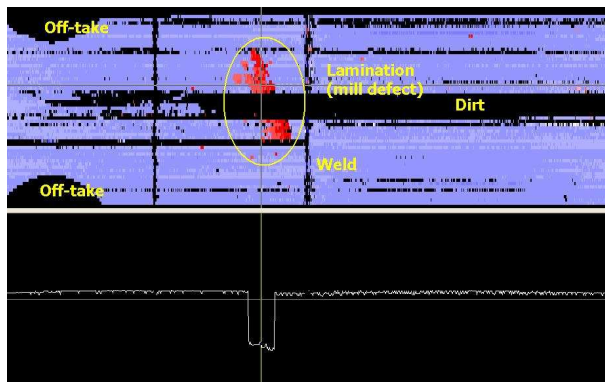
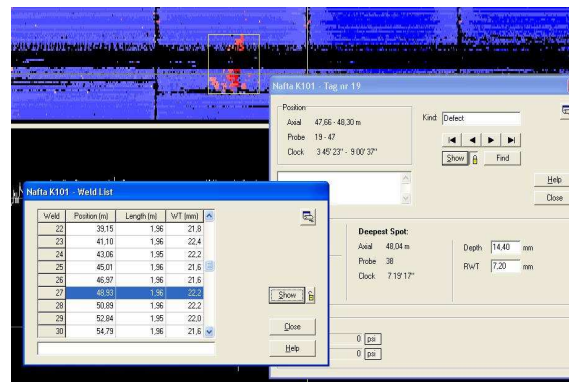
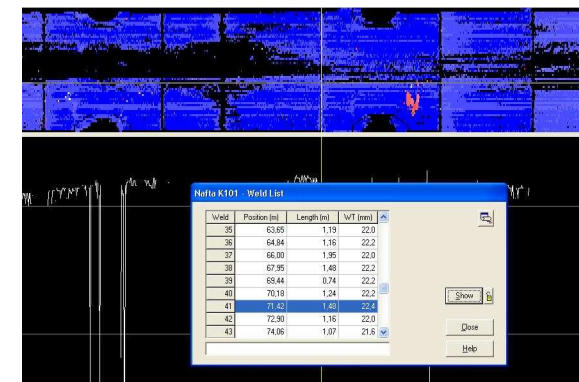
Findings on collectors K 100, K 101

- **No serious defects were revealed**
- Only lamination defects (mill defects), originating from manufacturing process were found
- Lamination parts were reinforced by installation of ‘hot sleeves’
- **Based on simulation, safe operation forecasted until year 2015, the next inspection with assessment planned 2015**
