RE-ESTABLISHING CONFIDENCE IN PE ELECTRO-FUSION WELDING BY ENHANCED SURVEILLANCE

Johannes de Bruin
Kiwa Technology
Apeldoorn, the Netherlands
Johannes.de.bruin@kiwa.nl

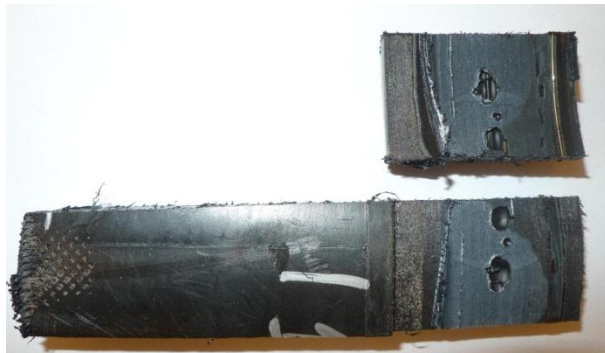
As a first step towards gaining an insight into the quality of the first generation electro-fused PE joints, the assemblies were tested by means of the peel decohesion test in accordance with ISO 13954. Figure 5 and Figure 6 show representative examples of the welding zones of the Rollmaplast and the Mannesmann couplers respectively. In the case of the Rollmaplast couplers, cavities were found at the welding zone in most of the samples. As regards the Mannesmann couplers, it appears that there is almost no cohesion possible between the coupler and PE pipe due to the high density of wires at the welding zone.

Figure 5 – An example test sample after the Peel decohesion test on the Rollmaplast couplers. Cavities were found at the welding zones in many of the samples.

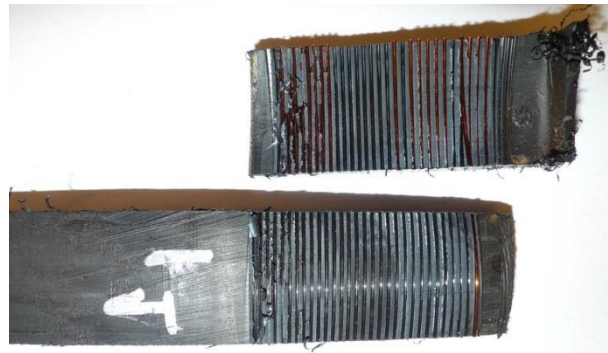
Figure 6 – An example test sample after the Peel decohesion test on the Mannesmann couplers. There is almost no connection possible between the coupler and PE pipe due to the high density of wires at the welding zone.

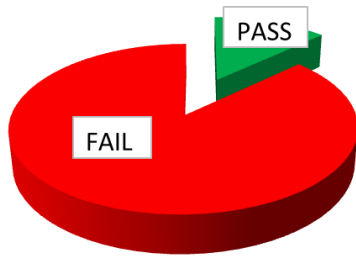
**Peel decohesion test (ISO 13954),
Rollmaplast**

Figure 7 and Figure 8 show the results of all the examined first generation PE electro-fused joints for the Rollmaplast (11 in total) and the Mannesmann couplers (14 in total) respectively. In both figures the red wedges indicate brittle (poor quality) joints, while the green wedges indicate ductile (good quality) joints. Both figures show that the first generation couplers have high rejection rates in the peel decohesion test. Approximately 75% of the first generation electro-fused joints do not fulfil the current requirements for mechanical strength.

Figure 7 – Results of the Peel decohesion test on Rollmaplast couplers. Of the 11 investigated first generation PE electro-fused Rollmaplast joints, only 1 passed the peel decohesion test.

The reasons for these failures have not been investigated extensively, but it appears that insufficient scraping and contamination of the welding zone (mostly by sand) are the chief causes. This cannot always be blamed on the PE welder, as during the period in question (the 1970s) cleaning of the welding surface was not mandatory and scraping using a hand scraper was considered sufficient. Nowadays such practices would not be accepted. In addition, the design of the PE couplers may lead to failures in the peel decohesion test. In the case of the Mannesman couplers, for example, the high density of wires means that there is almost no PE material between the wires. This means that there is almost no cohesion between the coupler and PE pipe possible. As a result, the coupler can easily be peeled from the PE pipe at the welding zone (wire zone).

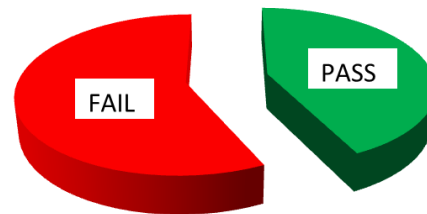
**Peel decohesion test (ISO 13954),
Mannesman**

Figure 8 – Results of the Peel decohesion test on Mannesman couplers. Of the 14 investigated first generation PE electro-fused Mannesmann joints, only 6 passed the peel decohesion test.

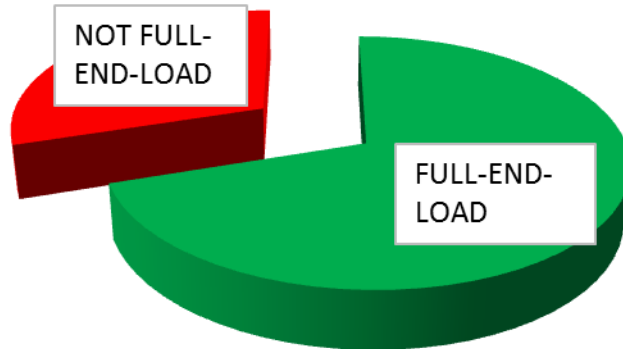
Axial tensile test, first generation EF joints

The results of the axial tensile tests are given in Figure 10. A total of 11 first generation PE assemblies were tested. The red wedge indicates the percentage of joints that were not full-end-load resistant, while the green wedge indicates the percentage of joints that were full-end-load resistant. The results show that approximately 33% of the first generation PE joints were not full-end-load resistant. Full-end-load resistant joints are mandatory due to the fact that most of the first generation PE joints are used in piping systems at gas pressures higher than 1 bar. Dutch standards specify that such joints need to be full-end-load resistant.

Figure 10 – Results of the axial tensile tests on the whole joint to test the full-end-load resistance of the joint. Of the 15 investigated Ø110, SDR 11 first generation PE electro-fused joints, 5 were not full-end-load resistant.

The mechanical stress, which is needed for yielding (of the thinnest PE pipe) of the full-end-load resistant joints, is the same as the tensile stress at yield values of PE materials. These values are approximately 23 MPa, depending on the quality of the PE material. The mechanical stresses at breaking point of the joints that were not full-end-load resistant measured during the axial tensile tests varied between 2 MPa and 16 MPa. This means that rupture of the joint can occur at very low stresses, which could lead to safety problems.

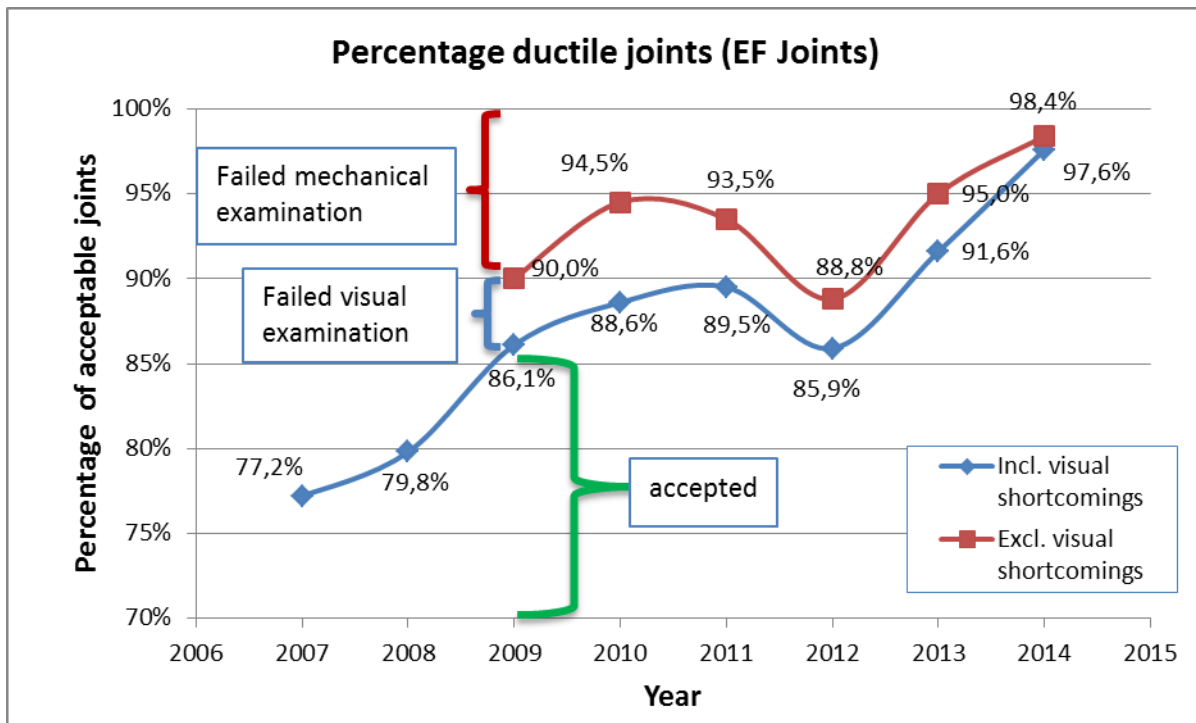
The results^[13] of the quality control assessment of electro-fused joints performed for Enexis over the last eight years are given in Figure 11. This figure shows the annual percentage of acceptable joints (indicated with the green bracket for the year 2009). Since 2009, an additional distinction between visual and mechanical shortcomings has been made. The blue line indicates the percentage of acceptable joints that have passed both the visual and mechanical examination. The red line indicates the percentage of acceptable joints that have passed the mechanical examination. This means that the gap between the red and blue lines indicates the percentage of joints that show visual shortcomings. For the year 2009, this percentage is approximately 4% (indicated with the blue bracket). The red line above gives an indication of the percentage of mechanically rejected joints. For the year 2009, this is approximately 10% (indicated with the red bracket).

Despite a dip between 2011 and 2012, the percentage of approved joints has steadily risen. The main reason for this is considered to be enhanced surveillance. This has led to more awareness by both the contractor as well as by the DSO, which has eventually led to more widespread knowledge of the correct welding procedure. This has led to, for example, better equipment (including better skinning tools), compliance with cooling times, correct use of PE cleaners and the creation of "ideal" work areas. There has also been a recent improvement in the percentage of assemblies that do not show any visual shortcomings (less than 1% in 2014). This also demonstrates that the welding procedure is being executed correctly more and more often.

Figure 11 – Results of the quality control of electro-fused joints (including and excluding visual shortcomings)

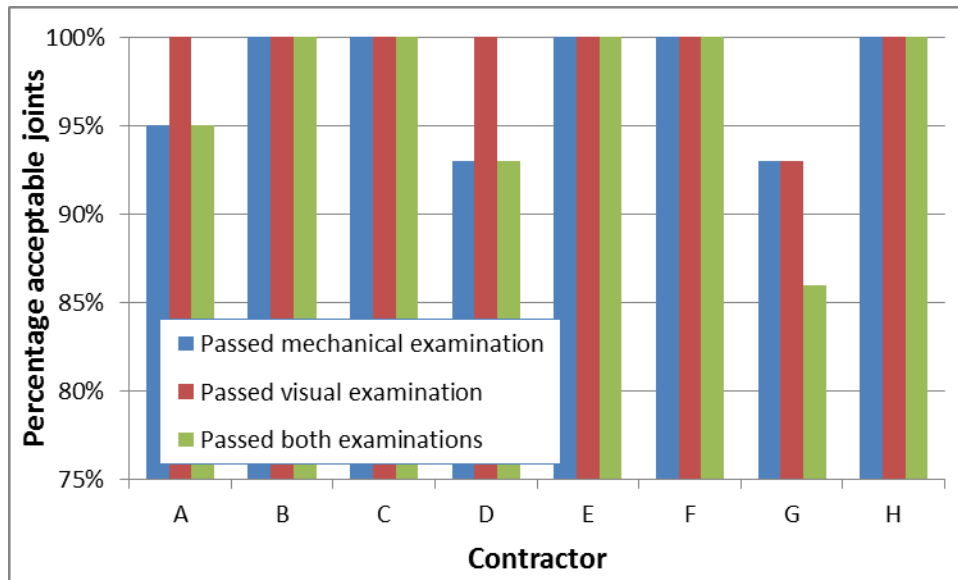
An in-depth focus on the results for the year 2014 makes clear that several of the contractors have achieved a 100% acceptance level (see Figure 12). It can therefore be concluded that it is possible, including under field conditions, to make perfect electro-fused joints. This will nevertheless require enhanced surveillance by all stakeholders and in particular by DSOs.

Figure 12 – Results of quality control assessment by contractor
