# **Failure Analysis and design modification of stack spool bolts under mechanical/thermal loading using finite element model and experimental data: A case study**

## **Abstract:**

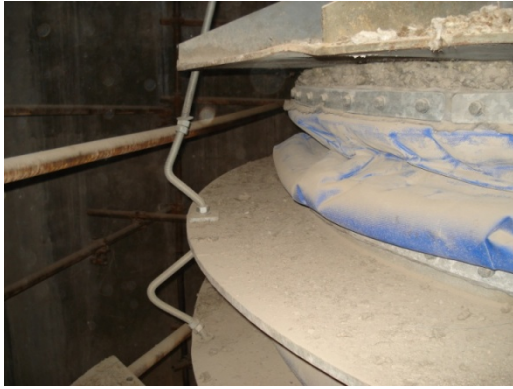
In the same way the double-flexible expansion joint crashed together with the 6 vertical guide devices under the abnormal compression forces. So we have excessive compression of expansion joint and failure of its adjustable tie bolts

Figure 8. Damaged expansion joint

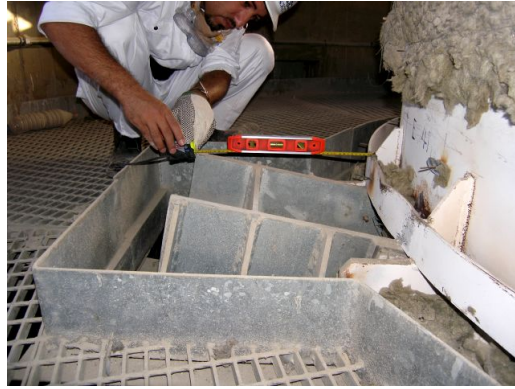
The failure of connecting bolts caused the liner to fall down of about 700mm finding a provisional support restrain on the 2 guide platforms located respectively at +41.00m and +75.00m. This failure is as a result of improper design of bolts, which should be reviewed. Another reason of the bolt failure is the exposure of bolts to the over design hot flue gas. Lack of proper flange joint sealing material (Ceramic Fiber) or insufficient amount of it will increase the exposure extents. High temperature extensively increases the rate of failure under static loads. The effect of the loading caused additional large deformations on the steel beams which have been subjected to high bending and torsion forces induced by the bumpers rigid connection. So we have distortion of guide platform H-beams at first, second and third elevations.

Figure 9. Stack fall down

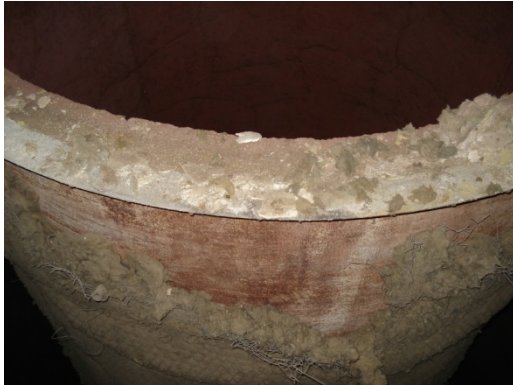
Figure 10. Spool 20

A few years after the stack was erected the bolts began to fail with replacement required approximately every 3 years. Failure happened on the 19 & 20 spools and when top spools fail, lower spools lose their connections and their weights suppress guided supports and expansion joint at the bottom of stack structure damaging them. An investigation was carried out and the main results are presented below.

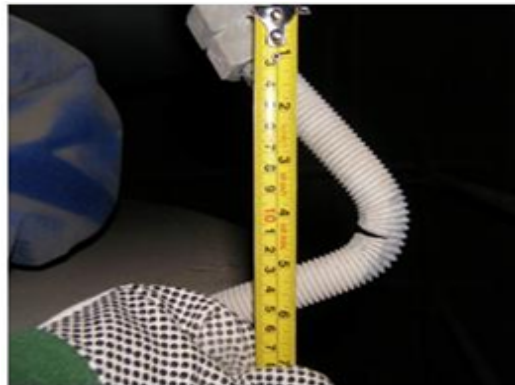
Due to the collapse of the liner the transition elbow has been subject to high vertical impact load which caused the failure of 2 tie rods connecting the curve to the concrete windshield.

Figure 11. Expansion joint tie rod

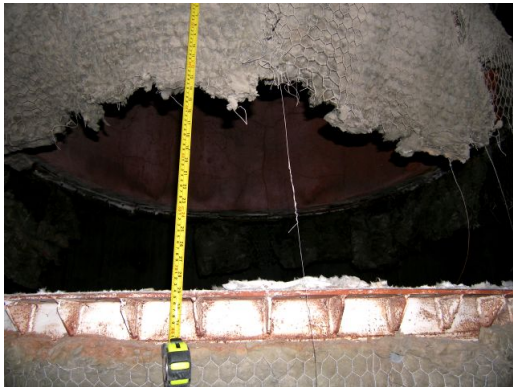
Figure 12. chimney spool fall

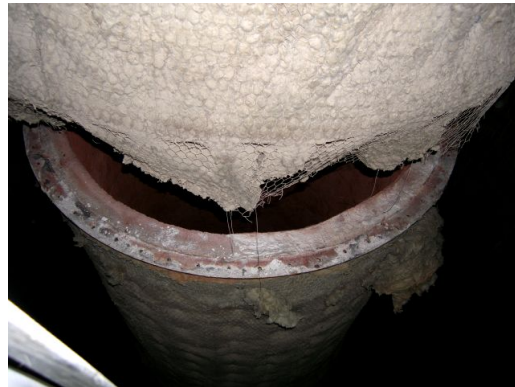
Figure 13. chimney spool fall

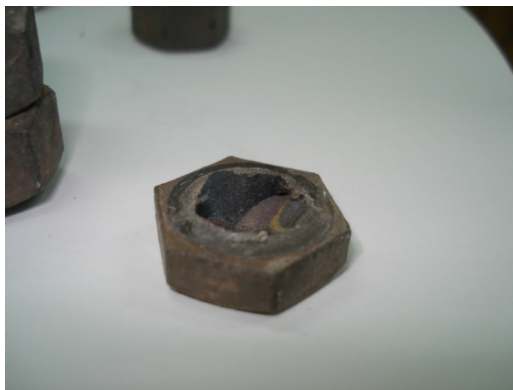
This stress concentration effect was severe on two points: 1- bolt head 2- at the beginning of the tread part where we have cross section area alterations. To overcome the limitations the material and type of bolts have been changed. Current bolt material (A-325) changed to higher strength material (A-193 B16) and machine bolt changed to stud bolt with double nut configuration. Using stud bolt instead of machine bolt reduce stress concentration points.

Figure 17 .Bolt head concentration points

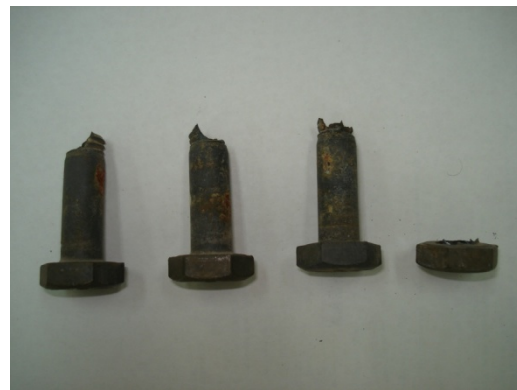
Figure 18. Bolt concentration points

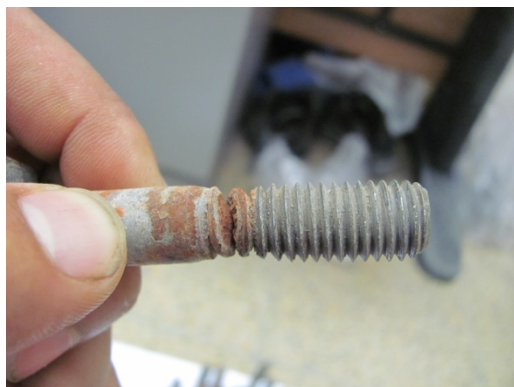
The evidence of the failure of the connecting bolts located close to the hanging support of the liner has been detected as the main reason of the failure of the liner. Two main reasons for bolt failures were extreme heat and stress concentration on bolts.

Figure 19.bolts crack

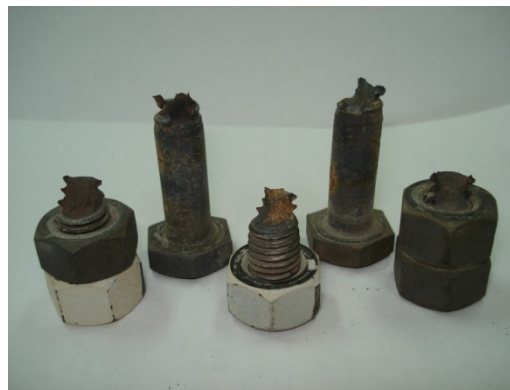
Figure 22. Bolt and nut failure

After analysis and investigation about bolt failure location there for decide to change type of bolt and concentration point shall be removed then used to stud bolt with two nut on each side
