International Gas Union Research Conference 2011

Failure of Field Joint Coating under Soil Stress

YoungGeun Kim

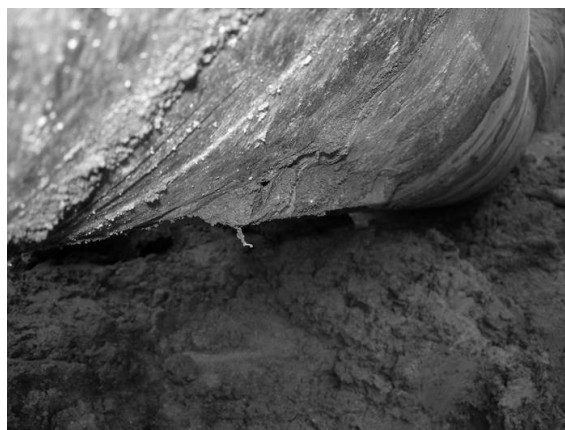
Many metal loss found by the MFL (Magnetic Flux Leakage) pig inspection was found to be related with the coating failure of the heat shrinkable sleeves.(5) The coating failure of the pipe was observed as wrinkle at the lower part of the pipe around 6 o'clock position.(Figure 1,2) And the coating failure at the girth weld joint is often leads to severe corrosion related MIC (Microbiologically Influenced Corrosion).(Figure 3) This type of coating failure was reported frequently in Korea. We found that about 90% of metal loss were related with this type of coating failure. The wrinkle at the bottom of the pipe is unusual in other country. The reason of the failure was sought in this work.

Figure 1. Coating failure at the field applied coating

The void fraction around the pipe in a case varied with the position.(Figure 5) The results were shown in Table 1. The void fraction at the invert position was highest and that at the haunch position was still high compared to spring line position. This phenomenon might provide the cause of soil flow around the pipe. And the flow of soil will induce shear stress on coating of the lower part of the pipe. These results explain the observed coating failures (Figure 1, 2).

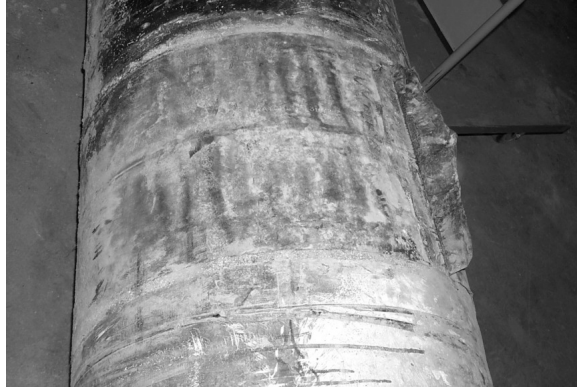
Figure 2. Wrinkles at the field applied coating

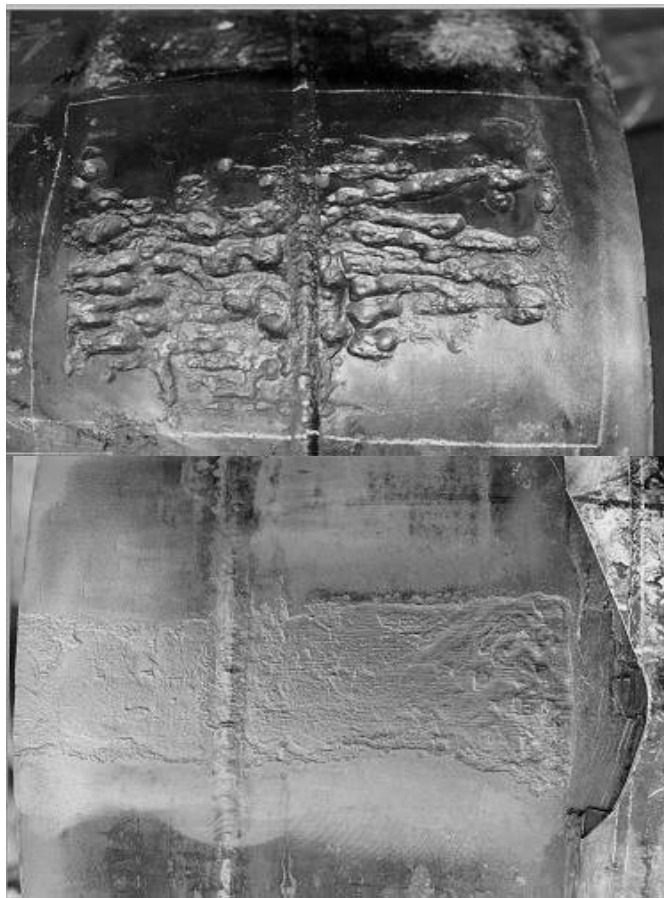
Figure 3. Corrosion of Pipe at the field applied coating failure

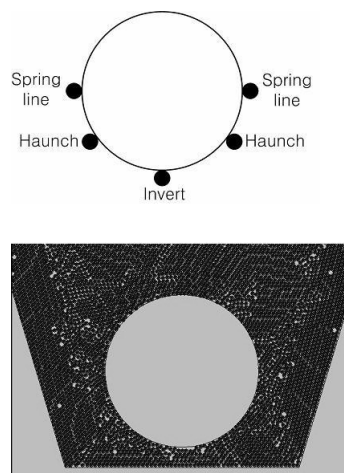
Figure 5. Particle Distribution around the Pipe from Particle Flow Analysis

Part	Void Ratio
Spring line	0.186
Haunch	0.2739
Invert	0.3147

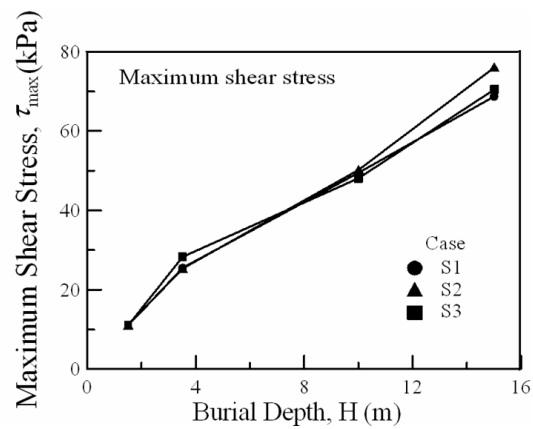
Figure 8. Variation of maximum shear stress with burial depth at 610 mm diameter pipe

The results for the second case were shown in Figure 8 for 610mm diameter ($t=14.3\text{mm}$). The shear stress was increased with depth of burial. The shear stress at the coating surface varied from 15 kPa to 70 kPa and continuously increased with the depth. The shear strength of mastic type heat shrinkable sleeve specified in EN12068 is 50 kPa (at 10mm/min. of crosshead speed) and that in NACE RP0303 175 kPa (at 1.3 mm/min, of head speed)(6,7). However the test results are obtained by fixed crosshead speed but the stress in the soil could be considered as static. Under the static load the coating could be sheared at much lower level of shear stress. A test method called Alyeska shear test is sometimes done at about 14 kPa of static shear load. Test duration for Alyeska test is 50 hours at maximum.(8) The stress on the coating exceeds the test load of Alyeska

test. The analysis results suggest that the shear stress of construction in the trench could induce shearing of the pipeline coating.

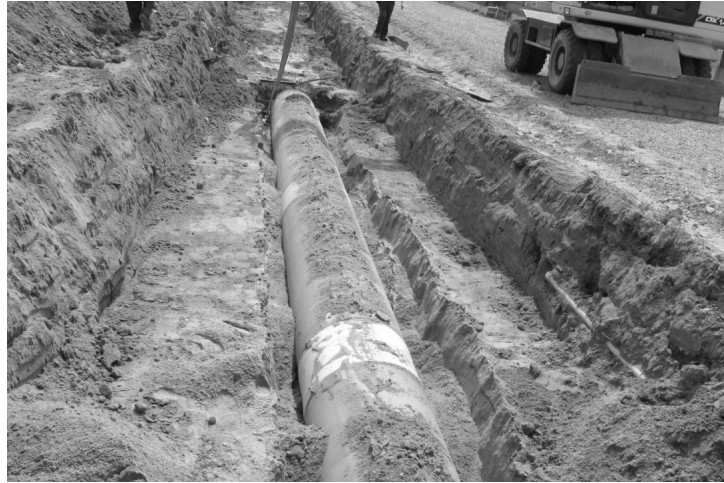
Figure 10. Excavation of the Buried Pipe for Field Test of Coating Performance

After 205 days after installation the pipes were excavated to inspect any imperfection.(Figure 10) Every coating was found to be sound except small wrinkles in circular direction. It was believed that the redistribution of hot mastic adhesive during curing induced the circular wrinkles. No severe wrinkles related to local adhesion failure was found in any condition. The coating defects which was found in the in-service pipe was not reproduced in this field test. There are several possibility in interpreting the results of this field test. The first implication is that the coating product with adequate shear strength could resist normal shear stress during construction and service. The second one is that the bad workmanship or the use of wrong backfill materials or limited working condition in the trench is related to the coating failure.

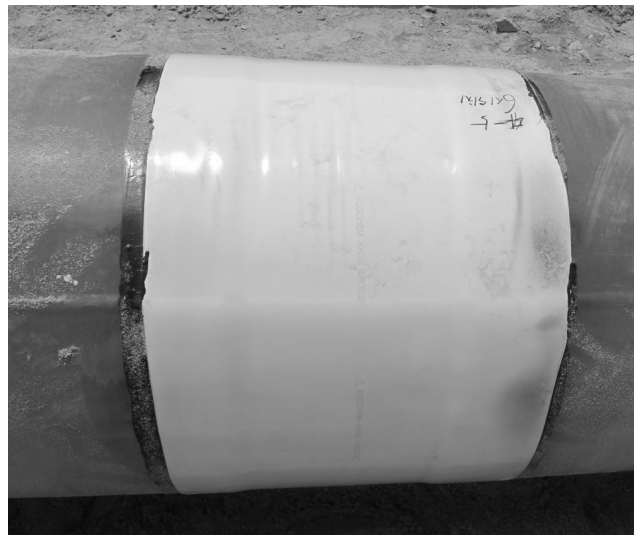
Figure 11. Small Wrinkles on the Surface of Excavated Buried Pipe (C group-5)
