Effects of the Large-scale Earthquake and Tsunami on an LNG Receiving Terminal

Nobuhiko Takei (The Japan Gas Association)
Minoru Makino (Gas Bureau, City of Sendai)
Toshihiro Meguro (Tokyo Gas Co., Ltd.)
Shohei Nishida (Osaka Gas Co., Ltd.)
Hidetoshi Osajima (Saibu Gas Co., Ltd.)

This paper presents a detailed report of the damages to this LNG receiving terminal (the Sendai City Gas Bureau Minato Works) from the earthquake and massive tsunami of a scale beyond all expectations, describes the emergency recovery and restoration efforts, and notes what can be learned from this experience.

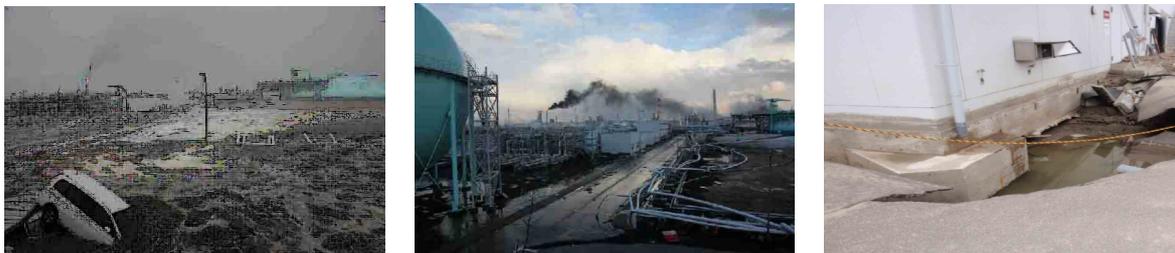
Fig. 4 Damage from the Tsunami

standards—suffered almost no damages from the earthquake. The production equipment did suffer extensive damages from the tsunami flooding, which reached a maximum height of 3-4 m. There was no loss of life, LNG leaks or other secondary damage. The initial response following the earthquake and tsunami was as follows. Immediately after the earthquake, the commercial electric power supply shut down, the backup power supply turned on, and production was safely suspended. Preparations were then made to resume production by starting up the emergency power supply facilities, but a tsunami struck one hour after the quake. With the tsunami, the resumption of production was immediately abandoned and the LNG storage tank and other emergency shut-off valves were closed remotely to prevent secondary damages. The flooding continued for about 1 hour.

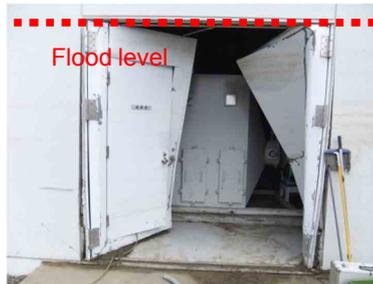
Fig. 6 Damaged Door

The damages to indoor equipment (power receiving equipment and substation, instrumentation and ventilation equipment, boiler, LNG receipt monitoring equipment, truck shipment monitoring facilities, etc.) and buildings included severe damages to a doorway (Fig. 6) and the loss of functions as a result of flooding via air vents and other building openings (Fig.

The doors of buildings with important facilities such as the power receiving and substation equipment that became the critical path to recovery were replaced with airtight (watertight) doors like those in the odorization room (Fig. 16), and the building opening was moved to a higher location (Fig. 17).

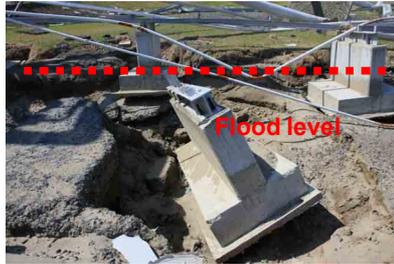
Fig. 8 Scouring of Piping Framework

The piping framework which has a shallow foundation collapsed from scouring in some areas (Fig. 8) and piping that was not fixed to the framework floated and was deformed (Fig. 9). The truck shipment monitoring building, which has a shallow foundation, was washed away (Fig. 10).

The piping framework foundation was changed from a shallow foundation to a pile foundation. A broad foundation base was poured (Fig. 18) and measures

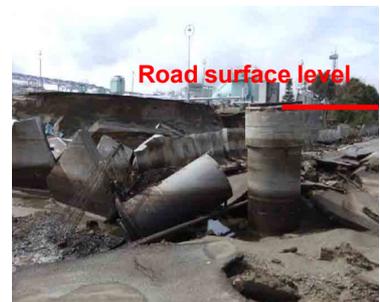
Fig. 11 Road Scouring

The extent of the scouring was severe at locations where the tsunami flow concentrated (Fig. 11). Most of the site gauges were flooded, and could not be used. The flooded valves failed because of salt and fine sand in their actuators.
