Managing Integrity of High Pressure Gas Pipeline: Root Cause Analysis and Hydrogen Induced Crack (HIC) Direct Assessment of Weldment Crack on 30" Gas Pipeline

- Constructed in 1989 and commissioned in 1991. It has been in operation for 20 years.
- 209 km length from SOC to Pasir Gudang MS.
- On 15 Feb 2009, pipe cracked at KP 69.2, Bekok along the circumferential weld from about 5-to-7 o'clock positions.

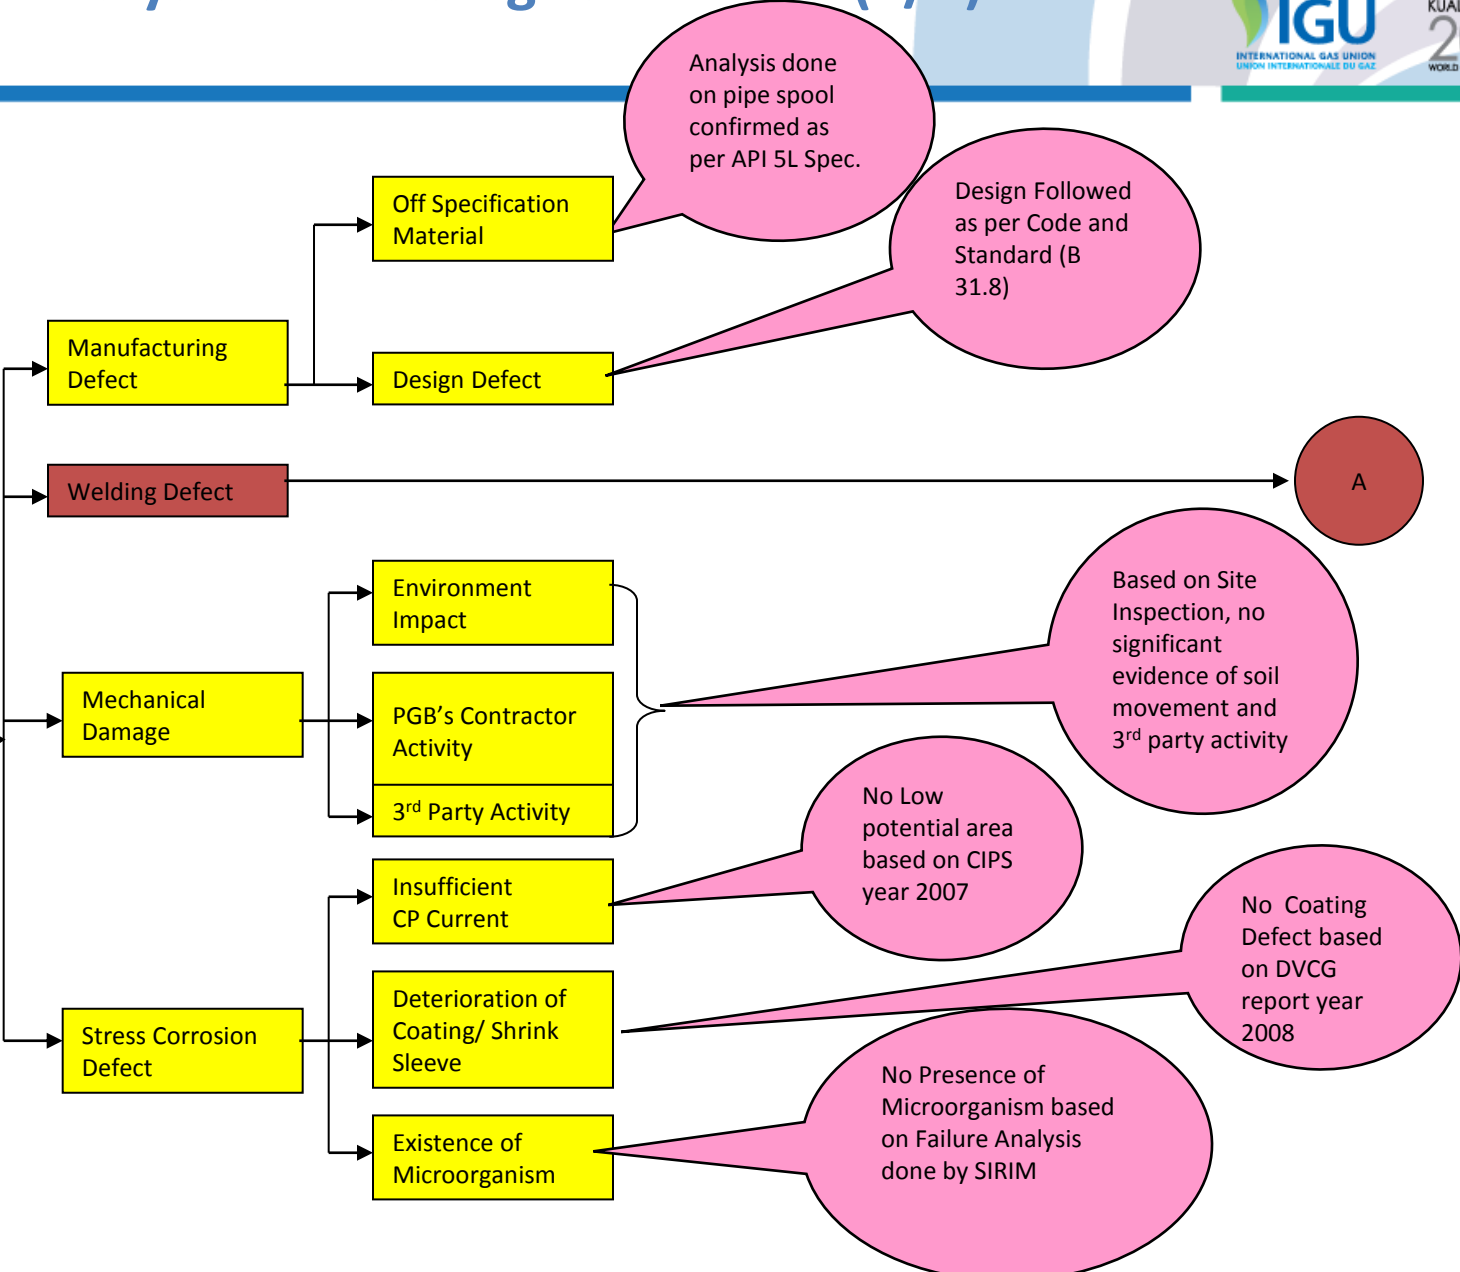
Pipe adjacent to welding joint (HAZ) at KP 69.2, PGU 2, Sector 3 crack and lead to leak and resulted estimated PONC of RM 4 M.

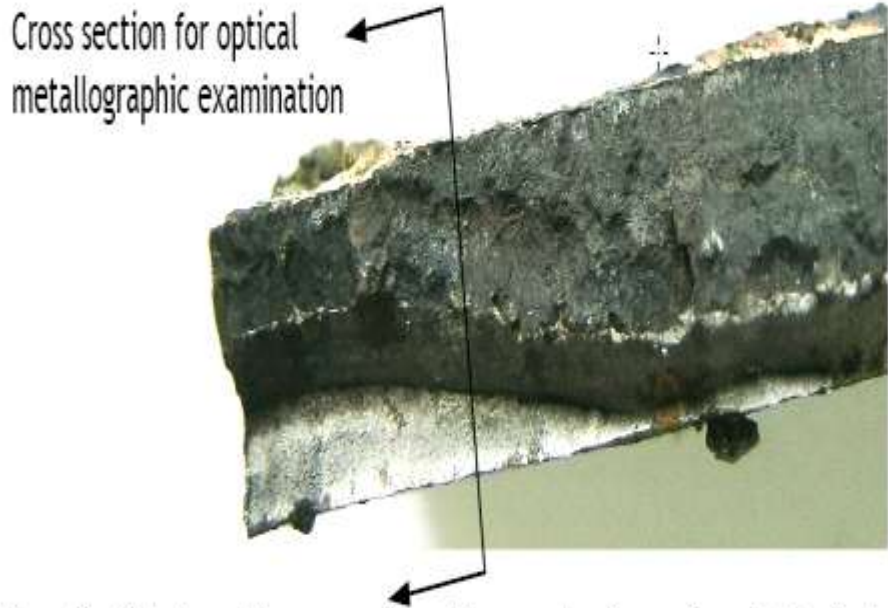
Figure 8: Metallographic cross section at the same location on the matching fracture surface (with that of Figure 7)

- Cracks initiated at weld toes due to hydrogen induced cracking mechanism leading to the formation of dark fracture surface filled with oxides.

- ✓ High-low weld imperfection
- ✓ Insufficient (or no) preheat
- ✓ Welding electrodes exposed to moisture in hot and humid conditions.
- ✓ NDT inspection conducted in less than 48 hours after the welding might miss any sign of HIC which might occur after a period of several hours.

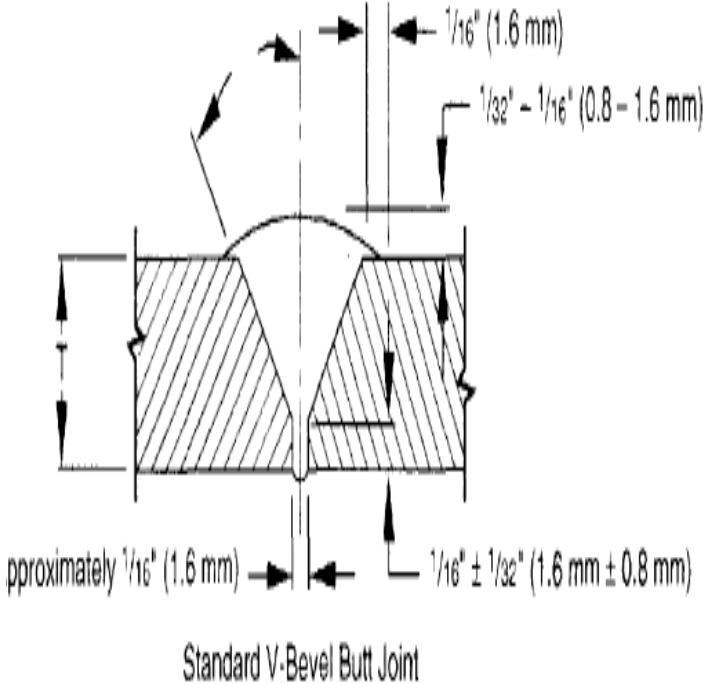
Figure 18: Macro examination of weld imperfection randomly selected from the sample

- ✓ The contributing factor highly possibly due to the welding process i.e. joint design incompliance with API 1104 standard
 - ✓ The defect/crack was not detected in the radiographic testing during the project/construction of the pipeline

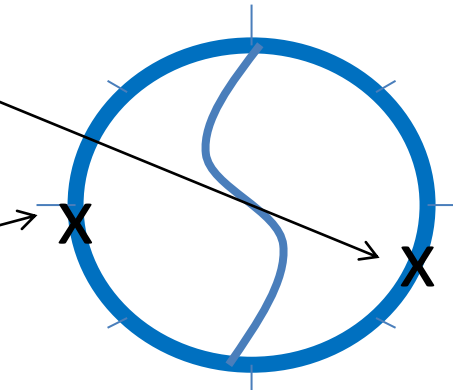
Location	Findings	Remarks
Bukit Siput	Cracks at 2 locations	1) 840 mm from 12 o'clock (L: 25 mm, D: 4-6 mm) 2) 1600 mm from 12 o'clock (L: 15 mm, D: 4-6 mm)

Position of cracks

Cracks RT Film

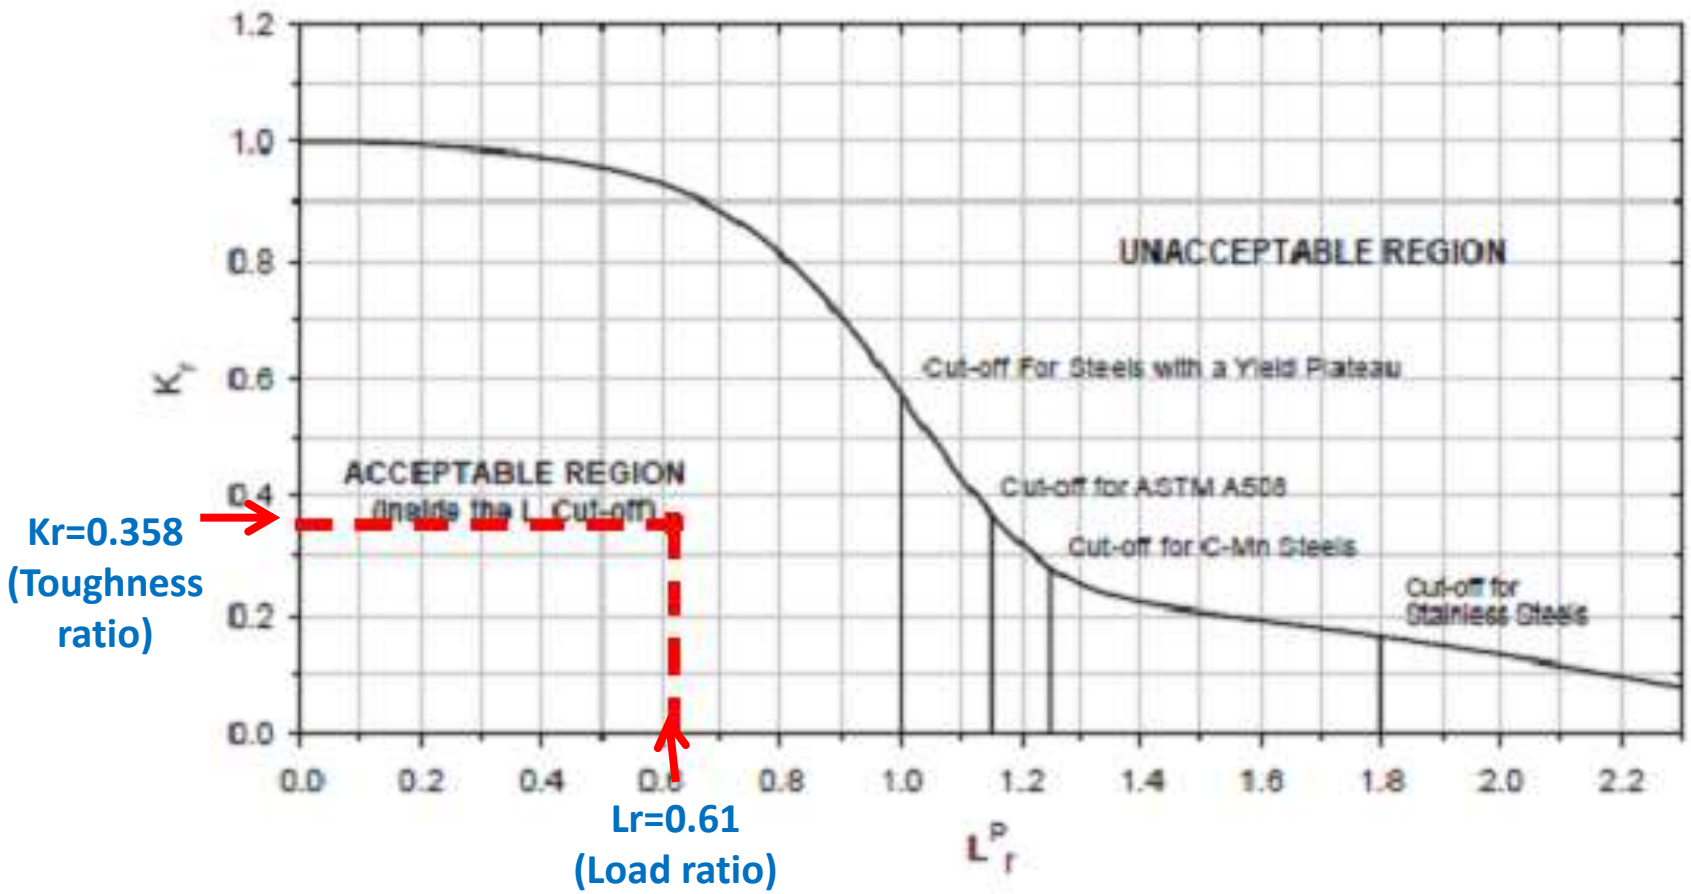
Conclusion: The crack on the weldment of the pipeline is acceptable per Level 2 assessment
