THEFT MITIGATION IN THE AUTOMOTIVE MARKET

Comgás

The Case

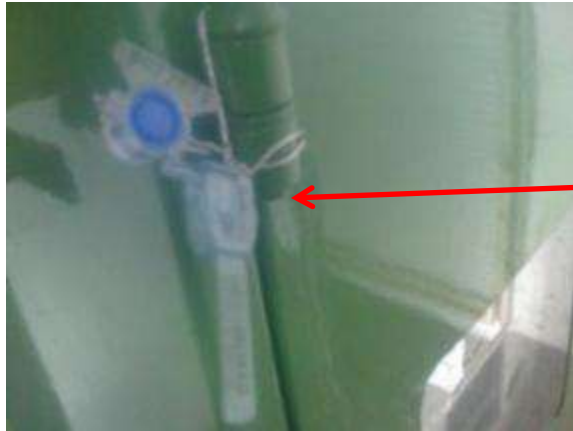
Seals Violations

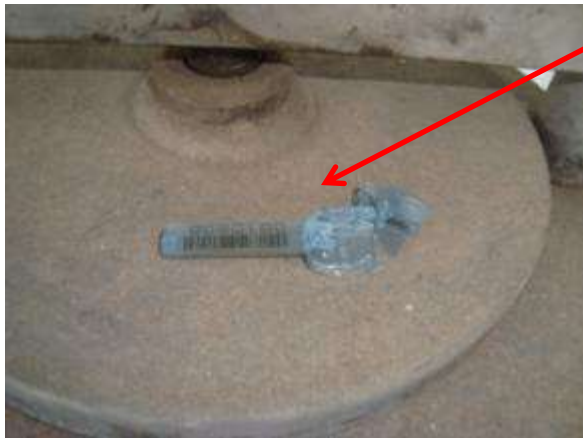
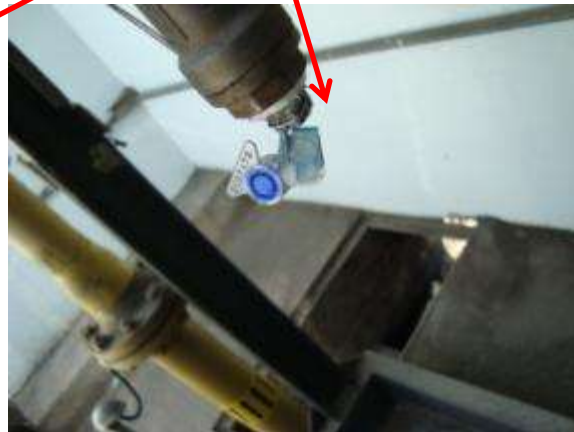
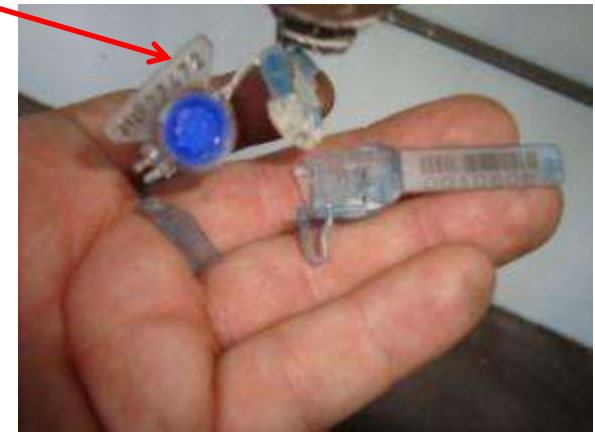
Violated seals

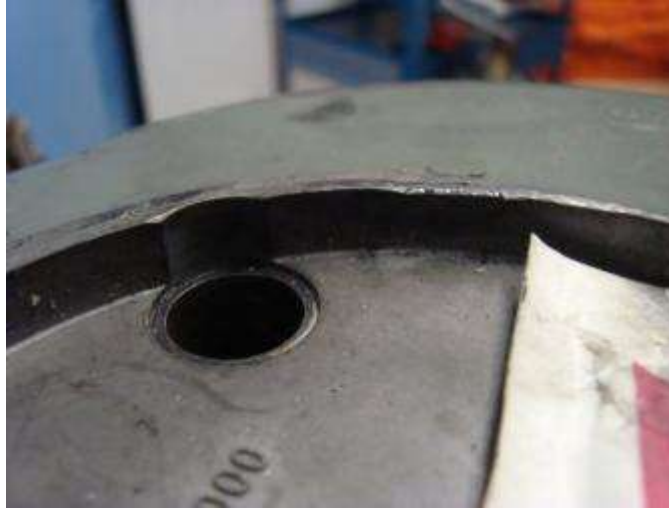
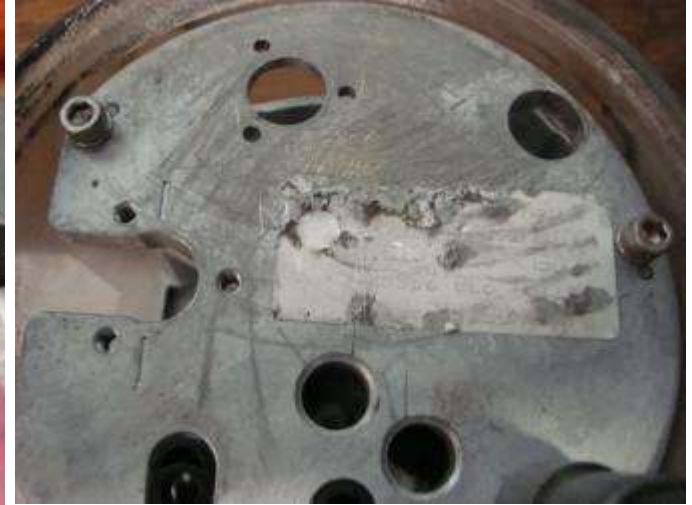
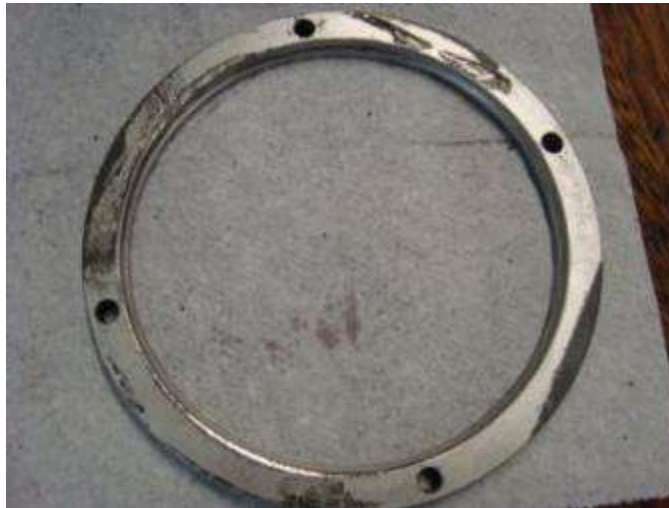
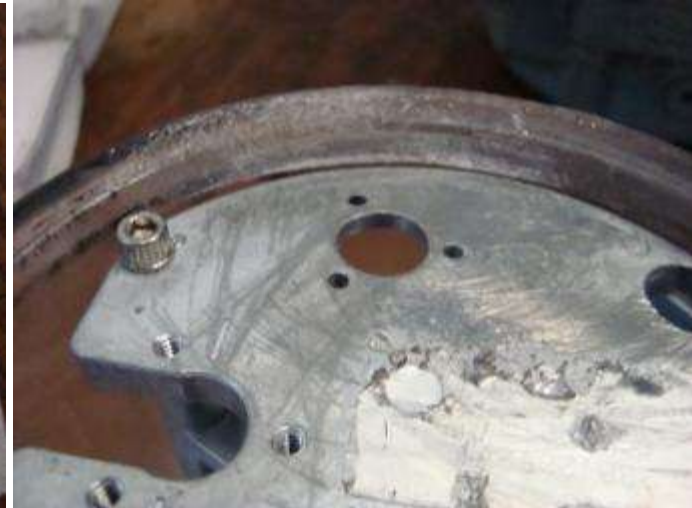
Meters Opened

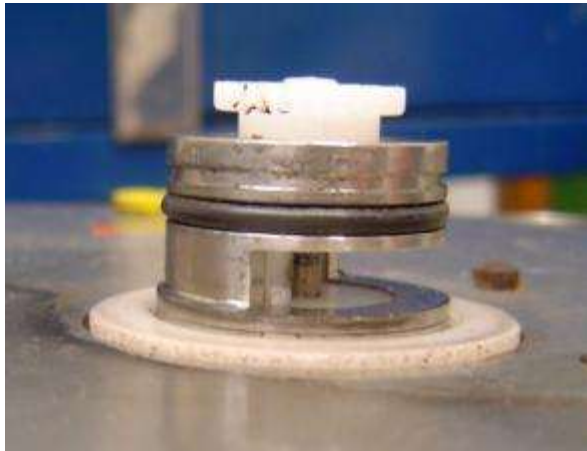
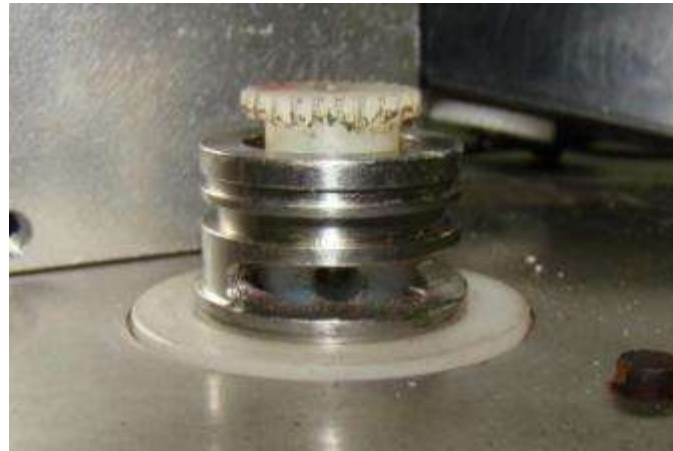
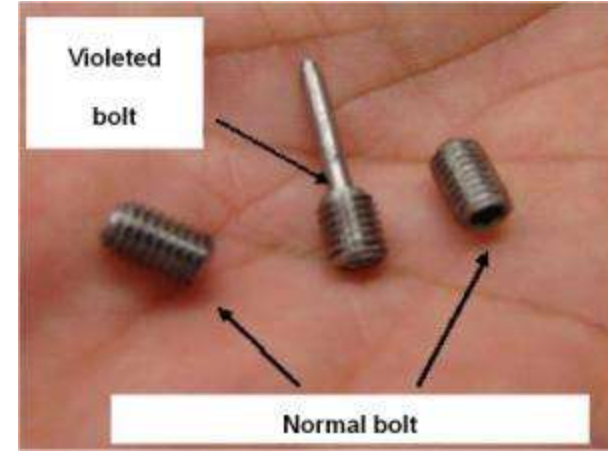
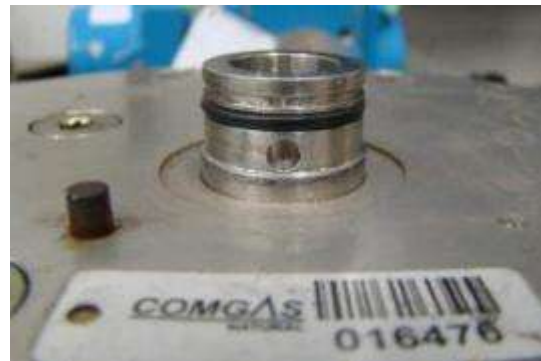
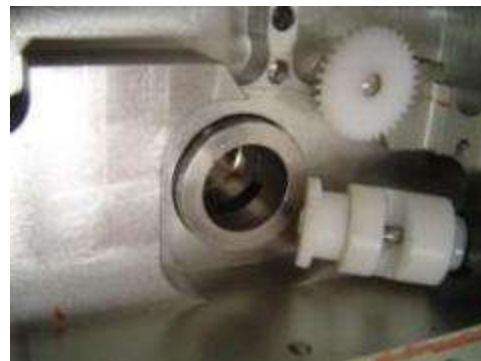
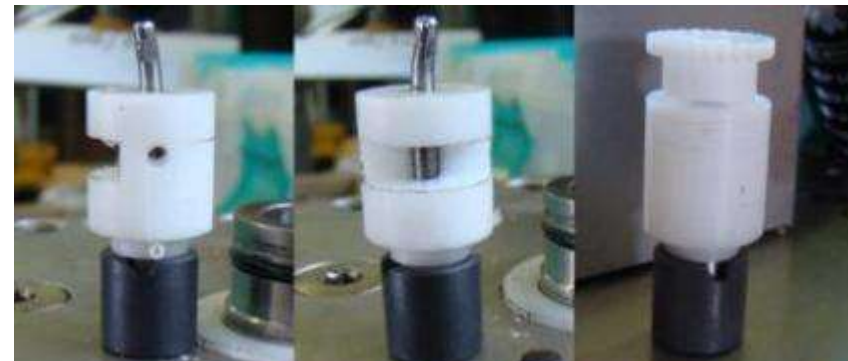
Holes in the Axis of the Meter & Screw Violation

Maisal de plástico do medidor inspeccionado evidenciando o furo (à esquerda), o cone sensível (ao centro) e um maisal de plástico padrão para esse tipo de medidor (à direita).

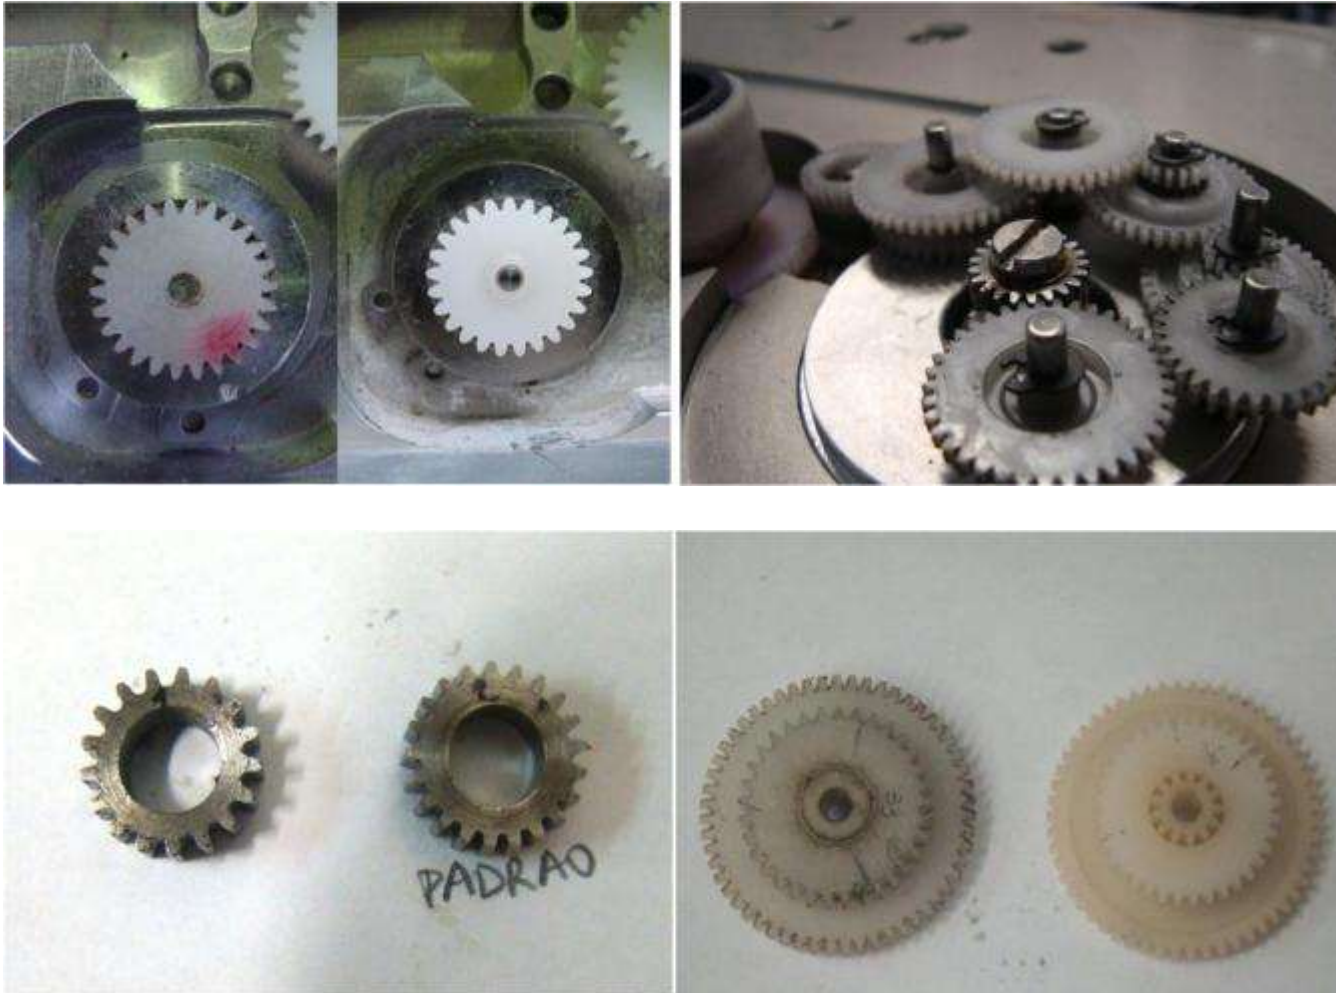
Gear Meter Violation

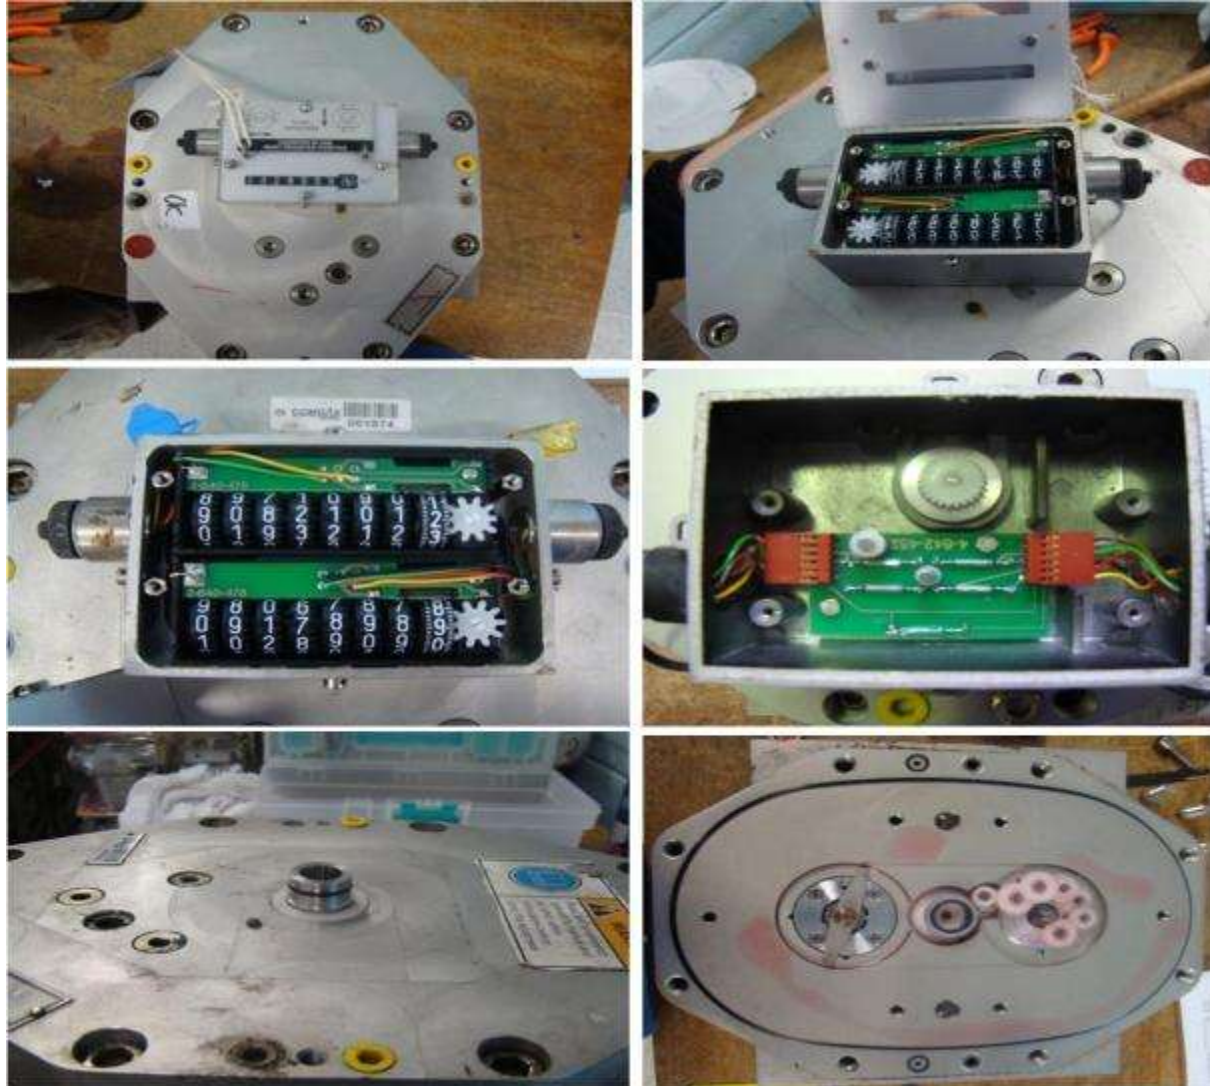
Meter Dial Violated

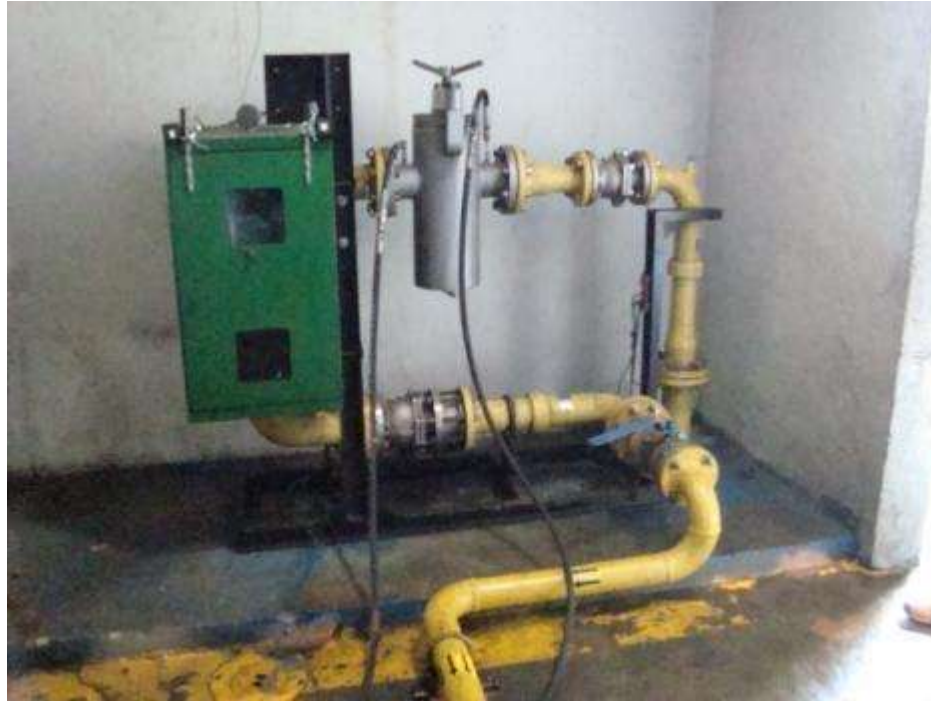
Meter By Pass

Meter & Filter

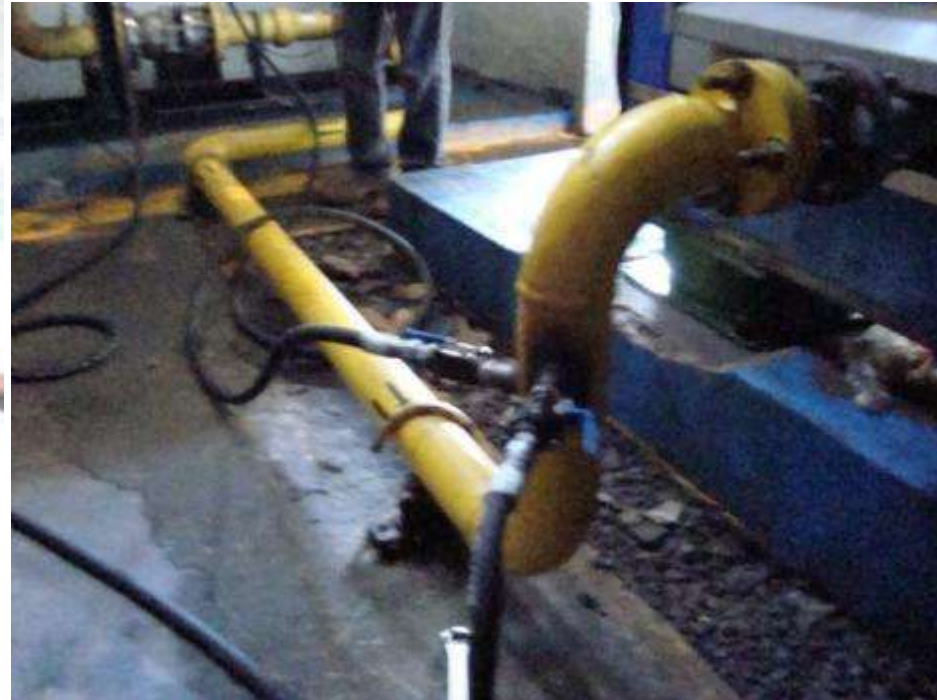
Compressor Entrance

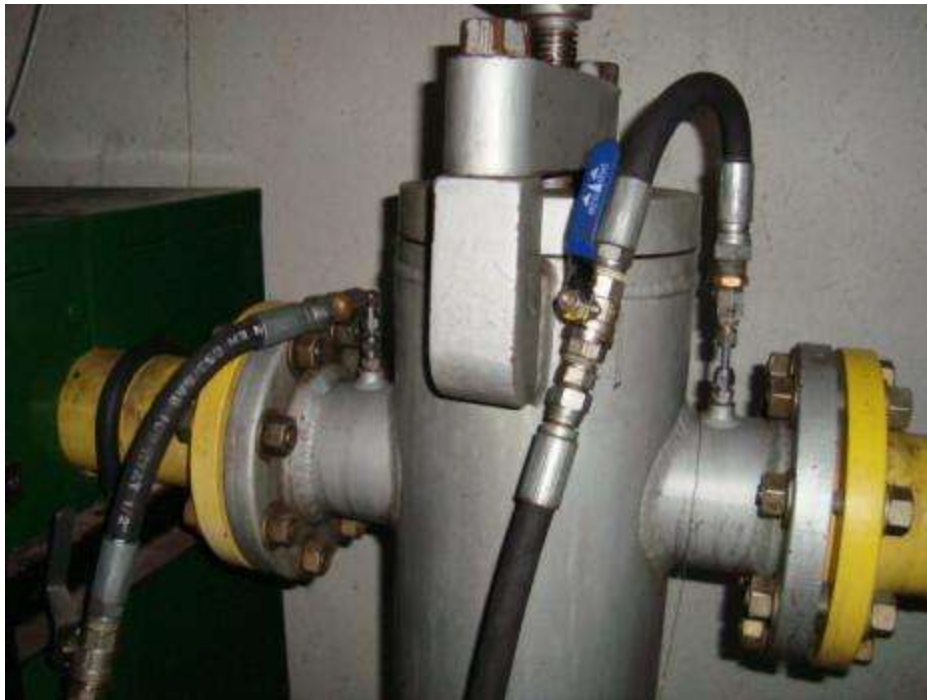
Meter By Pass

By Pass at Filter Pressure Gauges

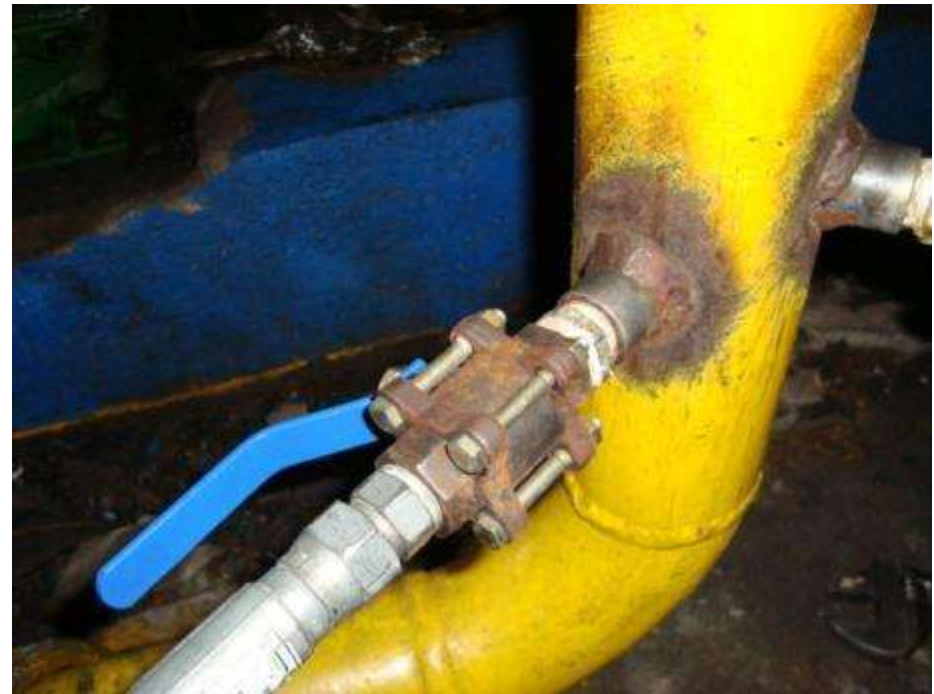
Compressor Entrance

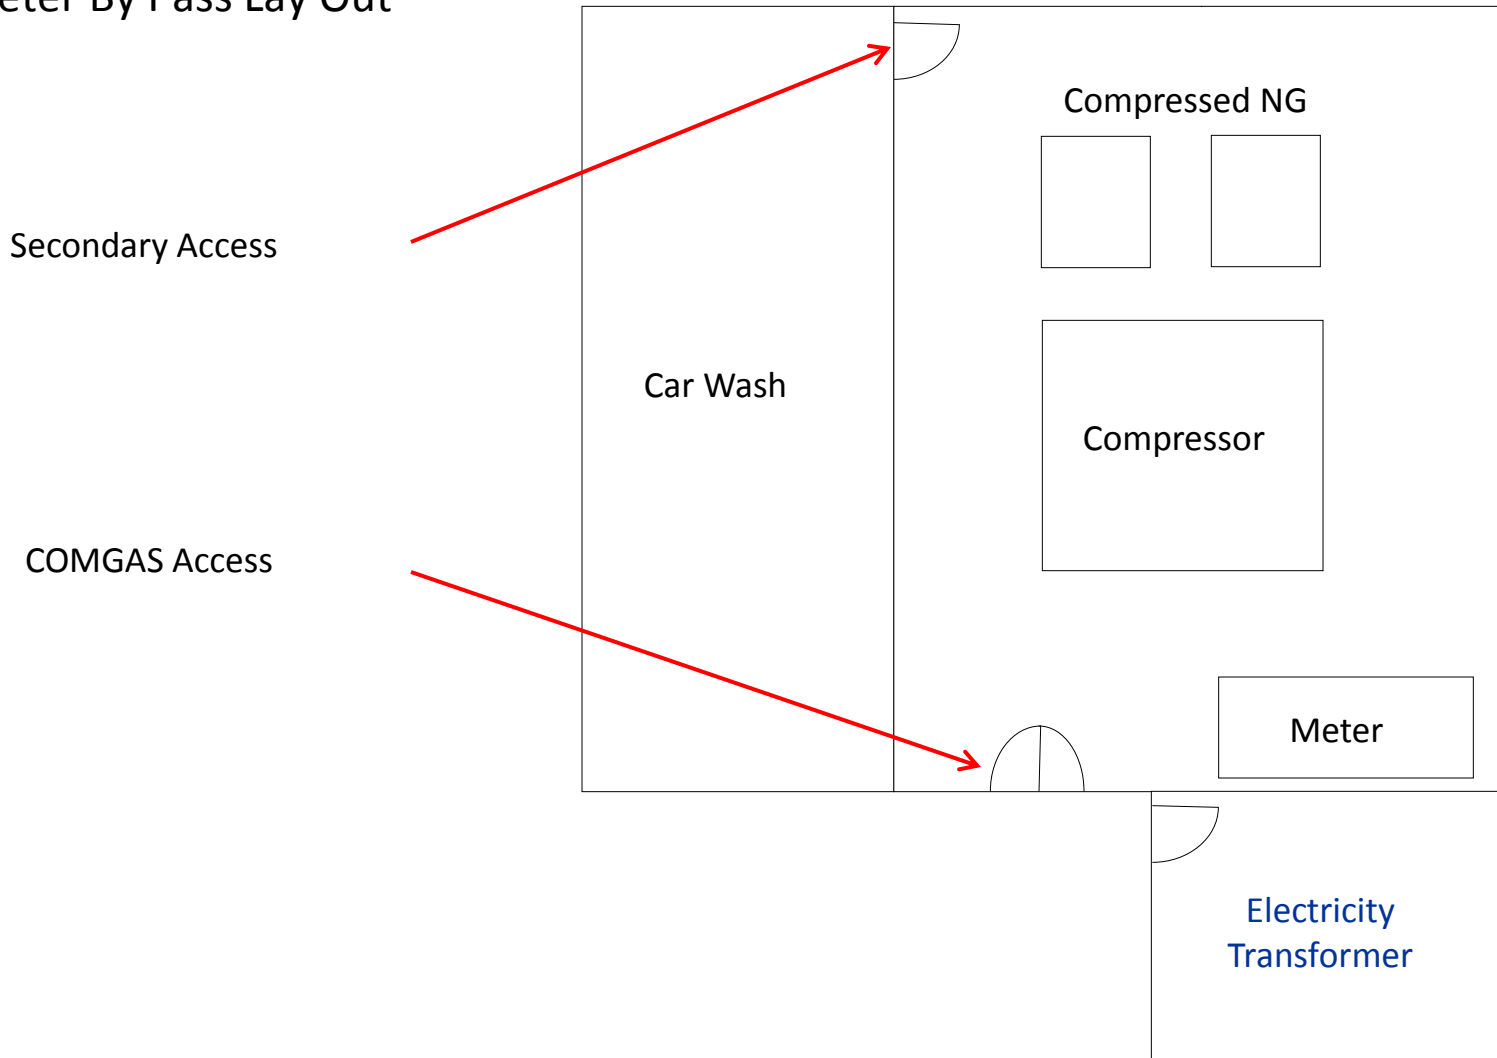
Meter By Pass Lay Out

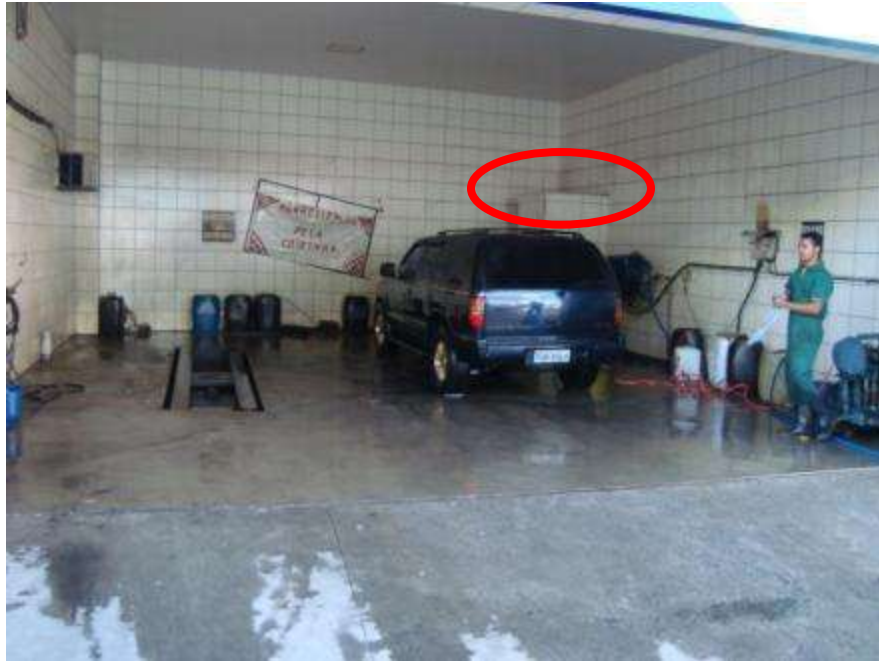
Meter By Pass Lay Out

Secondary Access

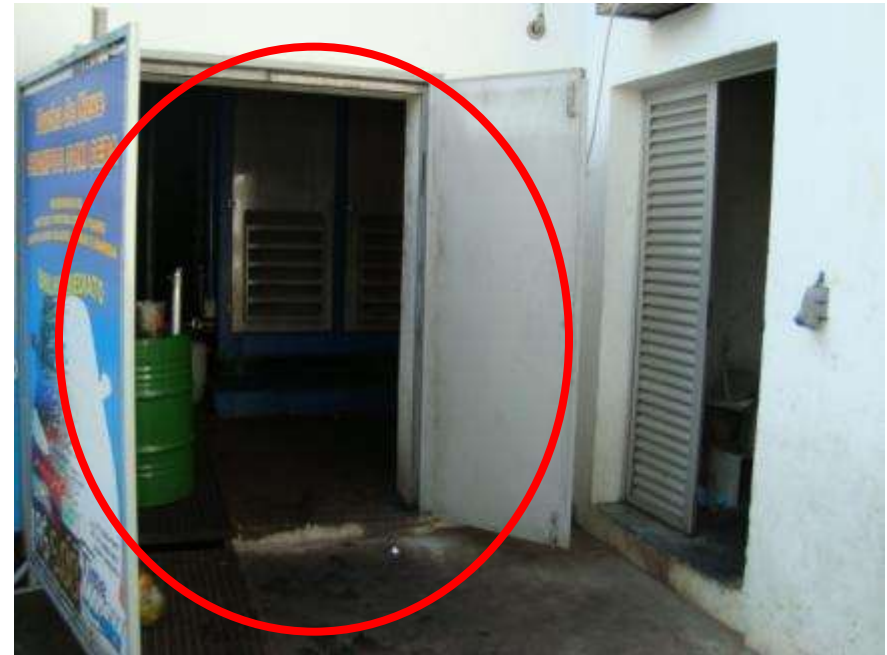
COMGAS Access

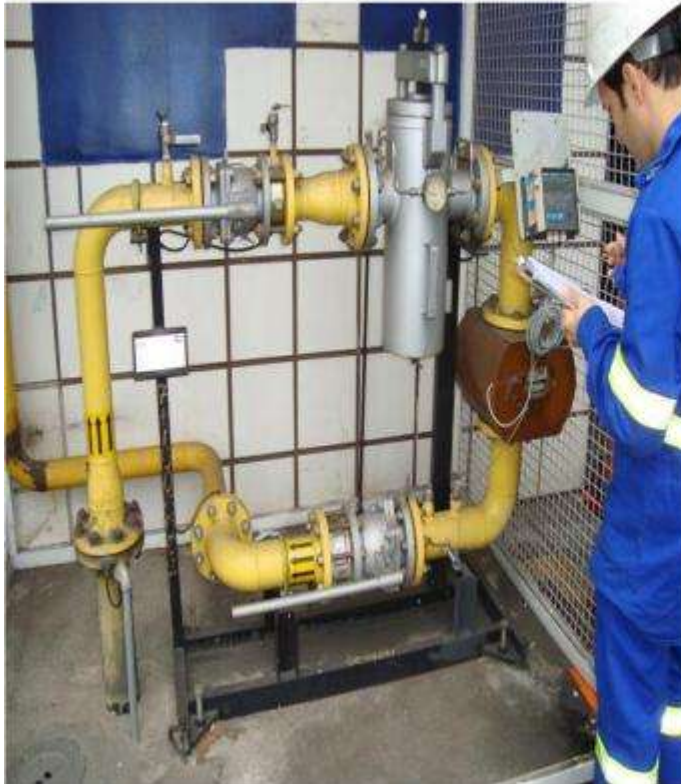
NGV Station A: before (meter with PU, without the box)
