25th world gas conference  
“Gas: Sustaining Future Global Growth”

# Effects of the Large-scale Earthquake and Tsunami on an LNG Receiving Terminal

Nobuhiko Takei,  
The Japan Gas Association  
6th JUN 2012

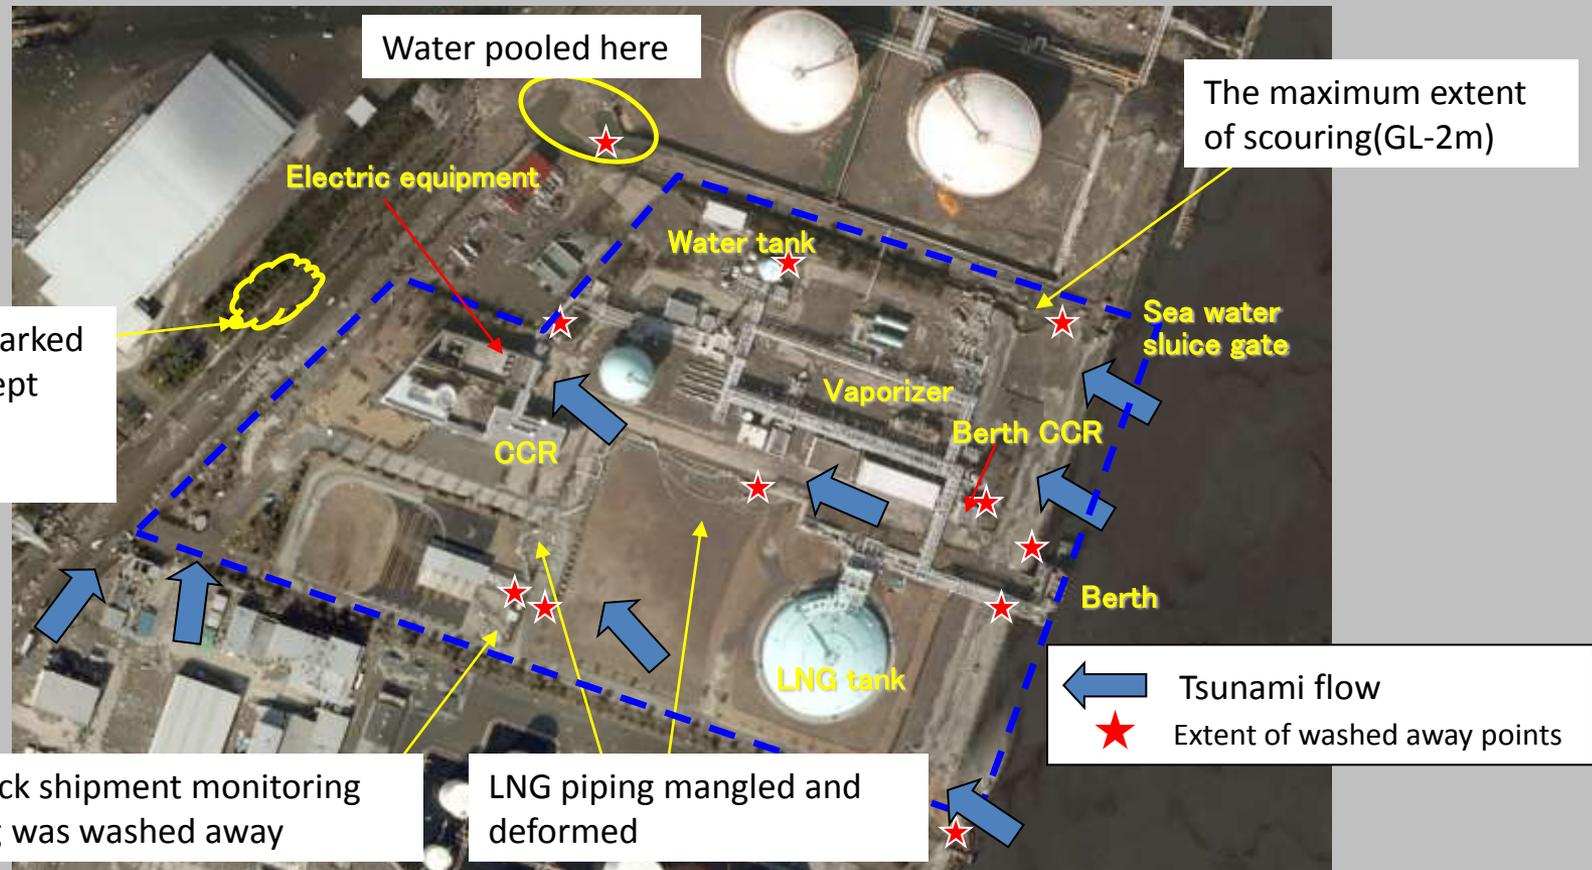
Photo : Geographical Survey Institute on the next day of the earthquake

- All areas except LNG tank area were flooded.
- Soil of 2 meters from the ground was scoured.

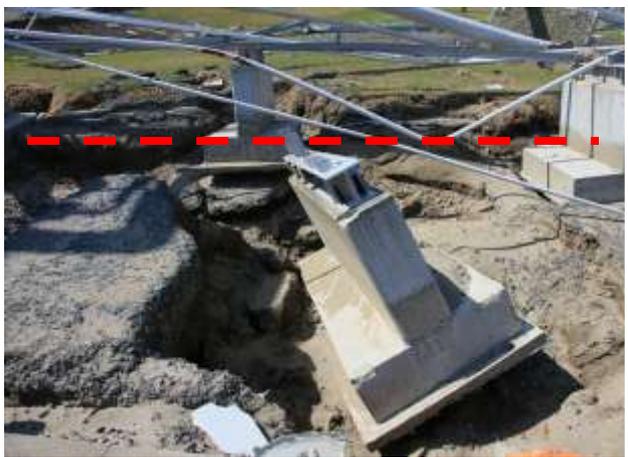
Flat slab foundation structures

- The area where flow was concentrated was seriously damaged.
- Drifting objects didn't cause serious damage.
- The slab foundation was damaged.
- Equipment with pile foundations were not seriously damaged.
- Erosion was quick to occur around unpaved locations.

■ The foundation of piping framework was changed from slab type to pile type.

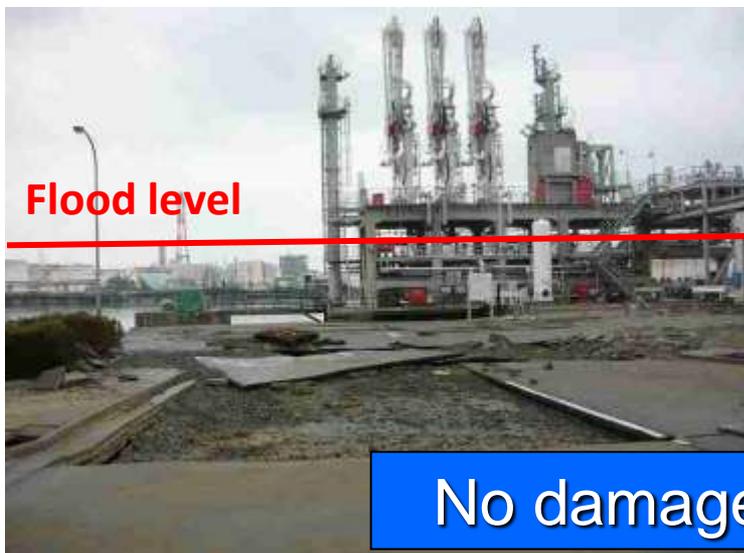
### ◆ 1. Receiving Equipment

Only some scouring on the surface of the ground which did not effect it's operationability.

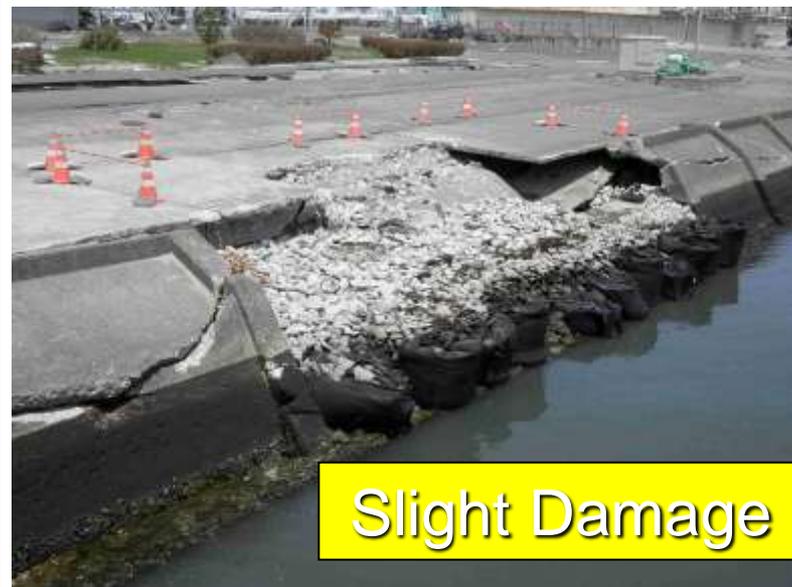
### ◆ 2. Bank

There was some partial scouring on the surface. However, there was no damage to the sheet-pile and the bank remained intact.

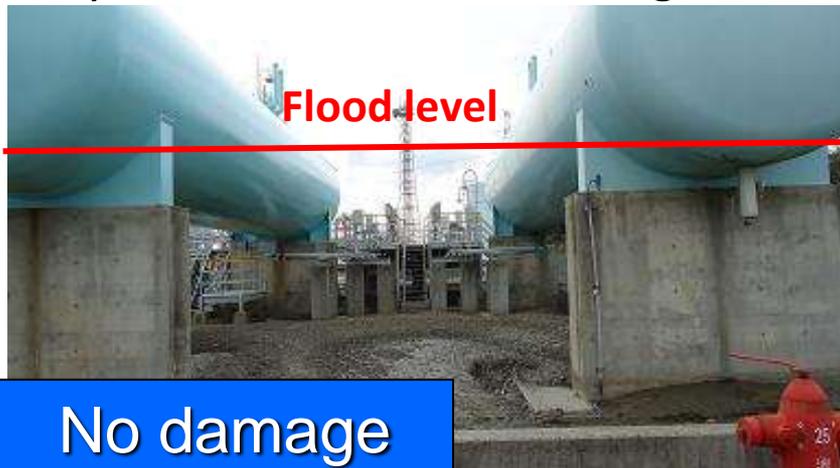
### ◆ 2. LPG storage tank

A part of it was flooded, some of the soil around the foundation was washed away, but there was no damage.

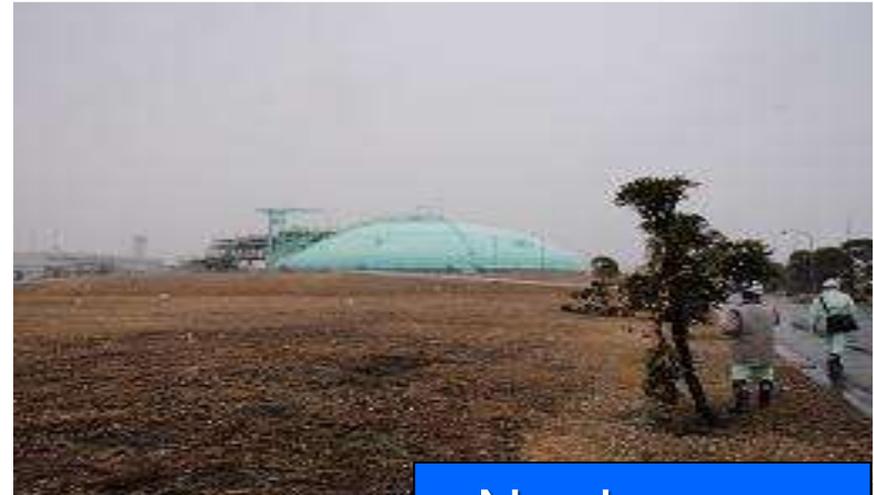
### ◆ 1. LNG inground tank

Luckily being on the top of a 4 meter banking hill spared it from being flooded.

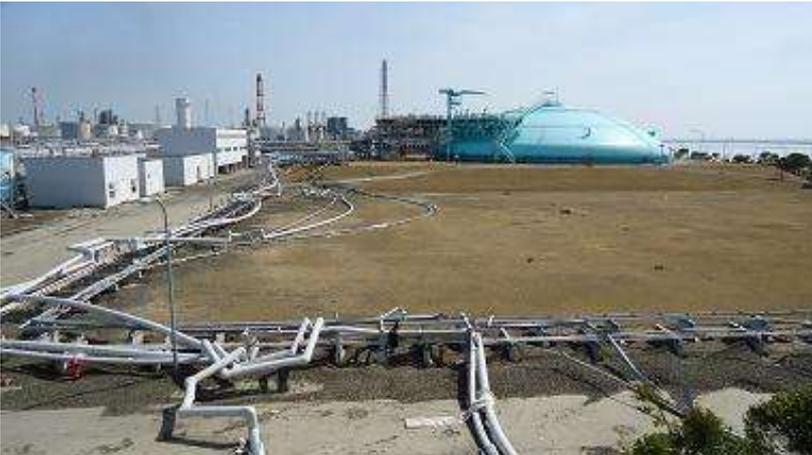
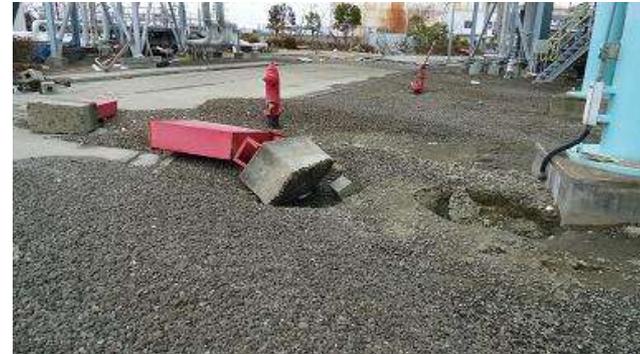
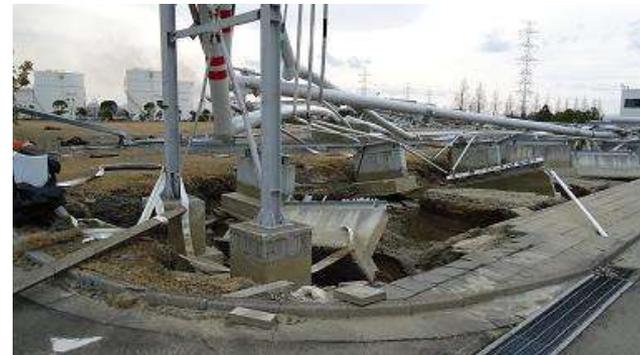
### ◆ 1. Shallow foundation of piping framework

- Framework collapsed due to being washed away around the foundation which were quite shallow.
- Although the piping was deformed there were no LNG leaks.

Damage

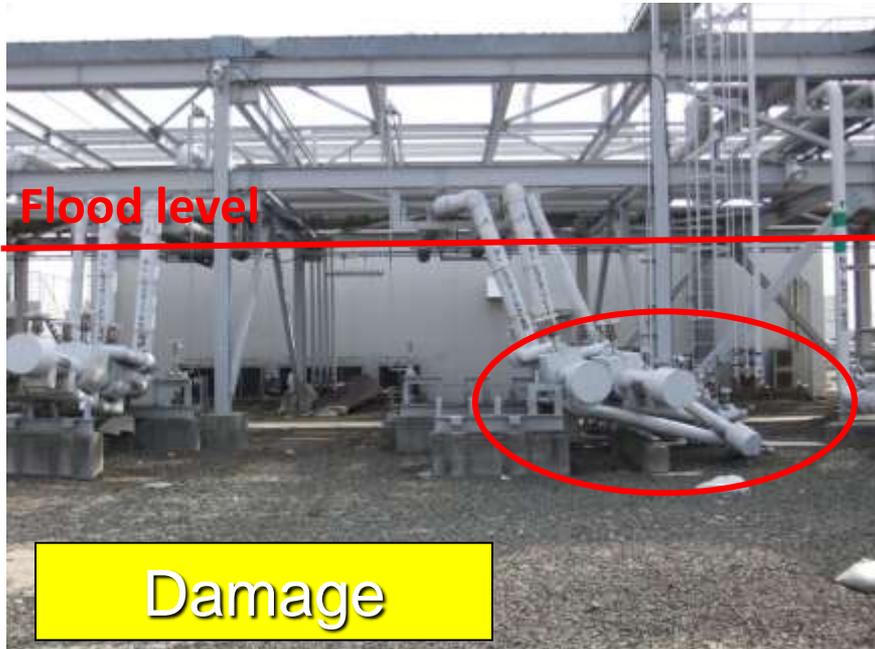
### ◆ 2. Loosely fitted piping allowed floating

- End of branch piping for future additional piping was not completely fixed to any framework and as such suffered severe deformation.
- Emergency shut down was carried out quickly, and there were no LNG leaks.

Secure pipes to prevent floating

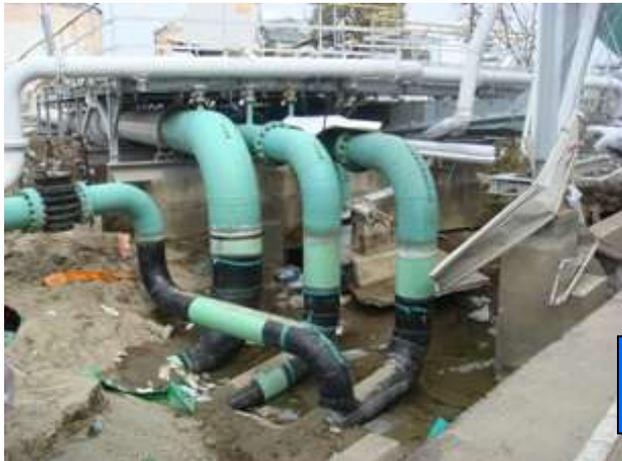
- ◆ 1. Gas distribution pipe

Although these were suffered severe water flooding, there was no damage and the operationability was maintained.

No damage

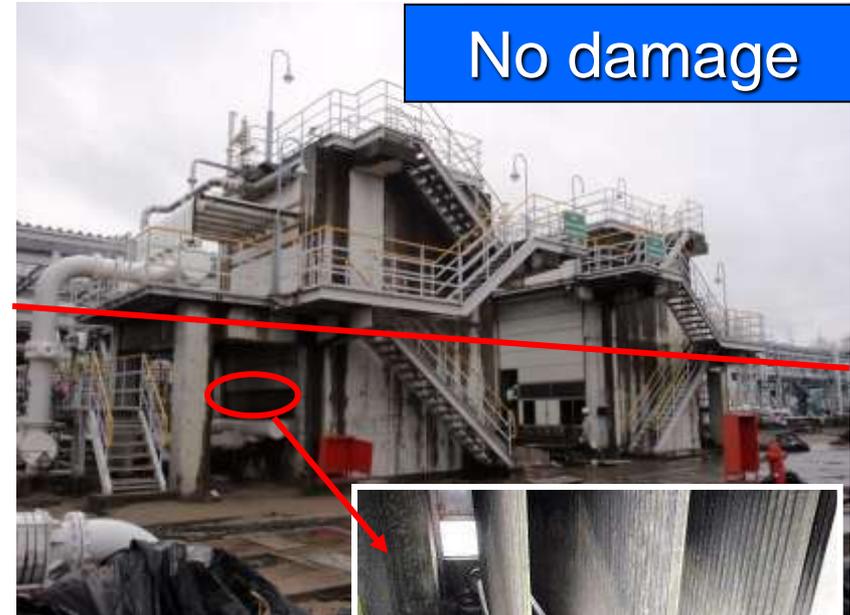
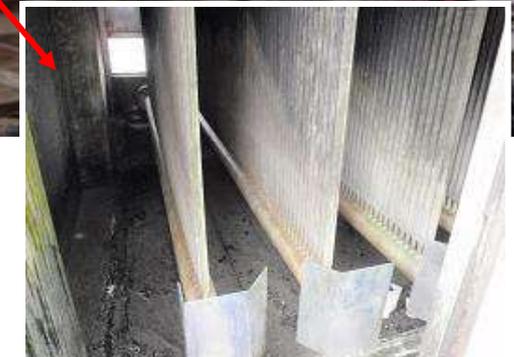
- ◆ 1. Open rack vaporizer  
It was not damaged.

No damage

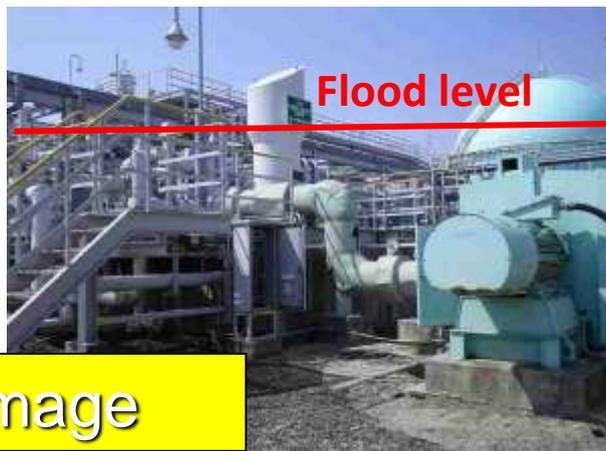
- ◆ 2. Submerged combustion vaporizer  
Control board and combustion air blower were flooded and the operationability was lost.

Damage

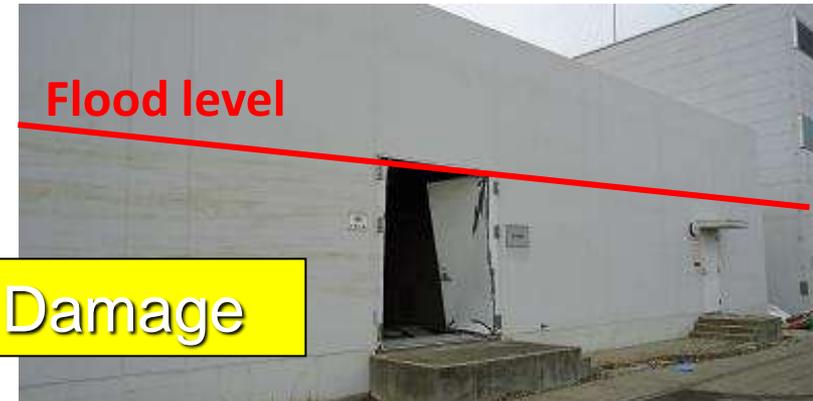
### ◆ 1. Substation equipment

Tsunami damaged non watertight doors allowing internal flooding.

The equipment operations failed.

Damage

- Replacing doors of important buildings with watertight (airtight) doors like those in the odorization building.

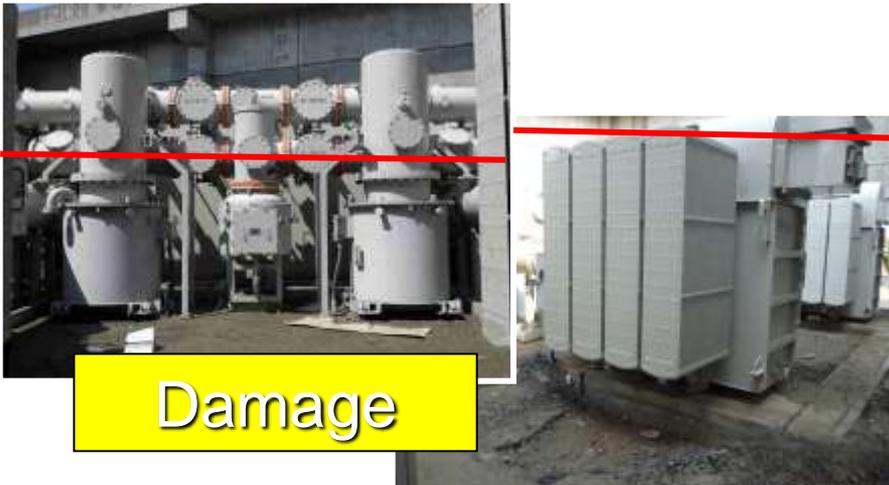
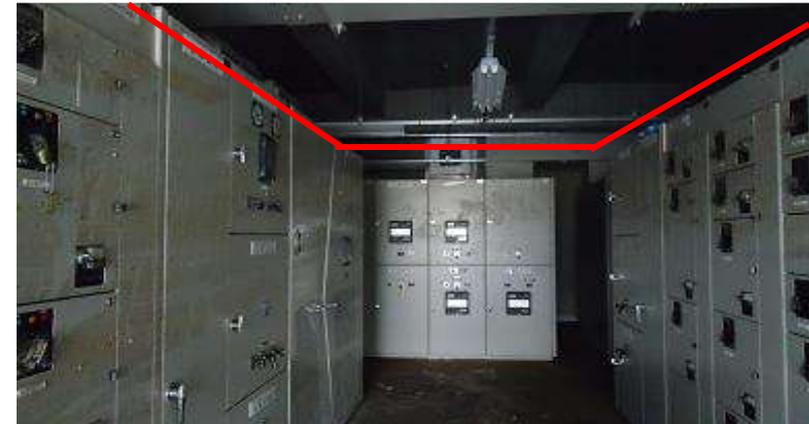
### ◆ 2. Power receiving equipment

Outside installation was flooded and equipment failed.

Damage

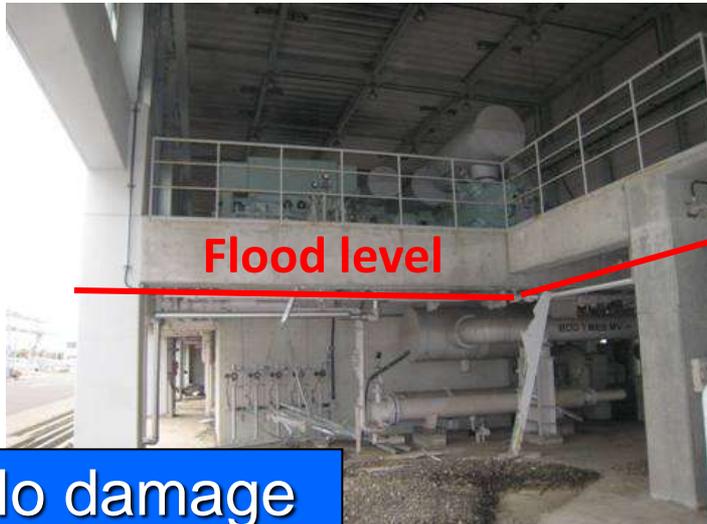
### ◆ 2. BOG compressor

It was installed on the second floor and not damaged.

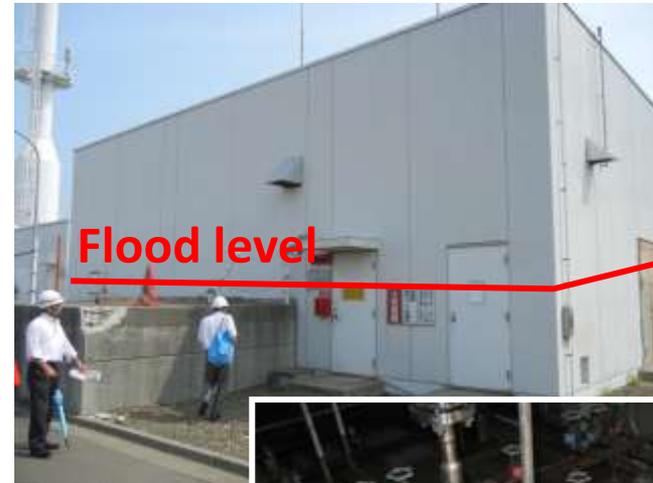
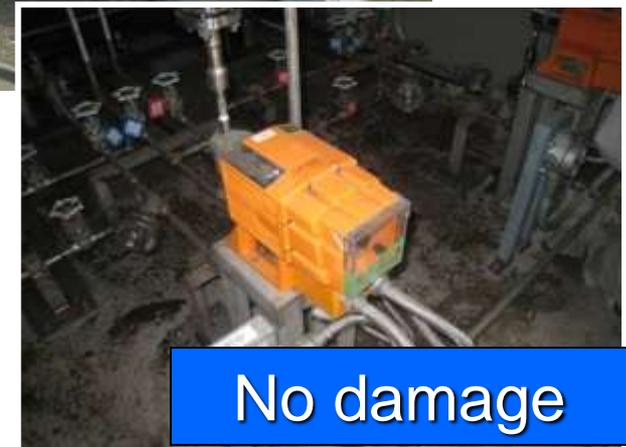
### ◆ 1. Odorization equipment

It had highly airtight doors with no aperture, no flooding occurred.

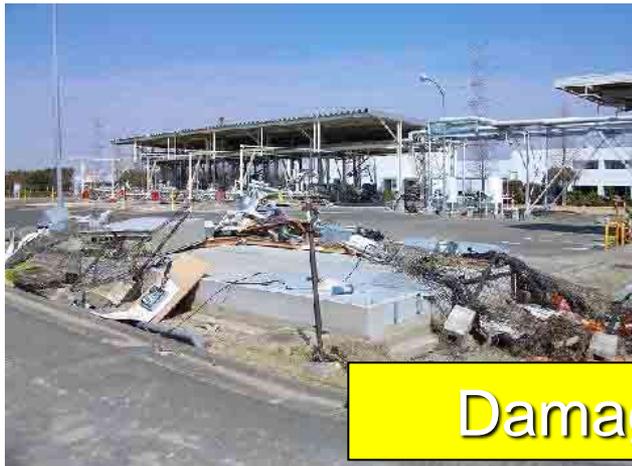
- ◆ 2. LNG truck loading building  
A lightweight building was swept away.

Damage

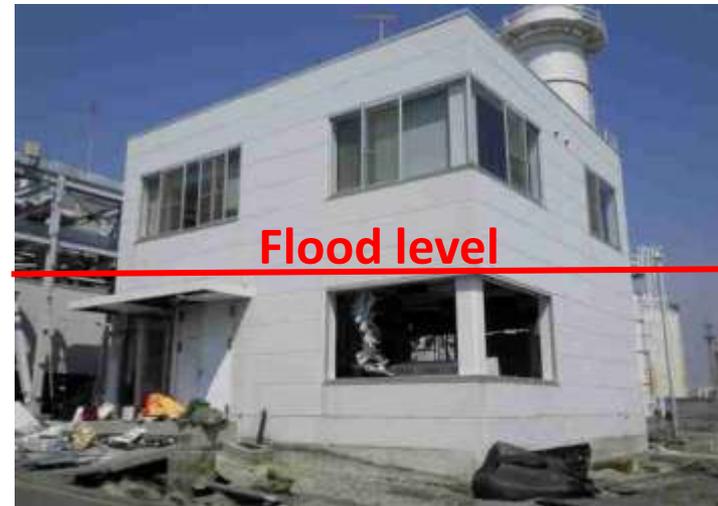
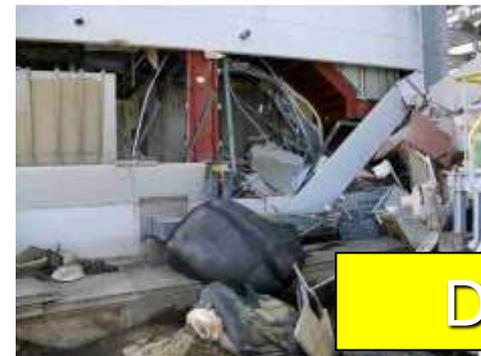
- ◆ 1. Berth control center building  
The wall and windows at the first floor were damaged.

Damage

- The LNG receipt and truck loading monitoring facilities, which had been on the first floor and suffered damage, were relocated to the second floor.
