MANAGING INTEGRITY OF HIGH PRESSURE GAS PIPELINE: ROOT CAUSE ANALYSIS AND HYDROGEN INDUCED CRACK (HIC) DIRECT ASSESSMENT OF WELDMENT CRACK ON 30" GAS PIPELINE

Abstract:

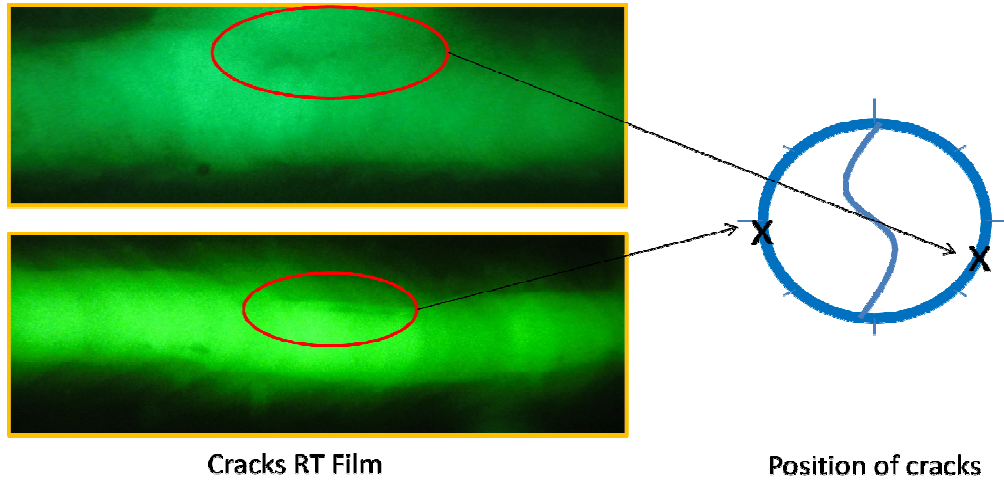
Location	Findings	Remarks
Tenang	Cracks at 2 locations	1) 840 mm from 12 o'clock (L: 25 mm, D: 4-6 mm) 2) 1600 mm from 12 o'clock (L: 15 mm, D: 4-6 mm)

Figure 1 – RT films showing crack-like flaws at two locations
