25th World GAS Conference, Kuala Lumpur 2012

Implementing Maintenance Programs for ageing pipelines: GRTG's experience

GRTG.Spa

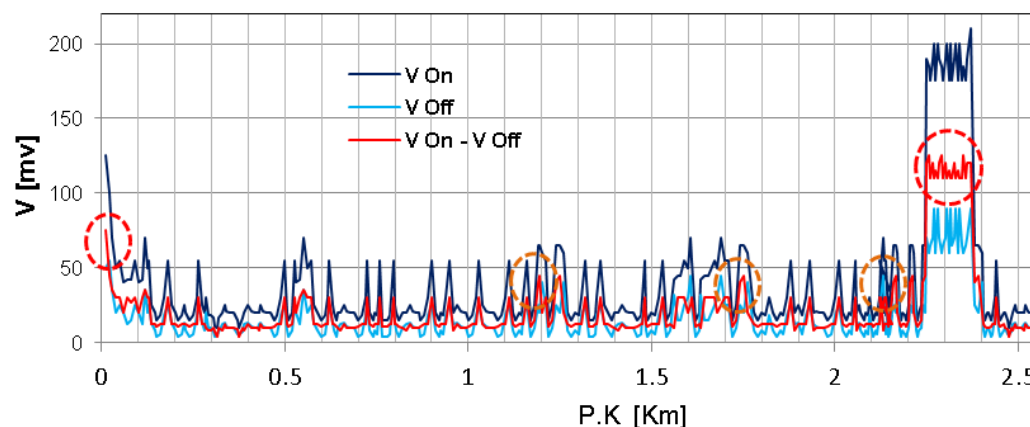
Ø 8" Hadjar Essoud DCVG's measurements

When we analyzed the above plot, we decided to undertake two excavations between PK 0,010 to PK 0,030 (20 meters) and PK 2,250 to PK 2,370 (120 meters).

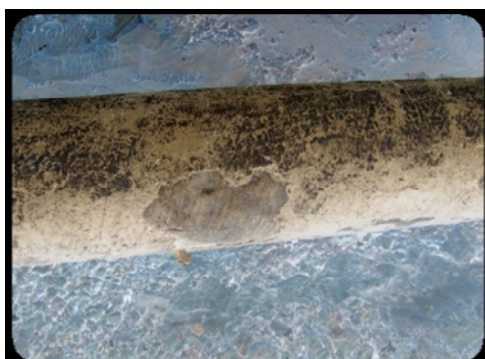
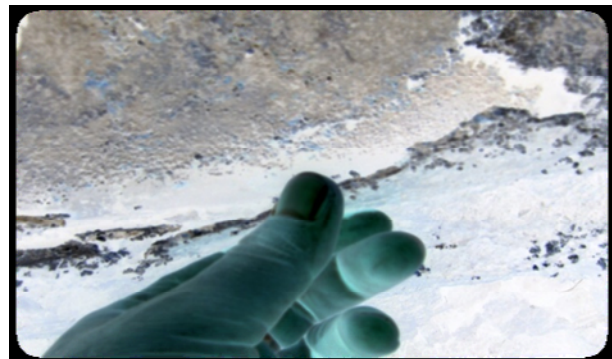
The first excavation permitted us to delineate three coating defects and notice that the pipe's wall surface is good.

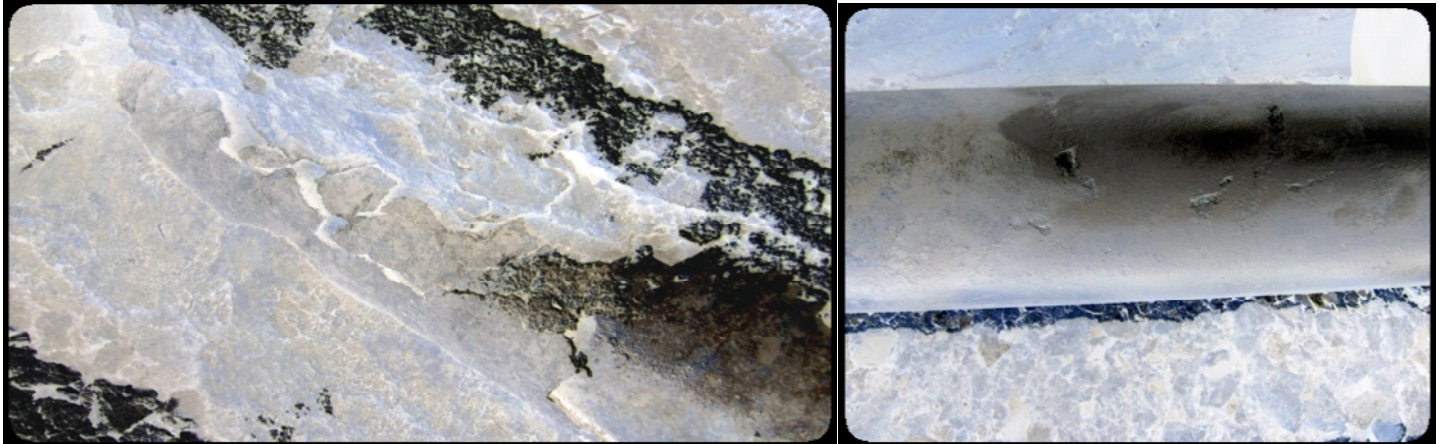
The excavations done between PK 2,250 to PK 2,370 (120 meters), permitted us to notice large coating defects and the presence of 11 corrosion's points, in a 5 m of one section of the pipe.

Taking into account the obtained results from these two excavations and the presence of many houses near the gas pipeline, the company judged useful to replace the entire pipeline in order to avoid any hazardous situation.

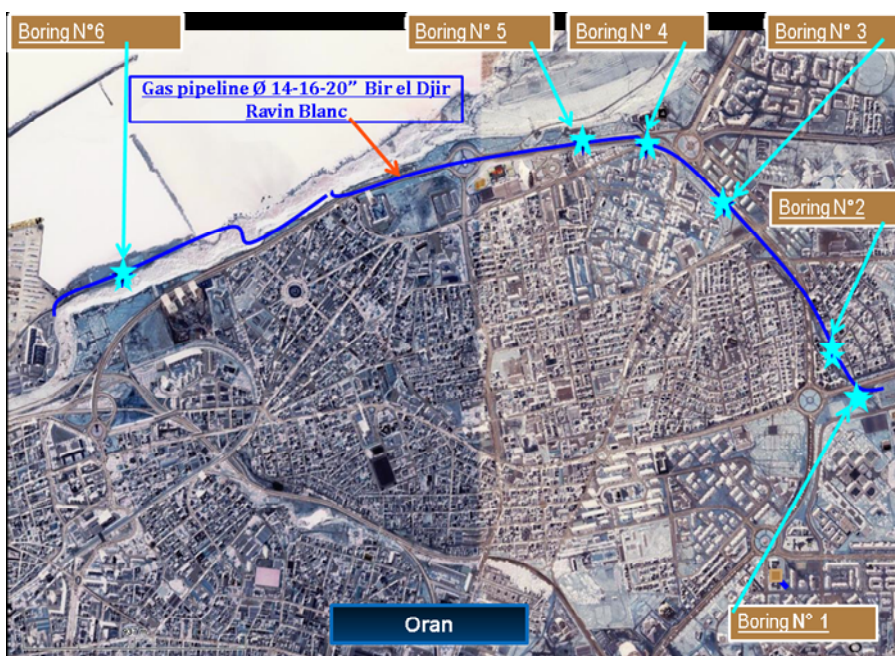
For this gas pipeline the historic CP's data is good. but because of the ageing and the fact it crosses high population density areas, the company decided to undertake On line's inspection. The analysis of the obtained data, gave us small chances to delineate the coating defects (no abnormal measurements).

The chosen excavations (boring 1 to 6) were then done by taking into account the high population density area, the lower soil resistivity and the obtained On line's measurements.

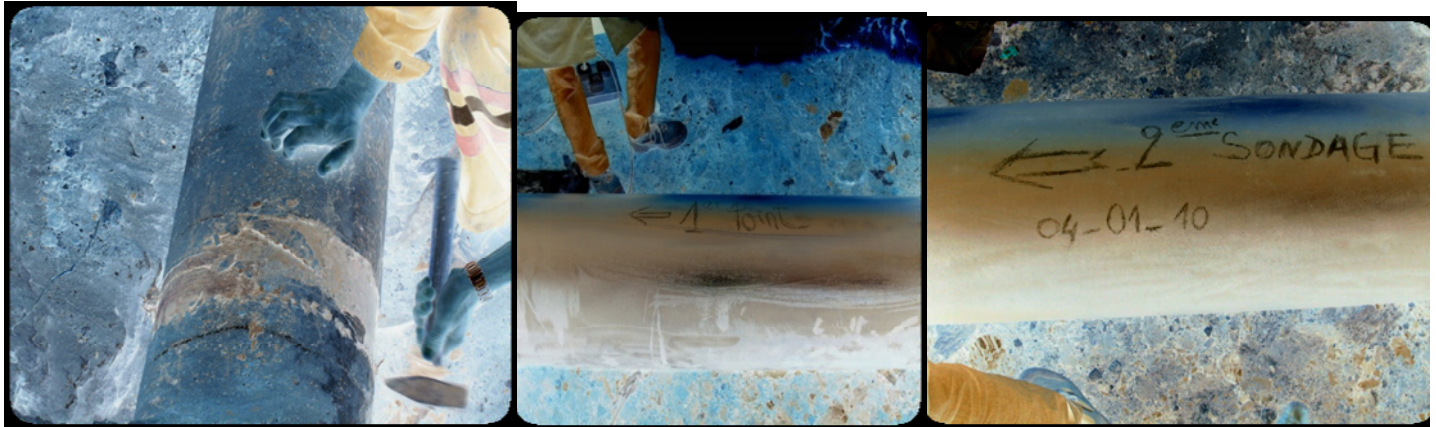
It was noticed that for the whole excavations done, the coating adhesion and the pipe's wall surfaces are good.

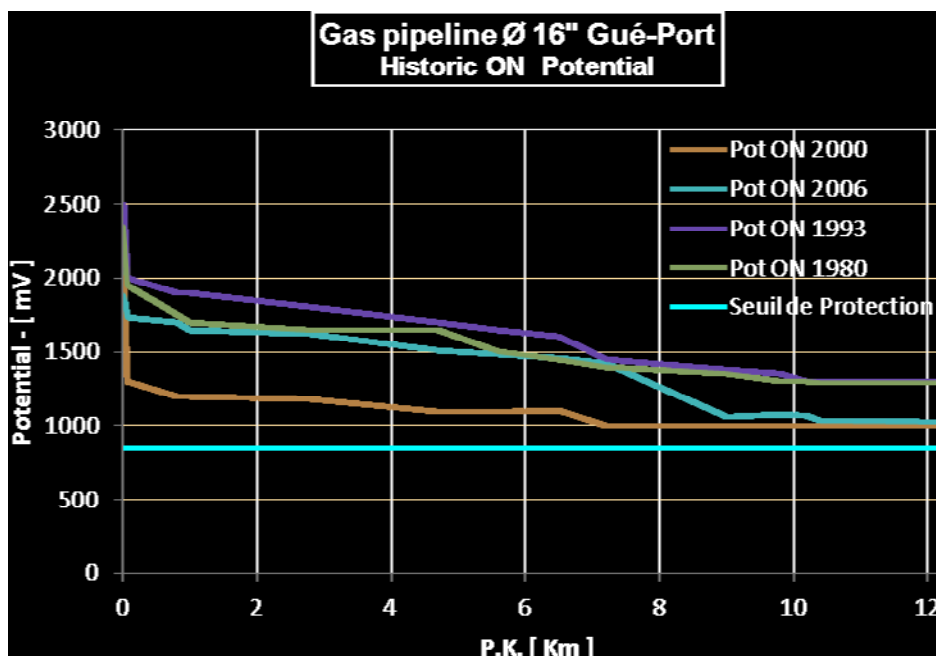
As it's shown by the above diagram, the PC's level for the 80's – 90's and 2000's years, was always above the threshold of protection (so for the 60's and 70's).

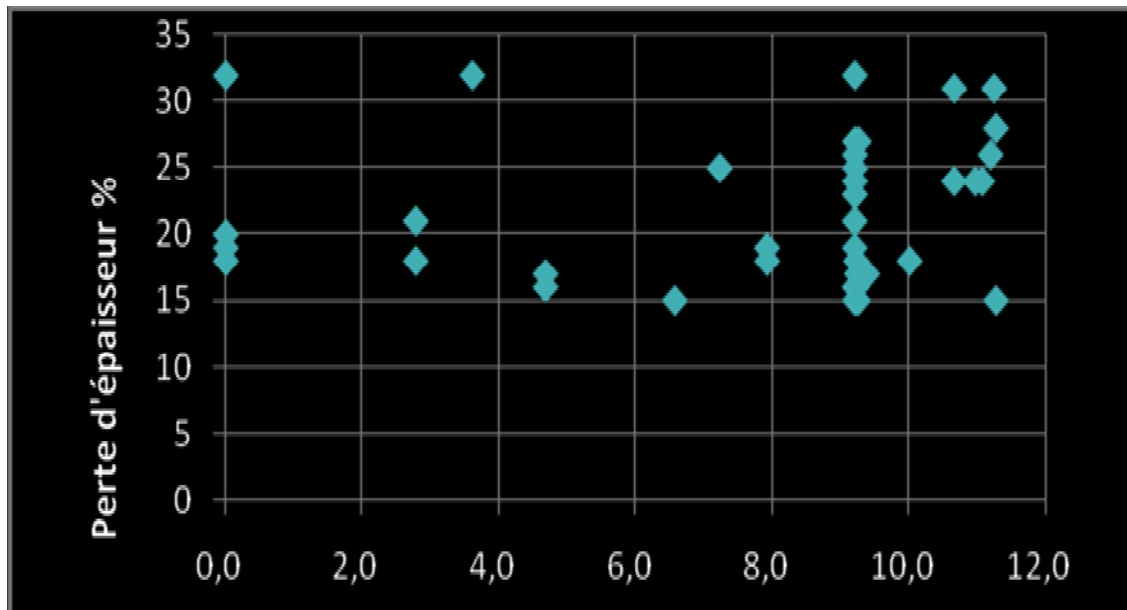
The In line's inspection undertaken on 2003 revealed few pipe wall's thickness loss numbers, as it's shown by the below chart:

The effectiveness of the CP's system and the rigorous monitoring undertaken by the CP's operators permitted the company to maintain the integrity of the pipeline (the presence corrosion's points could be assumed negligible).

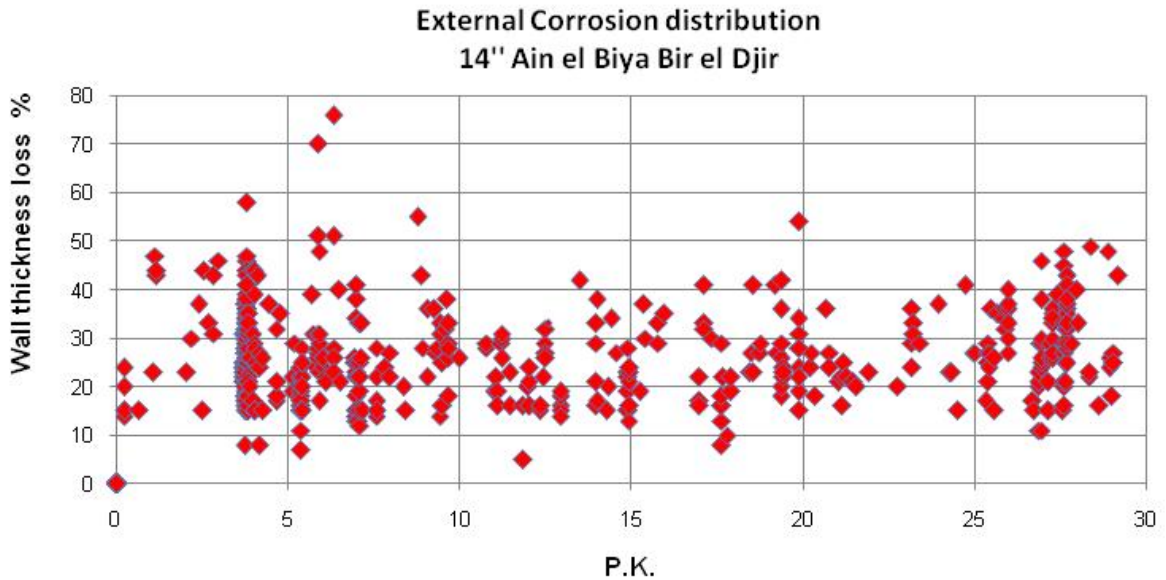
The In line's inspection undertaken on 2009 revealed the presence of 498 external corrosion's point, in which 34 are considered according to the ASME B 31 G, as dangerous points.

Another thing which surprised the company is the diminishing of the wall's pipe thickens from the internal surface. The results show that we've 1382 cases along the entire length of the pipe, among them 57 are considered dangerous.

The In line's inspection results are shown by the below chart for the external corrosion points.

The obtained results permitted to the company to establish rapid curative programs to eliminate the dangerous parts of the pipeline.

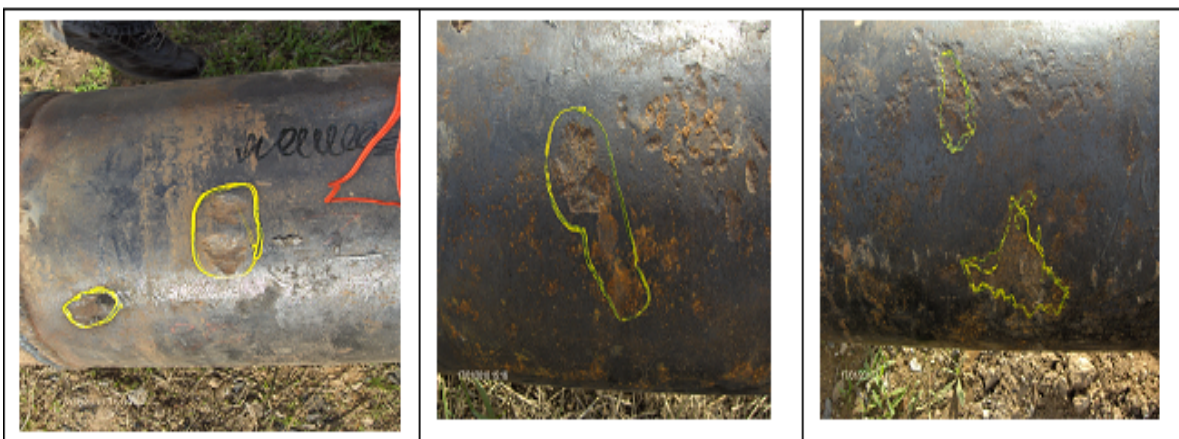
A test-tube has been constituted by most sever part of the tubes removed from the pipeline after the cut out operations, as shown by the below photos :

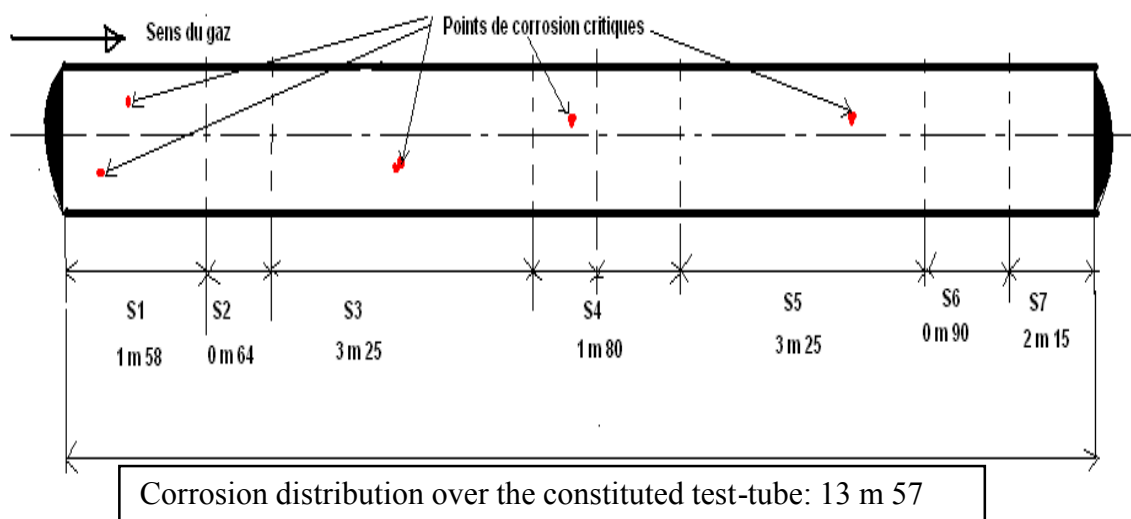
The total length of the 7.9 mm wall thickness of the test-tube is 13,57 meters, and the total number of the external corrosion's point is 25 among them 05 are considered dangerous.

The 05 dangerous corrosion's points are listed in the first lines of the below table :

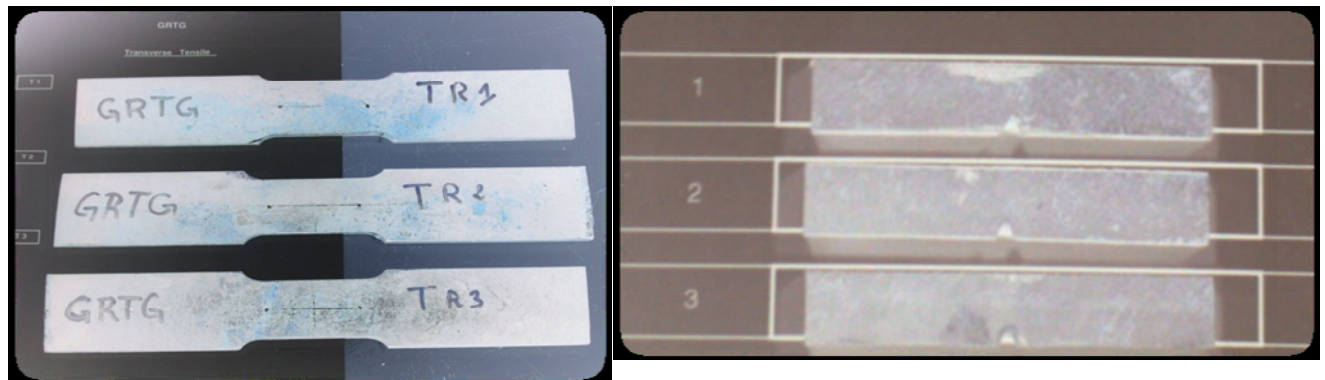
Rupture :resistance to the tension. The absorbed energy to the shock of a material.

The analysis of the obtained results by the laboratory (for the tension and elasticity limits), permitted to conclude that the tested sample has the same mechanical's characteristics as the tube of X 42 (according to the API 5L).
