Theft Mitigation in the Automotive Market

Company Name: COMGÁS – Companhia de Gás de São Paulo

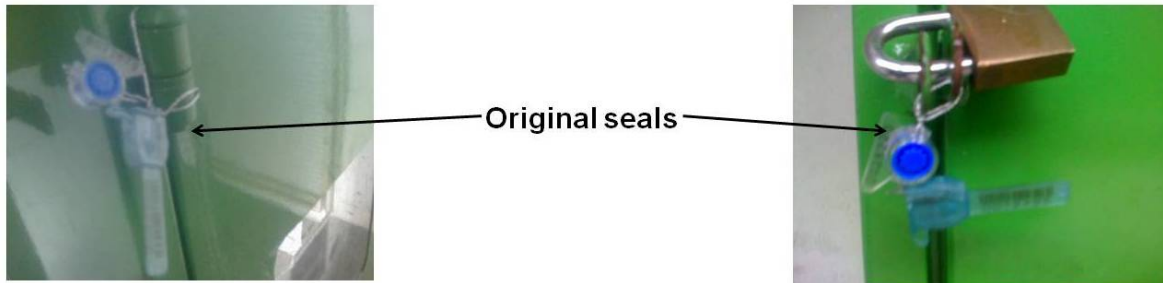
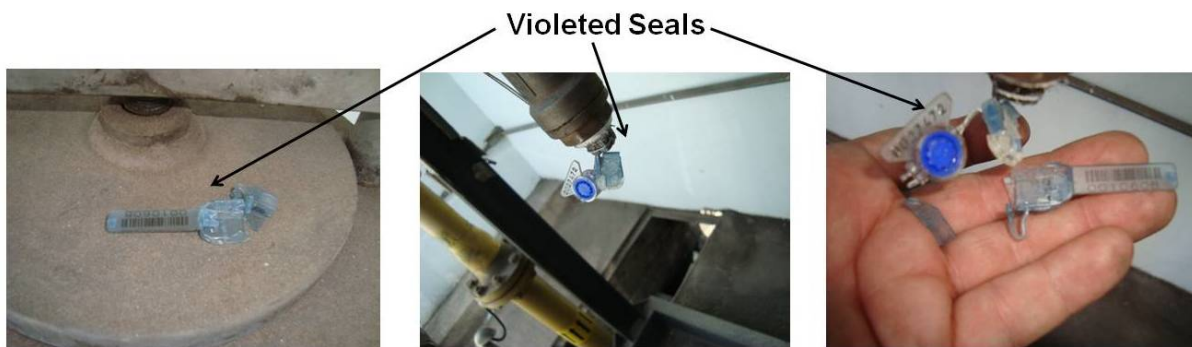
1- Seals Violation

The seals may be broken by actions that are not necessarily linked to the theft of gas. However, the exchange of original seals by non original seals and the violation of the original seals are clear indications of actions aimed at gas theft.

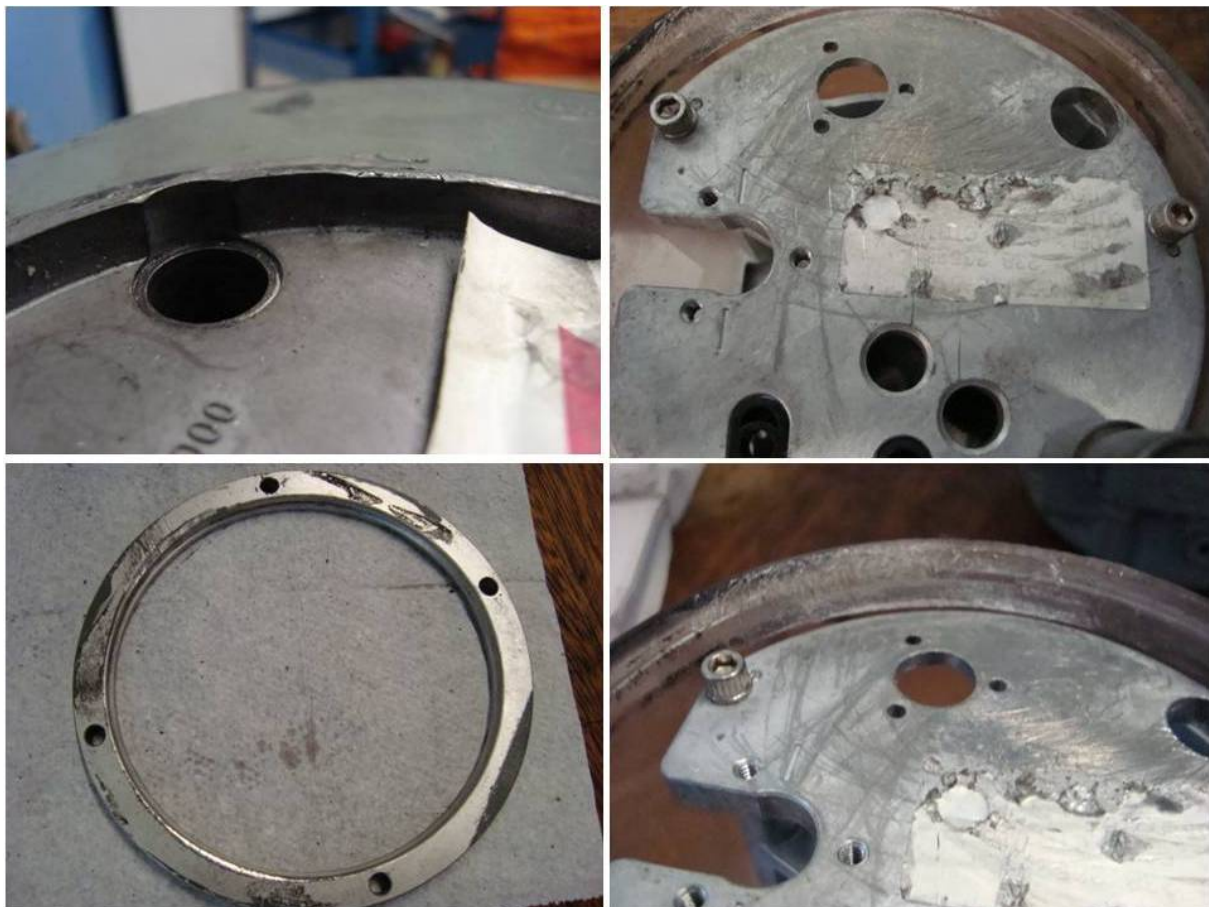
2- Meters Opened

The meters are owned by COMGÁS and according to the supply contract the customers are forbidden to manipulate these equipments. The attempt to open the meter is a clear indication that there was the intention to deviate gas.

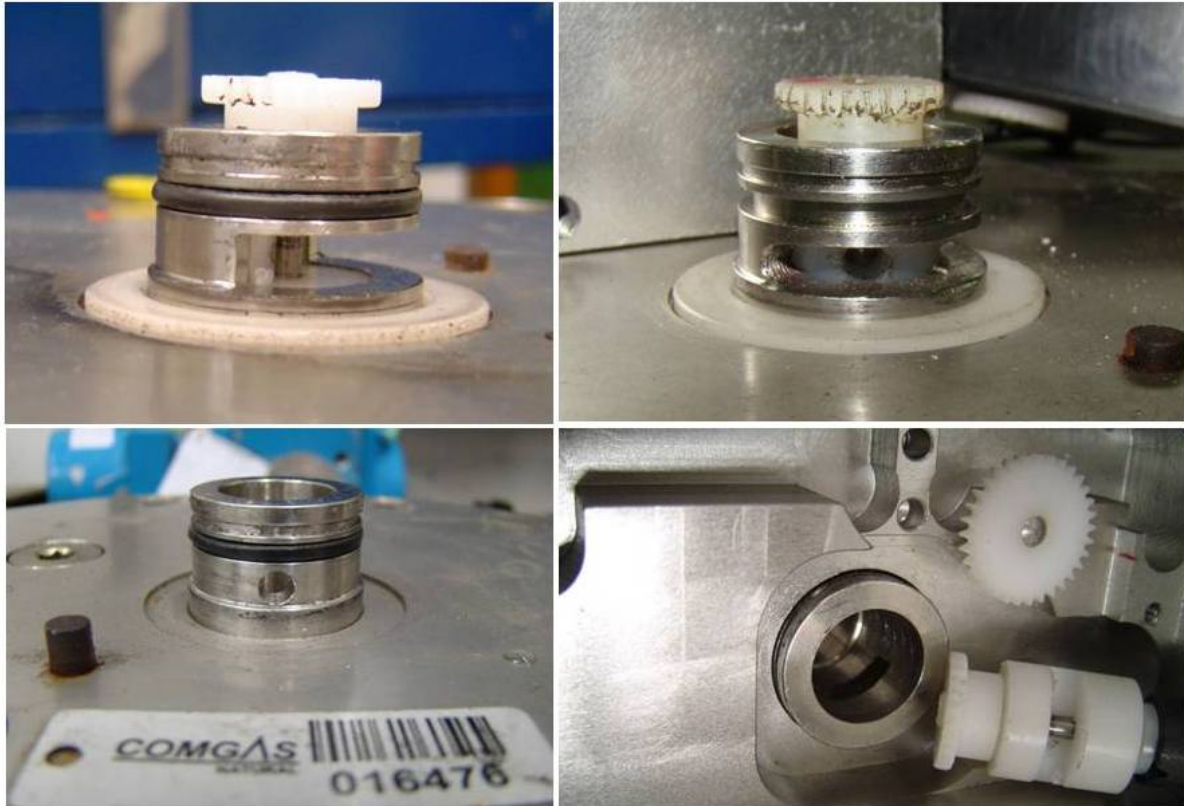
3- Holes in the Axis of the Meter & Screw Violation

This is a clear case of fraud: a hole in the axis that drives the record system of the gas flow metering. Through this hole the defrauders prevent the axis to rotate and do the correct record of the consumed gas.

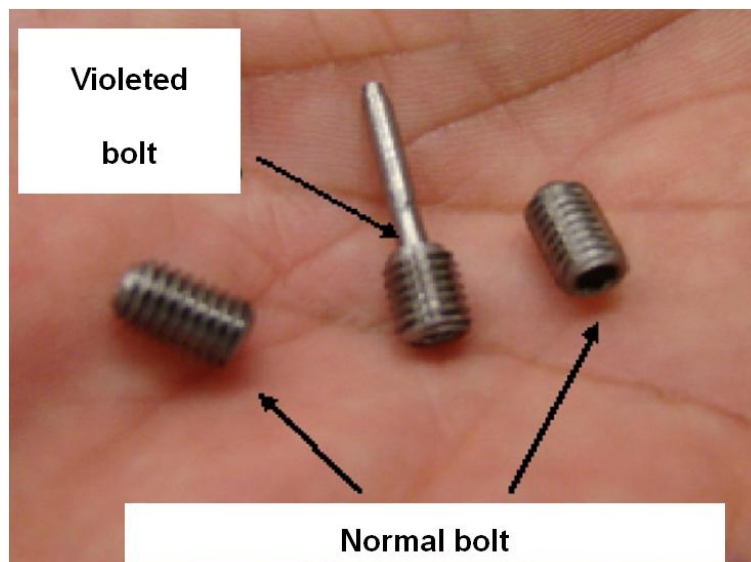
The photo below shows a violated screw. Through the extension welded on the original screw the defrauders prevented the right turn of the logging mechanism of the gas flow through the meter.

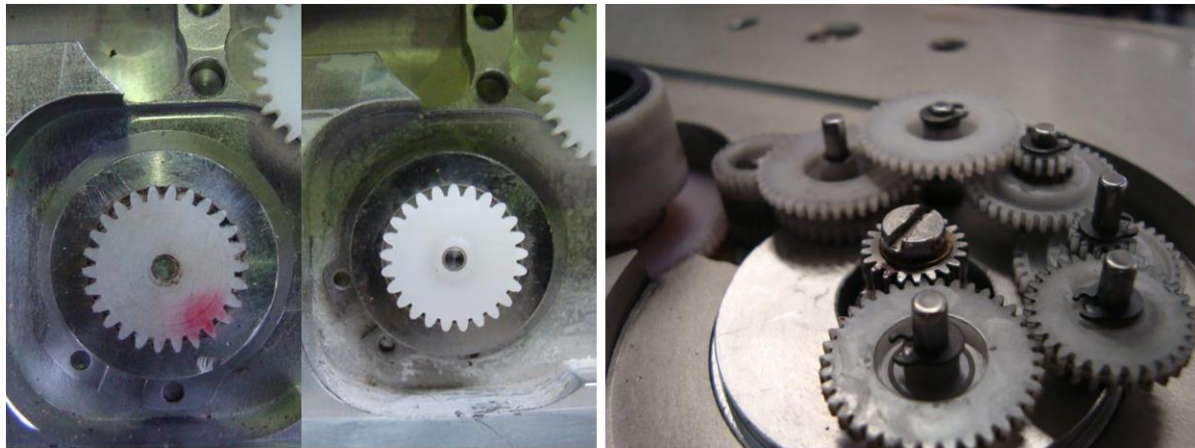
4- Gear Meter Violation

Gears with different number of teeth to adulterate the correct volume of consumed gas. This is a fairly complex meter tampering, because the defrauder has to know the functioning of the meter flow register.

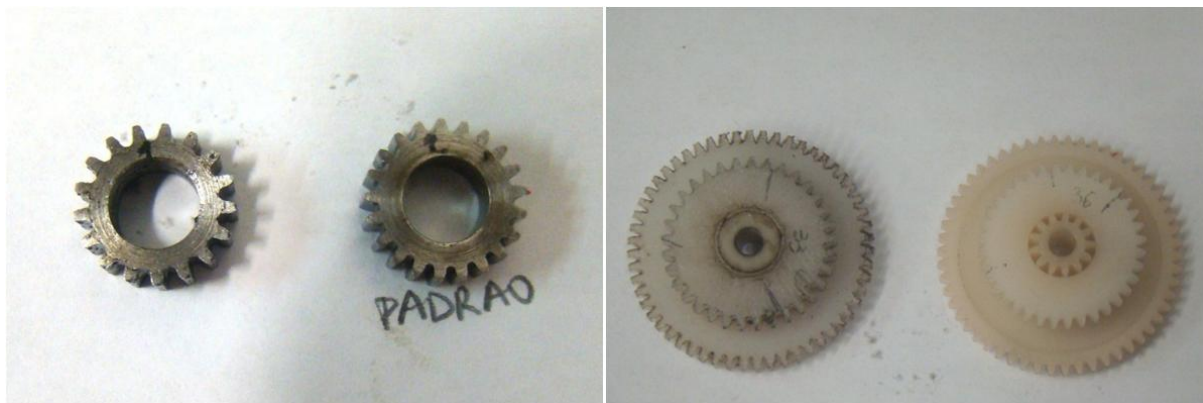
In the photo below on can see that the adulterated gears (left side) are quite similar to the normal gears (right side). This type of fraud could only be identified after a bench testing of tampered meters in IPT's meter calibration laboratories.

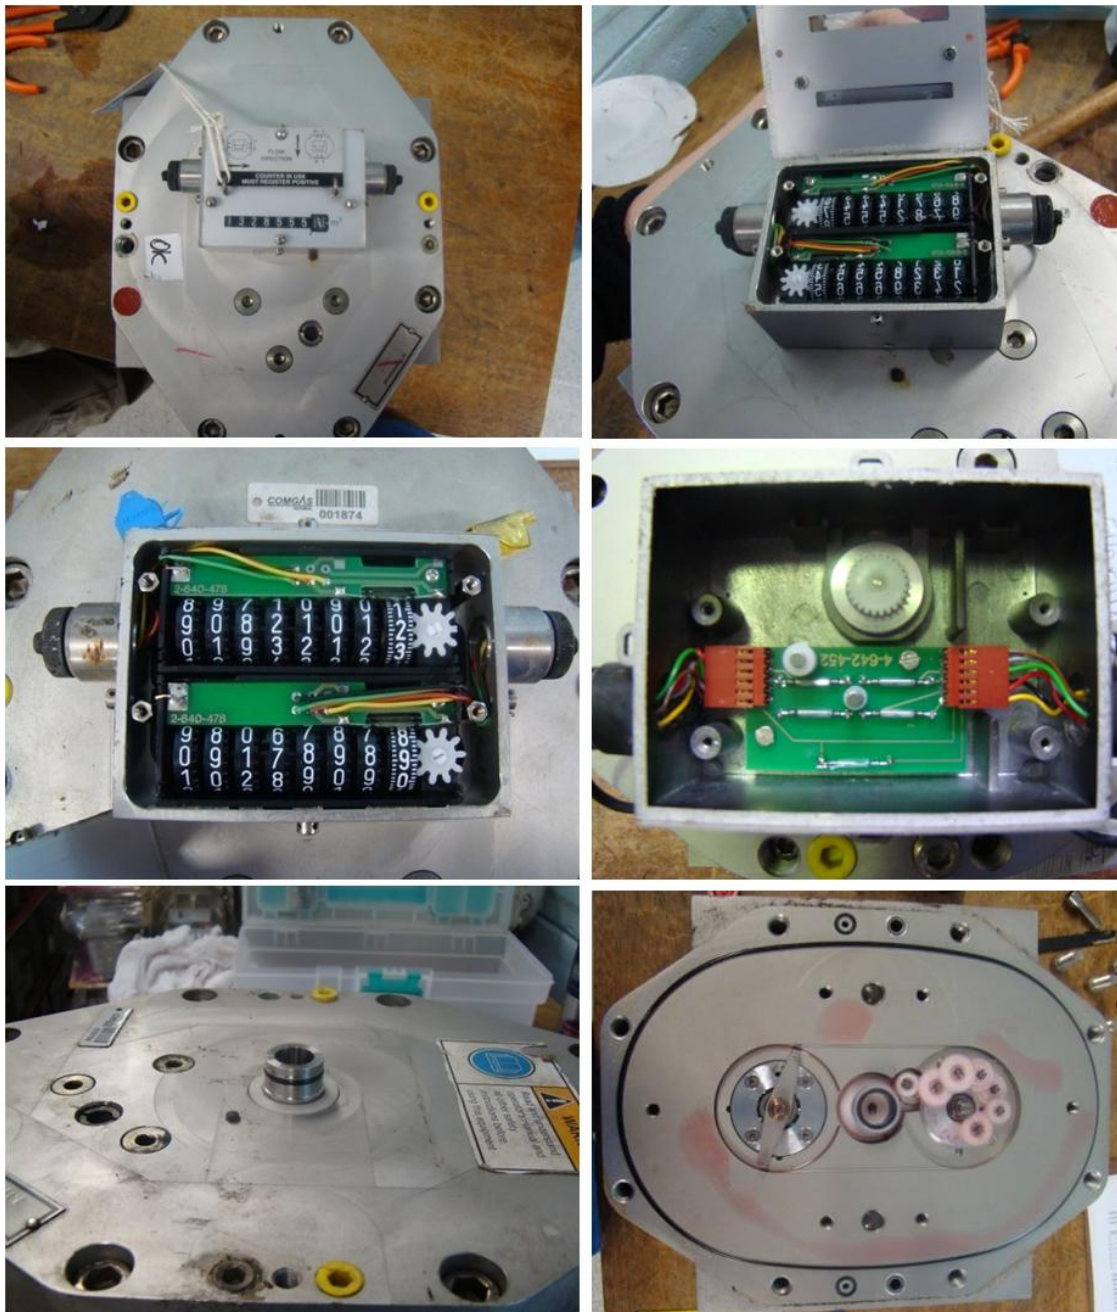
5- Meter Dial Violation

In these cases the defrauders accessed the meter dial and performed different types of actions to prevent the correct measurement of consumed gas. Commonly, the dials are physical damaged in order not to rotate properly. This type of action is easily noted. The second most common form of fraud with the dials is to disconnect them from the axis to impede consumption recording. This situation is more difficult to be perceived, as the dial can be reassembled before the inspection.

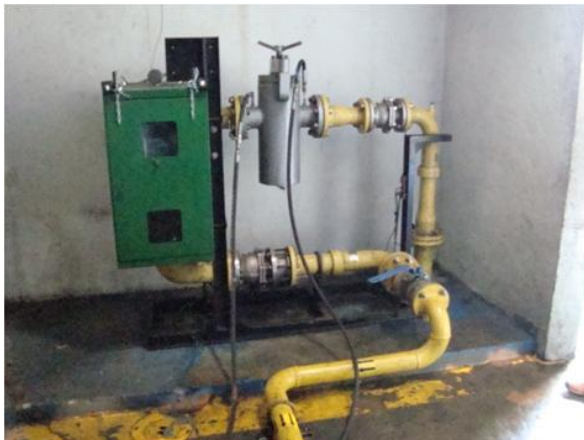
The photos below show a case where the bypass was done with flexible hoses from the filter pressure gauges point up to the connections welded at the compressor inlet. The by-pass was dismantled every time the COMGÁS team arrived at the station. The access to the compression area was made by the employees of the NGV station using a secondary hidden door. Usually the COMGÁS employees had to wait long periods to have access to the meter, the main entrance was locked and the key keeper was never at the station. "He had to be called to open the door".

By pass at the filter pressure gauges positions

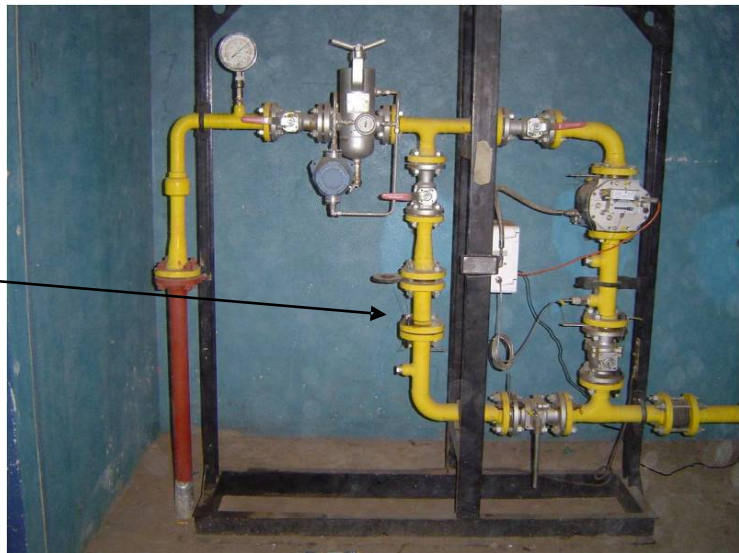
Reserve Stream (eliminated)

The photo below indicates the old design of a meter set for NGV station with two streams. As can be seeing the reserve stream could be an "invitation" for by-passes.

- 1- Training the field teams and meter readers to identify gas theft.
- 2- Changing the layout of the meter set which previously had two streams, the main one with the meter and a reserve one normally flanged. The reserve stream was eliminated just to avoid the assembling of by-passes.
