# REALIZATION OF INVAR ALLOY LNG PIPING

Takehiko Edamitsu; Osaka Gas Co., Ltd.

This report summarizes the contents of research, development and realization of Invar alloy LNG piping.

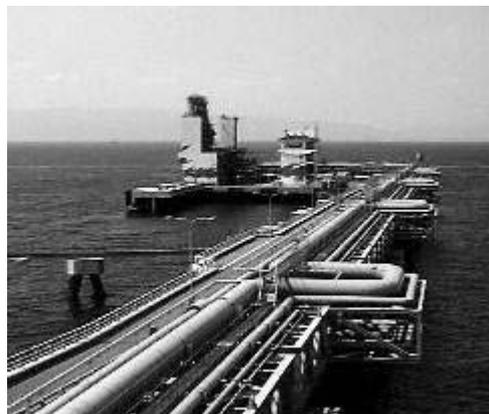
Austenitic stainless steel has excellent low-temperature characteristics and stable quality. However, due to its large coefficient of linear expansion, austenitic stainless steel requires a mechanism for absorbing thermal contraction up to approximately 3 mm per meter when it is used in LNG facilities. The mechanism that Osaka Gas generally uses for its LNG piping is a bent piping (Photo. 1).

Photo. 1 Austenitic Stainless Steel Bent Piping for LNG service

A bent piping, which is installed every 30 to 70 m, raises the cost of LNG piping construction as outlined below.

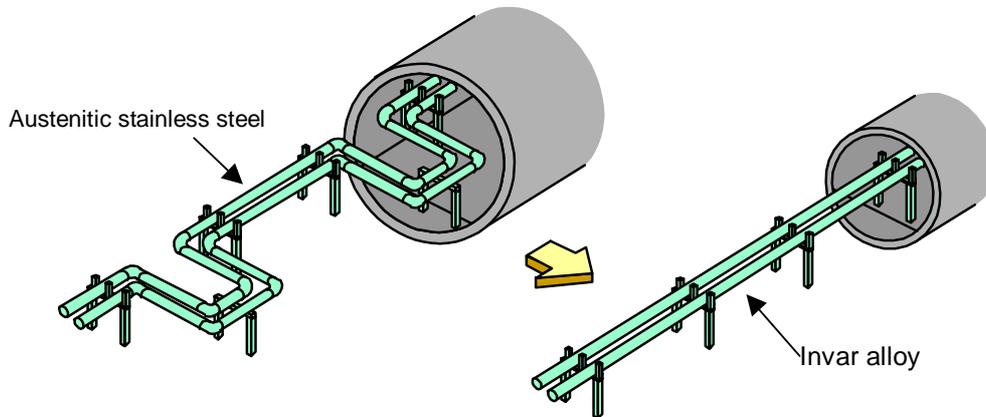
Fig.1 Conceptual view of Invar alloy LNG piping

Because Invar alloy has coefficient of linear expansion, which is, approximately 1/10 that of austenitic stainless steel, the Invar alloy piping eliminates the need for bend piping. Despite the higher cost of Invar alloy material itself, the total construction cost can be reduced as a result of straight piping without bent piping and the elimination of the abovementioned cost raising factors.

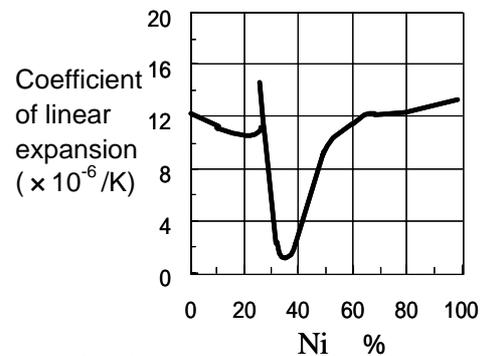
Invar alloy, an alloy of 64% Fe-36% Ni, has a very low coefficient of linear expansion. Fig 2 shows correlation between Ni content of Fe-Ni alloy and its coefficient of linear expansion. The coefficient of linear expansion reaches the minimum value at 36% Ni content. Table 1 shows standard, characteristic values of Invar alloy. Since Invar alloy has a stable austenitic structure, it has excellent strength and ductility at LNG temperature.

Fig. 2 Ni% in Fe-Ni alloy and coefficient of linear expansion MOL(vol.90.9)

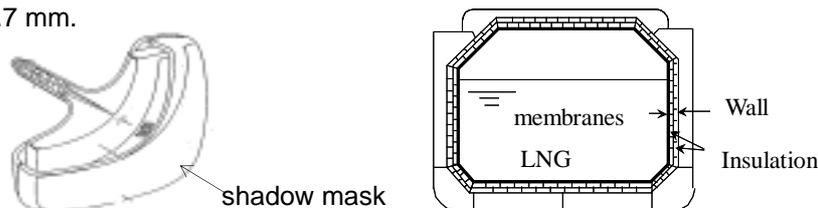
Invar alloy has been used as a functional material in special applications in which low thermal expansion is essential, such as CRT shadow masks and tension members (core material) of overhead power transmission lines, but it has seldom been used as a thick-walled structural material. As for LNG applications, Invar alloy is widely used as membranes for LNG carrier cargo tanks, but their thickness is limited to 0.7 to 1.7 mm.

Fig. 3 Examples of Invar alloy applications: CRT and LNG carrier

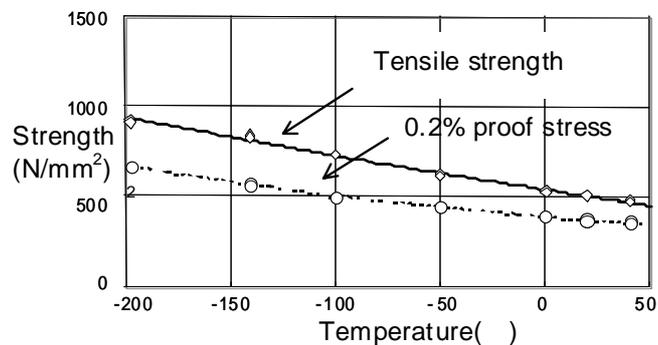
Fig.4 shows measurements of tensile strength and 0.2% proof stress of Invar alloy, as an example.

Fig. 4 Invar alloy strength characteristics

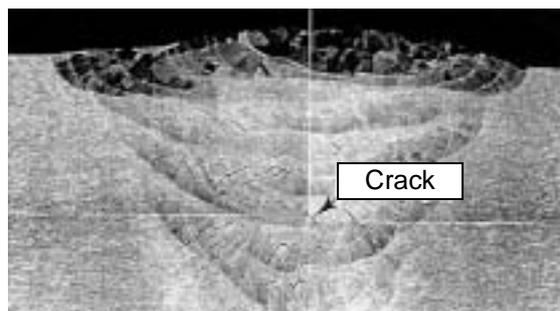
To investigate the mechanism of crack generation in the multi-pass welding of Invar alloy, macrostructural observation (Photo.2), microstructural observation, and a high-temperature ductility test were conducted.

Photo.2 Ductility dip cracks in multi-pass GTAW weld metal of Invar alloy

The results of these studies were analyzed in terms of location of crack, temperature rise caused by subsequent weld passes, and temperature ranges where ductility of weld metal degrades. These metallurgical investigations identified cracks observed in multi-pass welds of Invar alloy as ductility dip cracks, which occurred as a result of the ductility of the weld metal being degraded due to reheating by subsequent weld passes.

Based on these findings, it was concluded that ductility dip cracks in the multi-pass welding of Invar alloy were caused by segregation of S that reduced the bonding strength at the grain boundary.

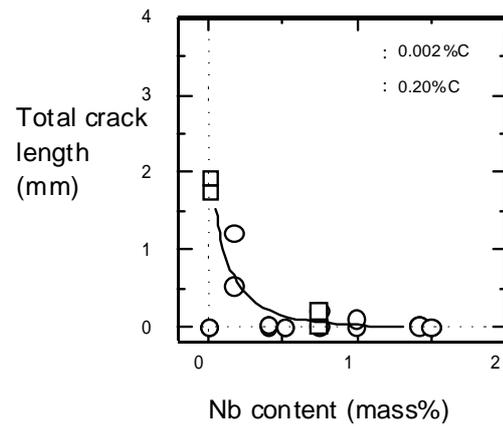
Fig. 5 shows the effect of C and Nb on the total length of ductility dip cracks generated in the bead during a double-bead longitudinal Varestraint test.

Ductility dip cracks occurrence was confirmed to decrease as the amounts of C and Nb were increased. When these elements were added individually, cracks were generated in the weld metal, but the complex addition of the two elements prevented cracks.

Fig. 5 Effect of C, Nb content on ductility dip crack prevention

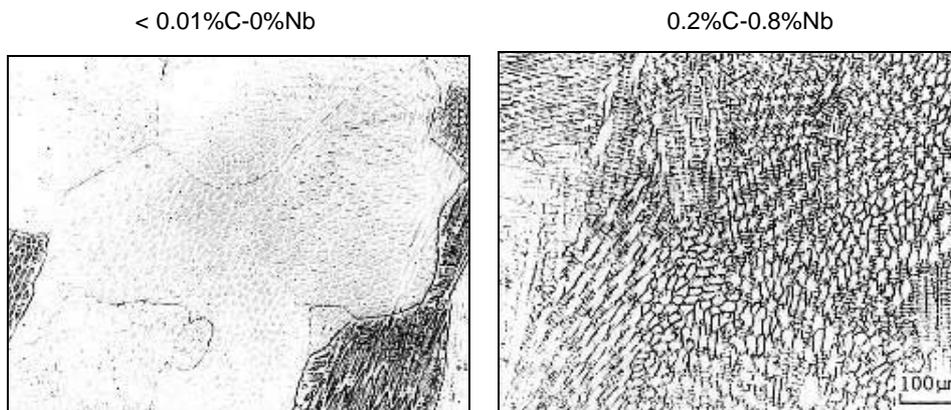
Photo 3 shows microstructures of two types of weld metal; one with C and Nb added, and another without. The solidified 0.01%C-0%Nb morphology with ductility dip cracks revealed a straight grain boundary (cellular structure), while the 0.2%C-0.8%Nb morphology without ductility dip cracks indicated a zigzag cellular boundary (cellular dendrite crystal).

Photo. 3 Microstructure of Invar alloy weld metal

conclusion that Invar alloy's susceptibility to ductility dip cracks was suppressed by the combined addition of C and Nb because the two elements resulted in the crystallization of niobium carbide (NbC) at the grain boundary, making the grain boundary structure complex and increasing its area to reduce segregation of S and the stress concentration at the grain boundary triple point.

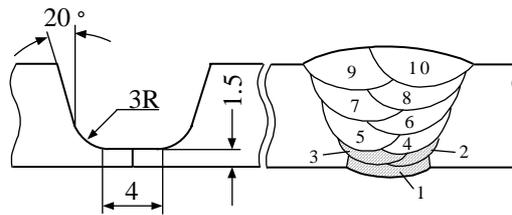
Multi-pass GTAW was conducted on Invar alloy plates measuring 9.5 mm x 200 mm x 100 mm and having a U-shape groove (see Fig. 6). In this welding test, constant welding conditions were maintained for the first and the second deposition layers indicated by the shaded area in the diagram, and heat input and wire feeding rate for the third and the subsequent layers were varied.

Fig. 6 Groove geometry and deposition sequence used

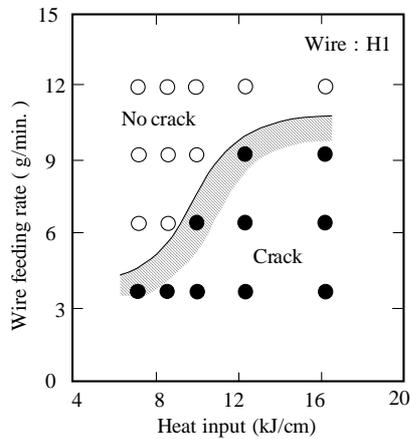
Fig. 7 shows the relationship between crack occurrence and weld conditions, i.e., heat input and wire feeding rate for the third and the subsequent deposition layers in all-layer welding using the low-Nb filler wire (H1). There were no ductility dip cracks at the points indicated with the white dots in the graph, and ductility dip cracks were observed at the points indicated with the black dots. The graph shows that ductility dip cracks occurred when heat input was high and wire feeding rate was low. The cracks were observed in the first half of the layers. It was presumed that these cracks were generated because the dilution rate of C and Nb added to prevent ductility dip cracks was higher at the bottom of the U-shaped groove.

Fig.7 Relationship between ductility dip crack occurrence and welding conditions

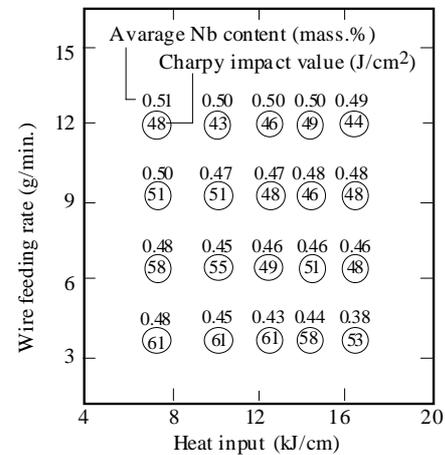
To verify this, welding tests were performed using the high-Nb filler wire (H2) for the first and the second deposition layers, and the low-Nb wire (H1) for the third and the subsequent layers. Fig. 8 shows the relationship between the heat input/wire feeding rate and the presence of ductility dip cracks. As shown in the diagram, the abovementioned welding technique prevented the generation of ductility dip cracks under entire test conditions. In the diagram, the figures in circles indicate Charpy impact values at the test temperature of 77K, and the figures above the circles indicate the average Nb content of the weld metal.

Fig.8 Nb content and Charpy impact value of weld metal under various heat input and wire feeding rate (the third pass and after)

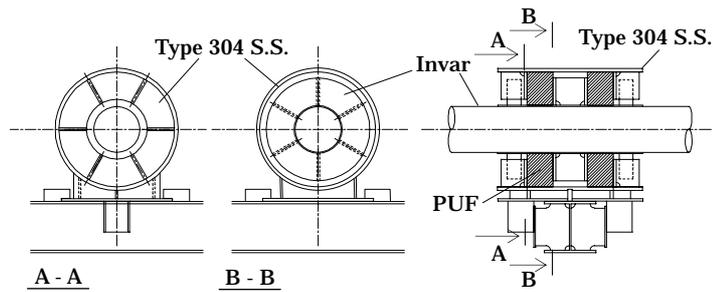
The support structure for Invar alloy LNG piping is required to have the following performance..  
High insulation performance

Bearing performance for high longitudinal load due to eliminating the bent piping

Fig.9 Example of axial stop for Invar alloy LNG piping

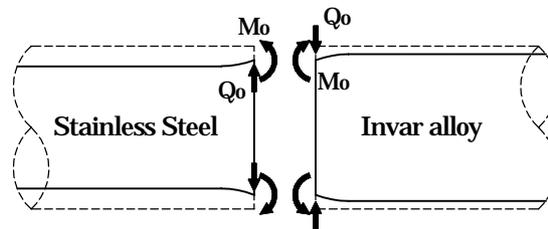
FEM analysis and thermal stress measurement using an actual joint were conducted to investigate the thermal stress behavior around welds of dissimilar materials, i.e., Invar alloy and austenitic stainless steel, under low temperatures. The analysis and measurement results indicated that the generated thermal stress intensity was within the allowable value, and confirmed that the weld was robust even after repeated cooling and heating in a pressurized condition. Furthermore, a method was established for the theoretical analysis of the thermal stress behavior of welds of dissimilar materials.

Fig.10 Deformation and constraint forces at dissimilar joint boundary

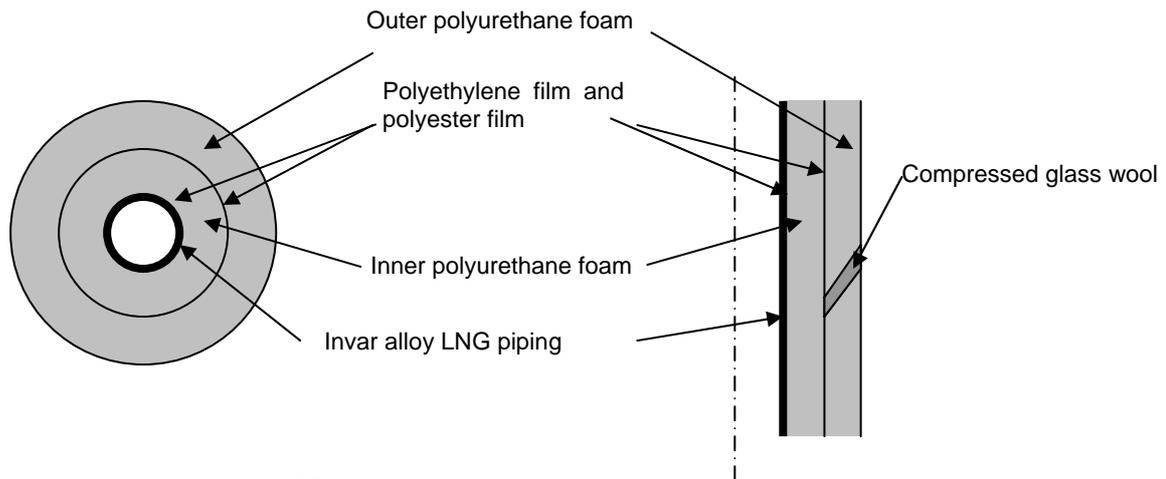
An insulation structure was established for preventing decline in insulation performance caused by expansion of the gap between each block of polyurethane foam in low temperature condition caused by difference of coefficient of linear expansion between Invar alloy and polyurethane foam. Fig.9 shows the structure of insulation.

Fig. 11 Insulation structure for preventing expansion of the gap

Between invar alloy LNG piping and insulation, and between inner insulation and outer insulation, polyethylene films are installed for sliding. Compressed glass wool is stuffed in the gap between the polyurethane blocks. It expands when the gap extends due to thermal contraction of polyurethane blocks. The gap is slanted to elongate the pass of thermal conduction.

This structure was tested under the low temperature of LNG, and its performance was confirmed.

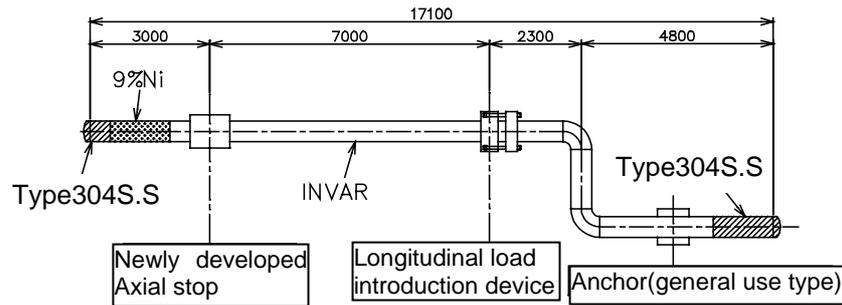
A small-scale (12"x 20 m) Invar alloy test piping system (liquid nitrogen piping) was constructed (Fig. 12). The level of stress was measured at various parts of this piping system during a process of low-temperature cooling/pressurizing and a process of repeated cooling and heating. Through these tests, it was verified that there was no progressive increase of strain and that the robustness of the weld was maintained.

Fig. 12 Constitution of Invar alloy test piping

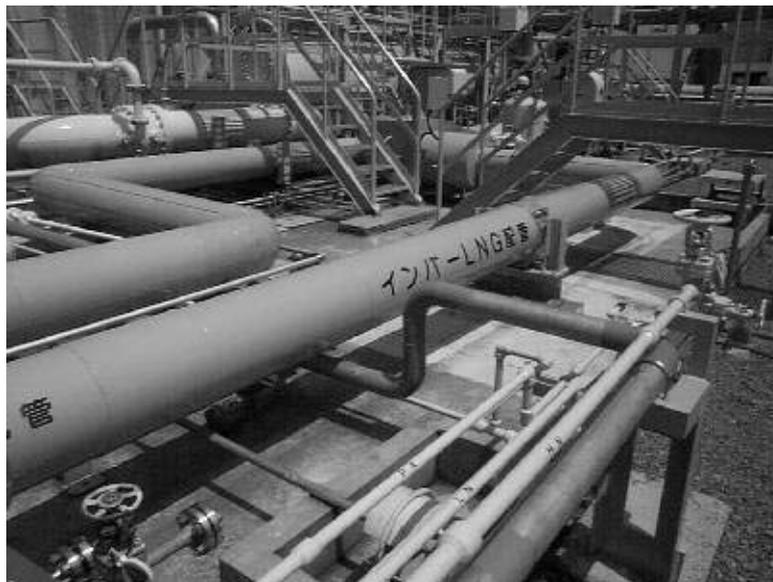
In the spring of 2001, an Invar alloy LNG piping was installed in the Osaka Gas Senboku Terminal II for the first time in the world (Photo 5).

This Invar alloy piping, which is 6" in diameter and 9.5mm thick, has been serving as an interconnection piping to an LNG vaporizer satisfactorily.

Photo 5 Invar alloy LNG piping that serves as an interconnection piping to an LNG vaporizer

Moreover, this piping was inspected after 6-month service to verify its integrity.

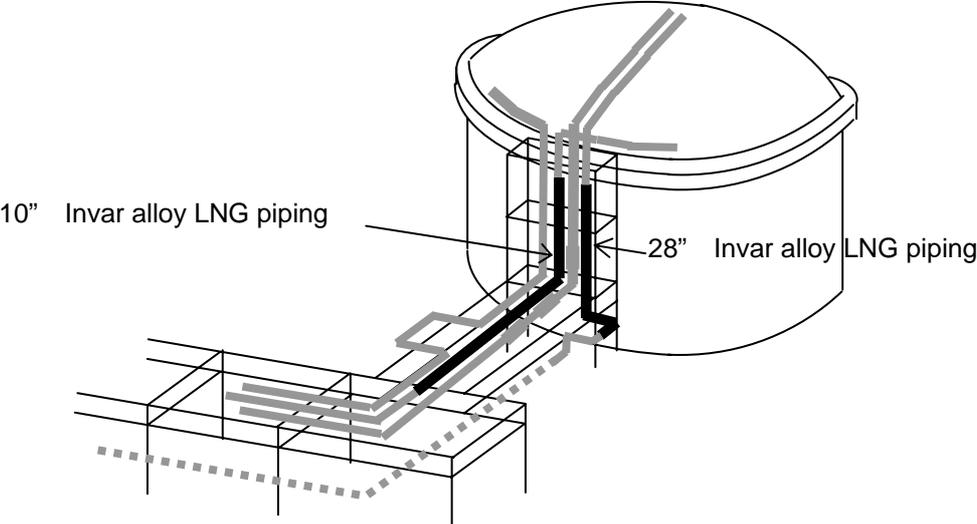
Now the second application of Invar alloy LNG piping as an interconnection piping to an LNG storage tank (180000kL,in LNG terminal at Himeji) is under construction and planned to be commissioned in August 2003. With evolved technologies, Invar alloy LNG piping of 28" and 10" in diameter has been realized.

Fig. 13 Invar alloy LNG piping that serves as an interconnection piping to an LNG storage Tank
