# WGC2006 - Amsterdam WOC 3 Committee Sessions

## Study Group 3.2

**Increased Service Life in  
the design, construction,  
operation and maintenance  
of Gas Pipelines**

# Network life time

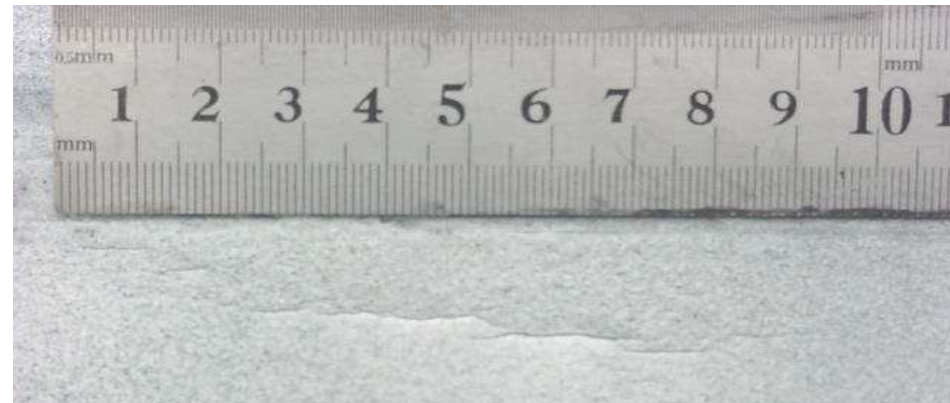
## Identified Cracks

Stress Corrosion Cracking (SCC) appears as very thin, long and deep colonies of cracks, on the external surface of the underground pipelines.

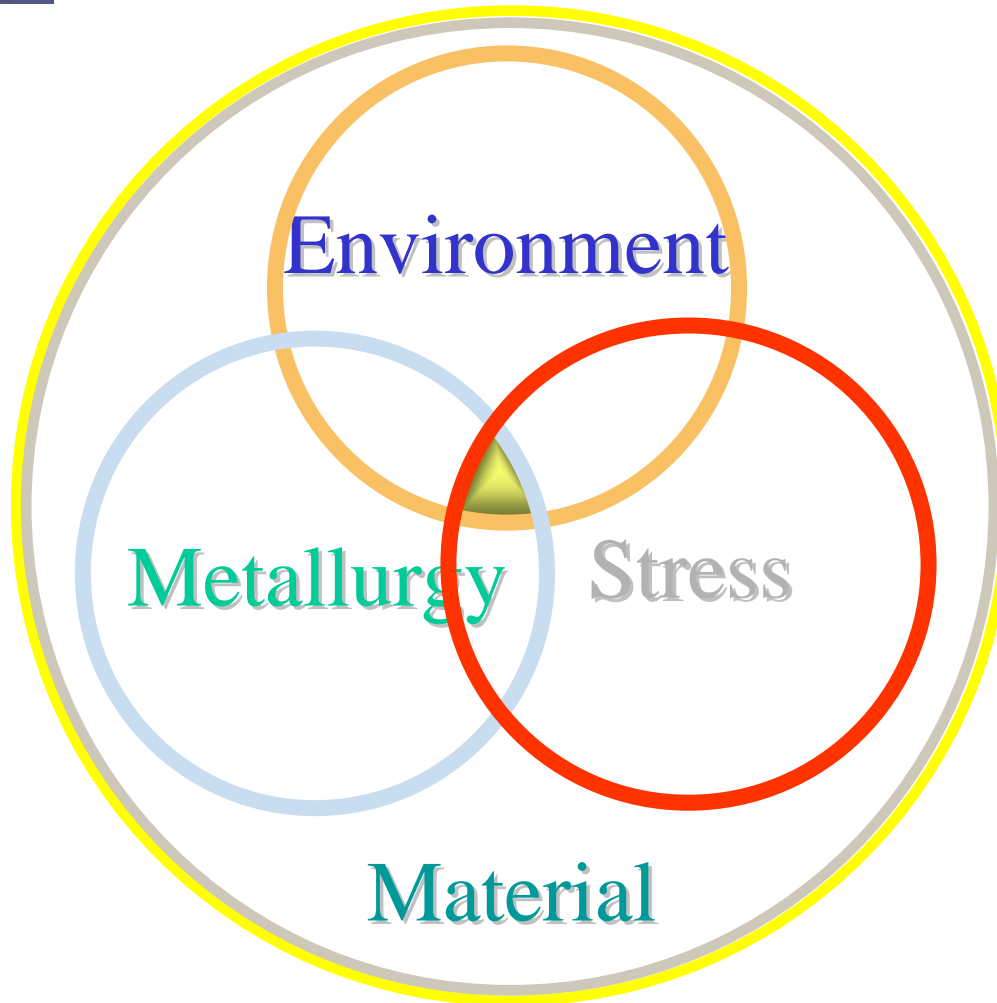
# SCC - Conditions for SCC

Three conditions must be met concurrently for SCC; there must be a tensile stress, a cracking environment, and a material that is susceptible to cracking in that environment. If any of these three conditions is not met, cracking either does not start, or it slows down, or it stops.

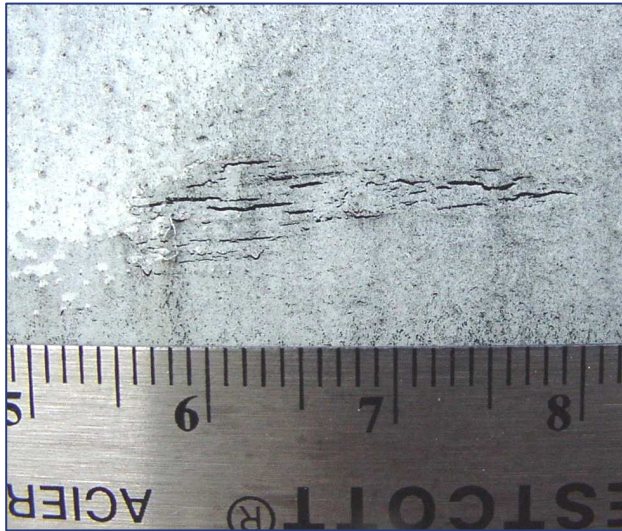
# Hydrostatic test Argentina Neuba I pipeline

Diameter:	24"
Pipe wall thickness:	7,14 mm
Material:	ASTM X52
Year of installation:	1973
Coating type:	Asphalt
Hydrostatic test pressure :	110% SMYS

**3 three failures due to Hydrostatic test  
were found.**

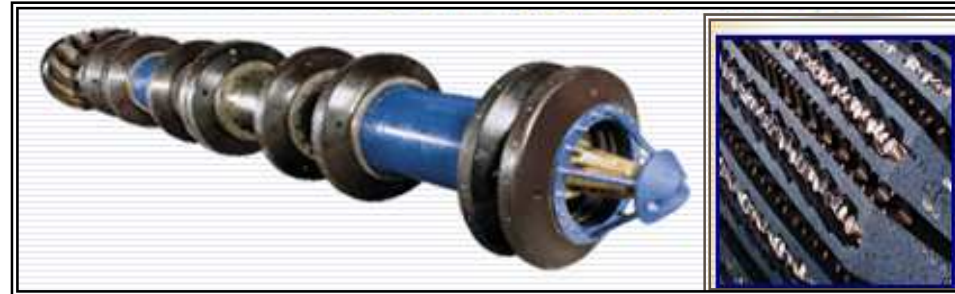
- Ultrasound Tool

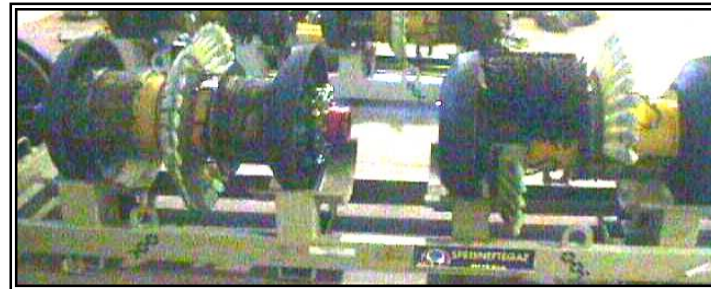
- Magnetic Tools (MFL + TFI)

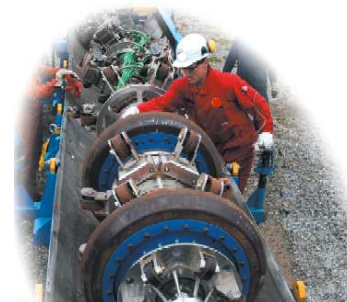
- EMAT Tool

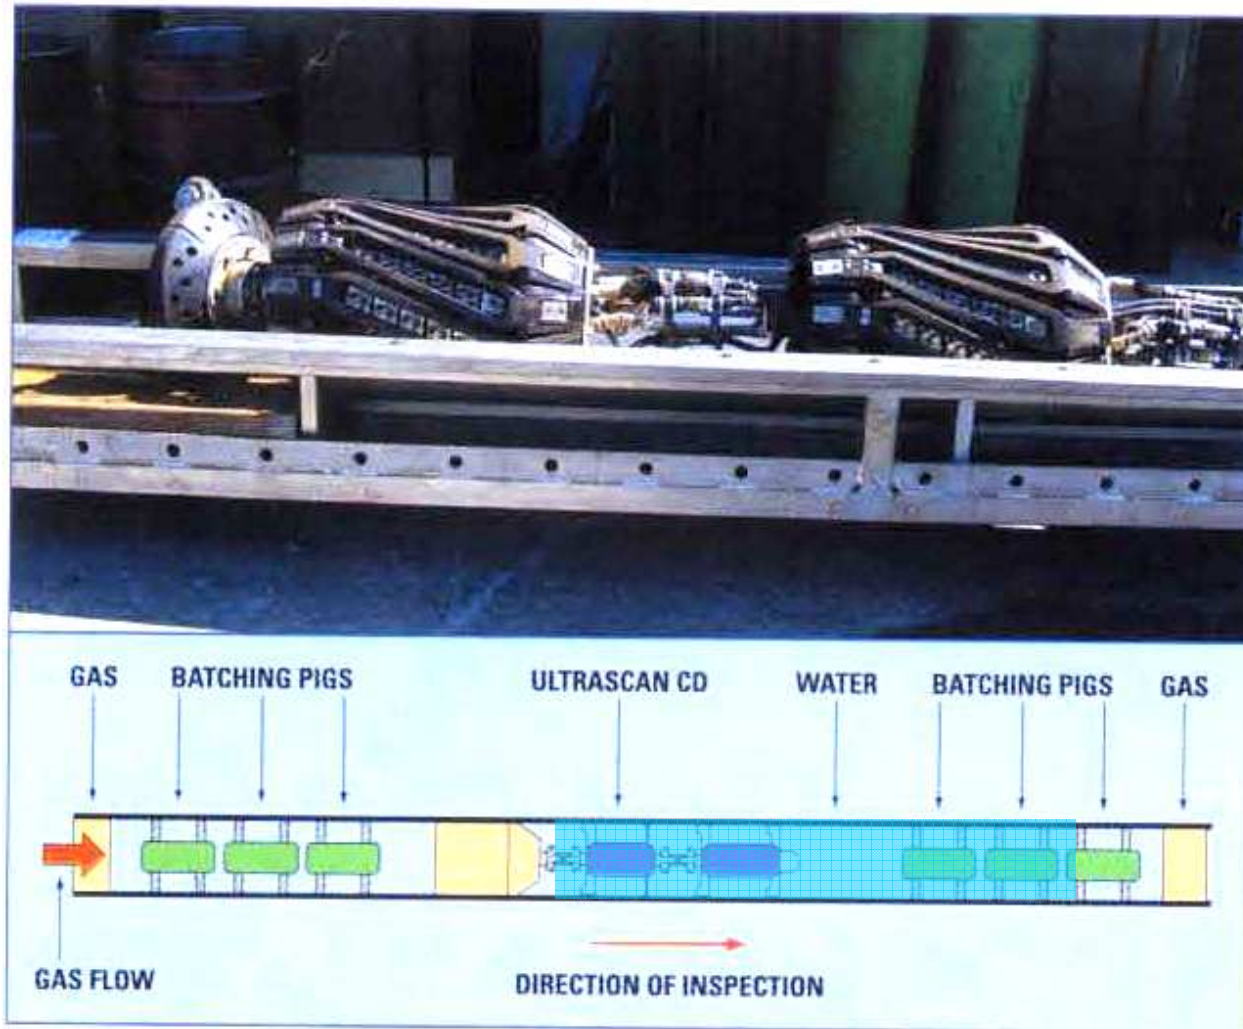
# Ultrasound Tool

Main disadvantage: liquid batch required.

- **Liquid – coupled UT** too cumbersome and expensive
- **MFL + TFI** has not adequate discrimination
- **EMAT** 's possibilities still need to be demonstrated in field operation

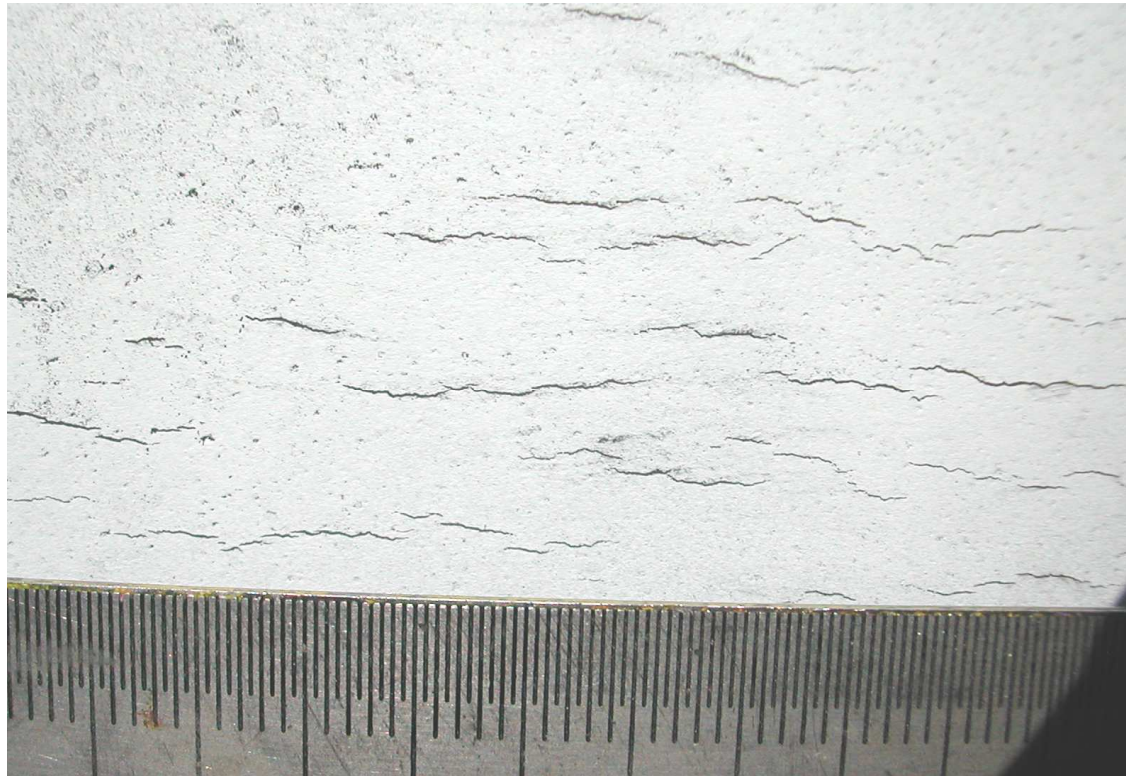
## MFL + TFI tools - Argentine conclusion Not enough discrimination .

Due to the fact that high pH SCC cracks are not open (intergranular and not transgranular), the disturbances in the magnetic field are almost impossible to detect.

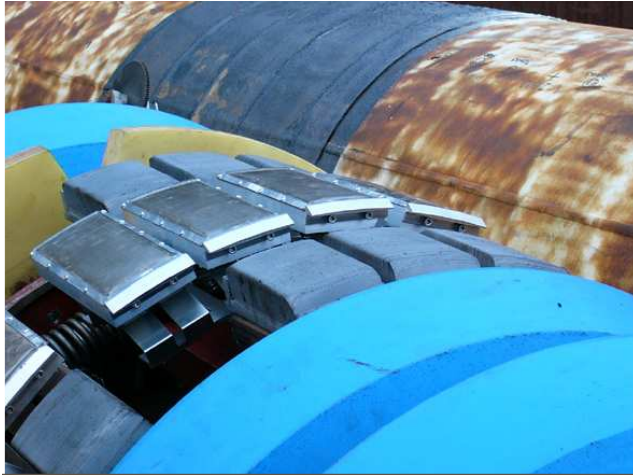
**Cracks**

- EMAT waves are reflected at cracks
- Echo wave appears

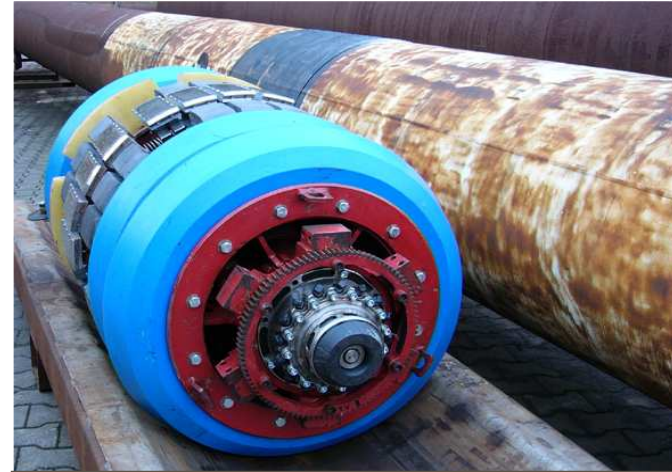
**Coating Disbondment**

- EMAT waves are attenuated by coatings
- Coating disbondment decreases signal attenuation

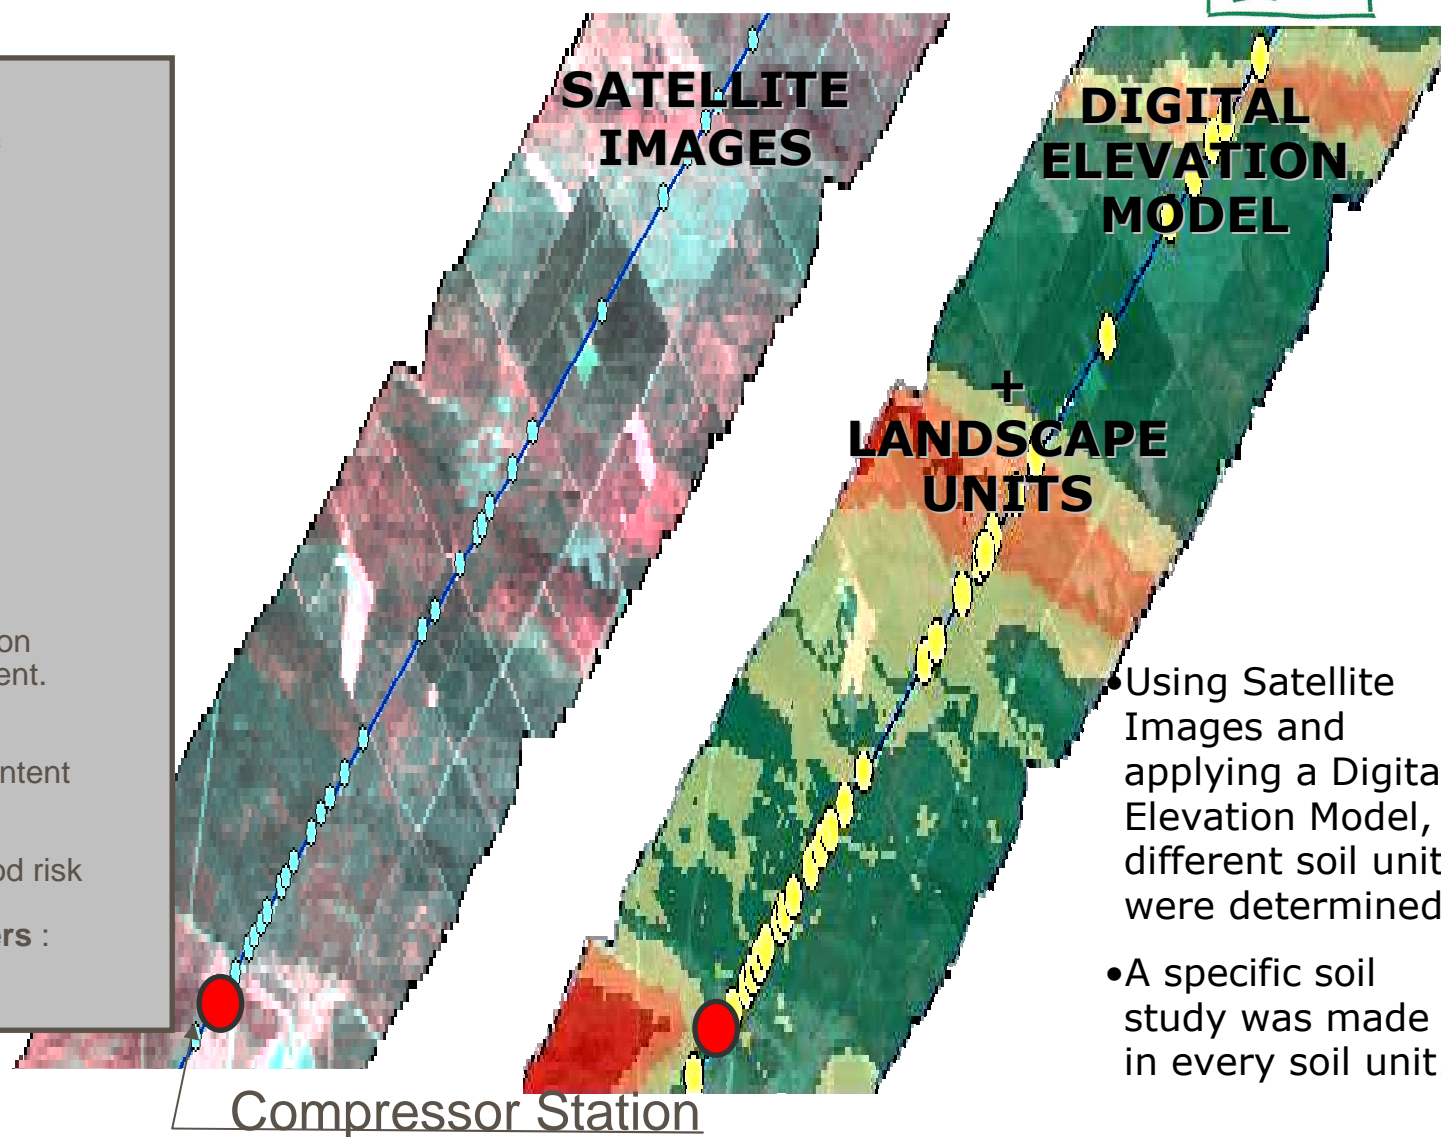
- Using Satellite Images and applying a Digital Elevation Model, different soil units were determined.
- A specific soil study was made in every soil unit.

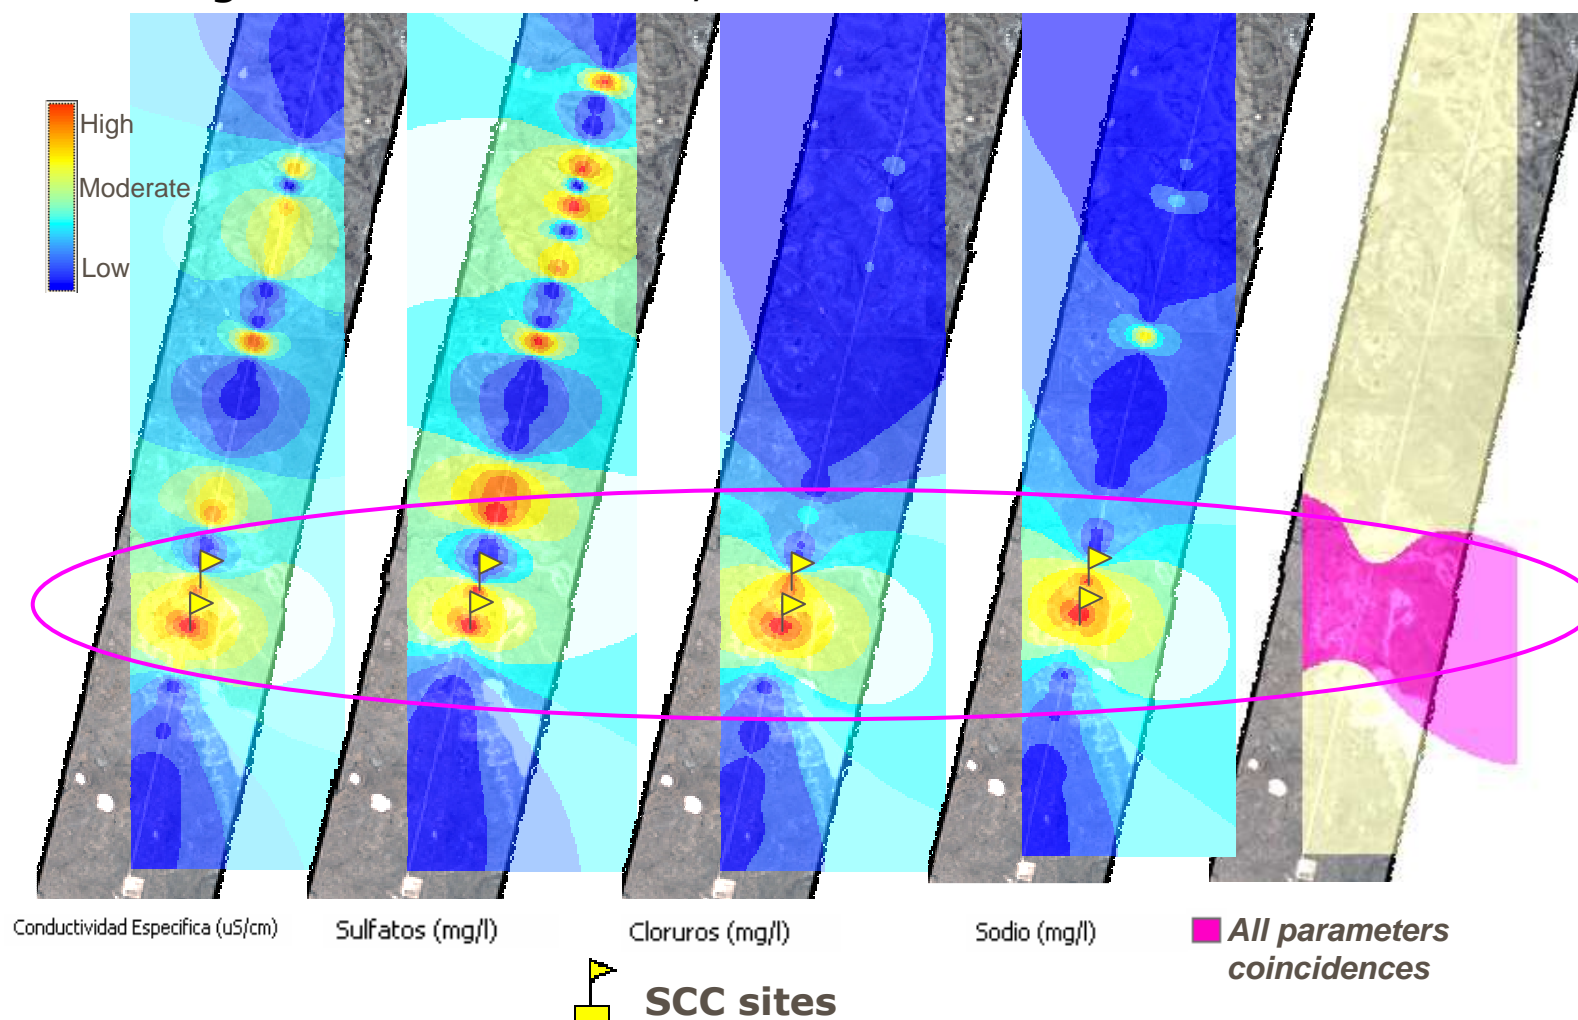
- The charts show the coincidences among SCC sites and high values of Sulfate, Chloride and Sodium.

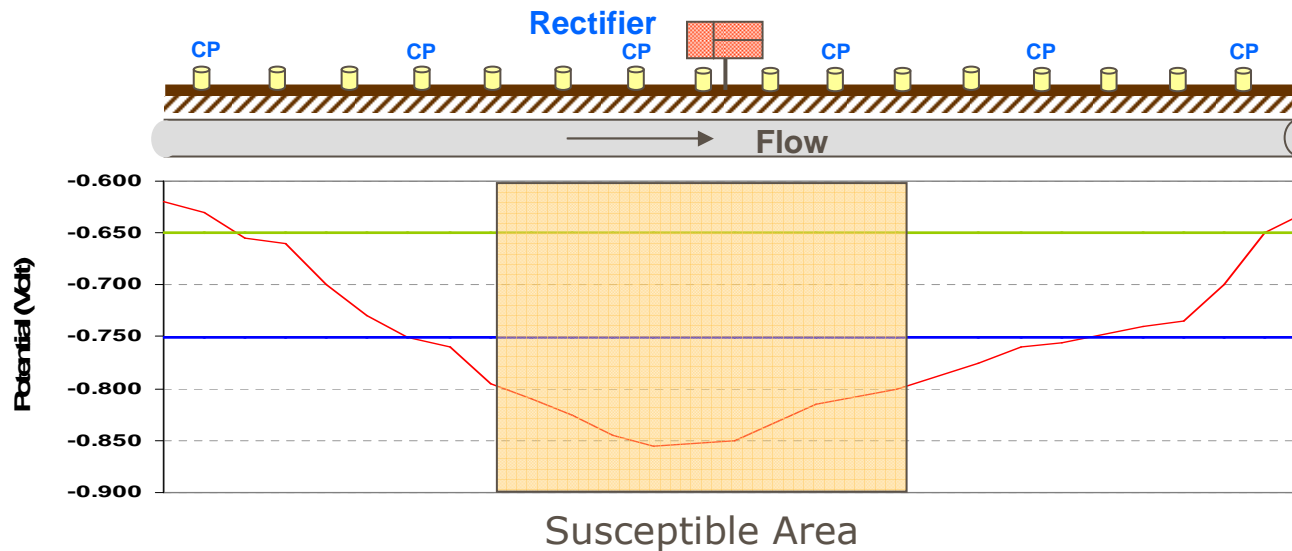
**In Argentina** Near to Rectifier- High conductivity Soil

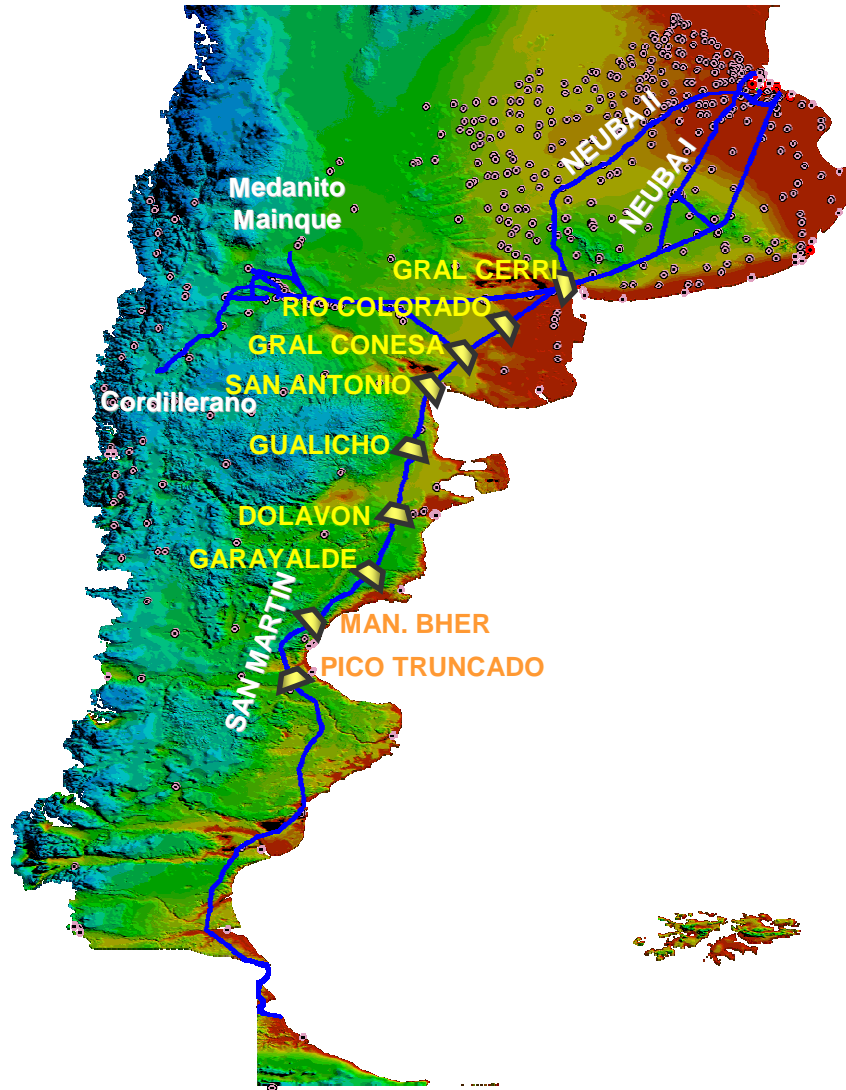
# Completed Task

By applying this DA SCC 80 digs were done and one colony was found.
