Limitation of detection range in guided wave testing of buried pipeline

As guided wave test is one of the promising inspection methods for the integrity of plant facility, it could be also a promising tool for inspecting buried pipeline. However, guided wave tends to leak into soil rapidly, and the coating of buried pipe also decreases the signal significantly. There has been ambiguity in detection range limit in buried pipe application. In this work, two types of sensor, magnetostriction sensor and piezoelectric sensor were applied to the buried pipeline test loop. The test loop with standard defects at various lengths was constructed at burial depth of 1.5 m. The results showed that the detection range is of 5~10 m. The magnetostriction sensor showed better S/N ratio at the results. But the lack of circumferential resolution limited the interpretation of signal. The piezoelectric sensor showed lower S/N ratio with circumferential resolution. The results showed the possibility of the method and the limitation together. The method was applied to existing valve station. It reveals several indication of metal loss at the unpiggable sections. The results were shown in this work.

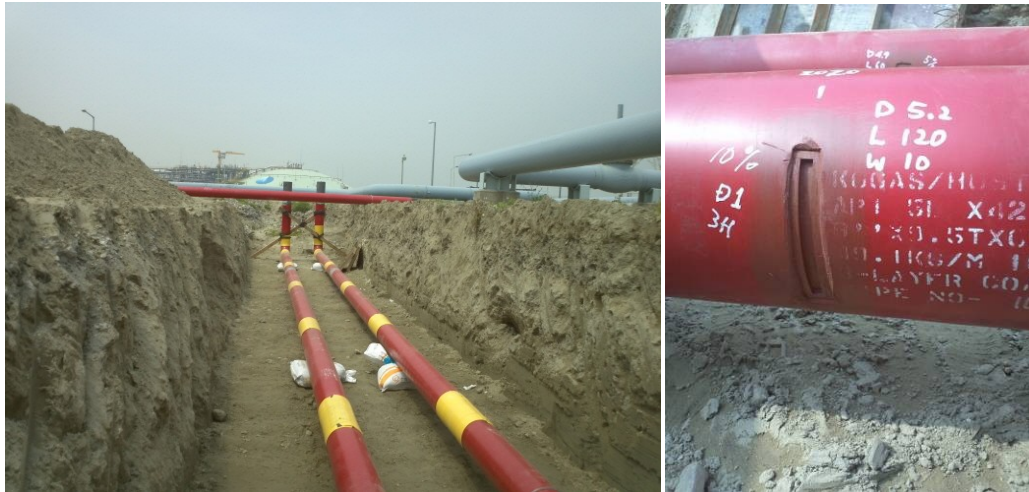
Figure 1. Test pipe installation and artificial defects

The test pipes of 8 inch diameter were constructed at sites (figure 1). The artificial defects were machined along the pipe. The defects were designed to have about 5% and 10% cross-section area at each pipe (figure 2). The details of the test pipes were shown in table 1.

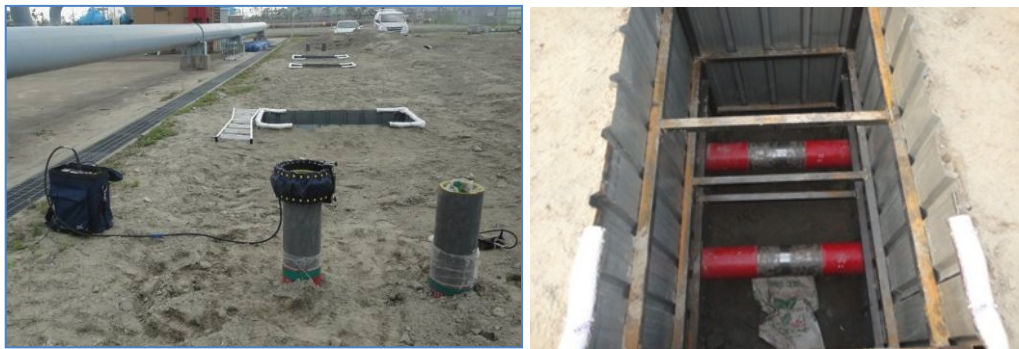
Figure 2. Test pipes and holes for measurement

The pipes were inspected with piezoelectric sensor type tool (GUL Co. G3) and magnetostriction type sensor (Digital Ultrasonic Co.) before burial. And the trench was backfilled with soil except for measuring holes (figure 2). Schematic diagram of test loop pipeline with defects relative to measuring points is shown in figure 3.

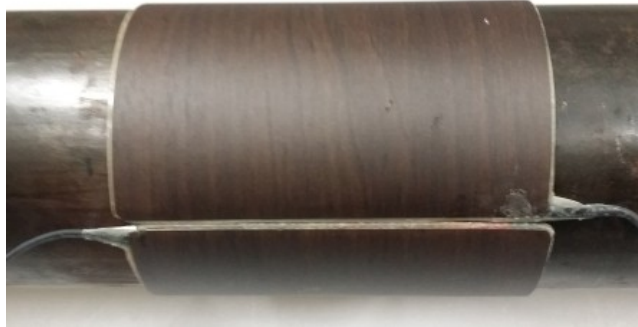
Figure 4. Installation of magnetostriction type sensor

The sensors applied to the test pipeline before burial are shown in figure 4 and figure 5. The typical signals taken before burial were shown in following figure 6 ~figure 7 and signals after burials in figure 8 ~figure 9. The signals taken after burial decays faster compared to respective sensor's signal results before burial due to the thick PE coating. Weld and defects signal could be identified up to about 10m range. The signal to noise ratio by magneto-striction sensor is much higher. The piezoelectric sensor showed circumferential resolution which magneto-striction sensor doesn't have and enabled to distinguish between weld signal and local defect. This capability is very useful practically when there is not much information about pipeline weld locations.

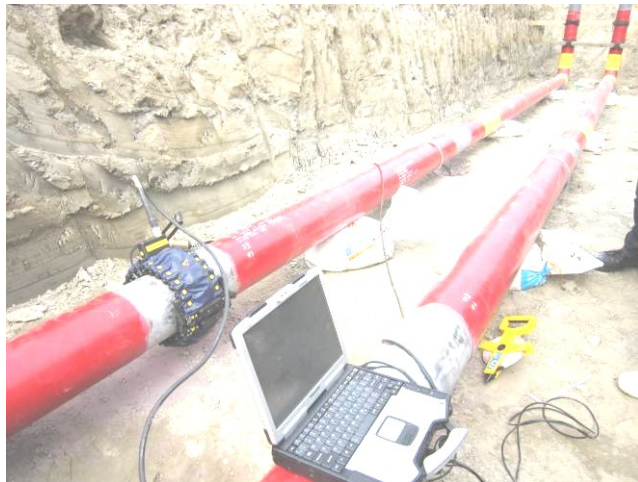
Figure 5. Installation of piezoelectric type sensor

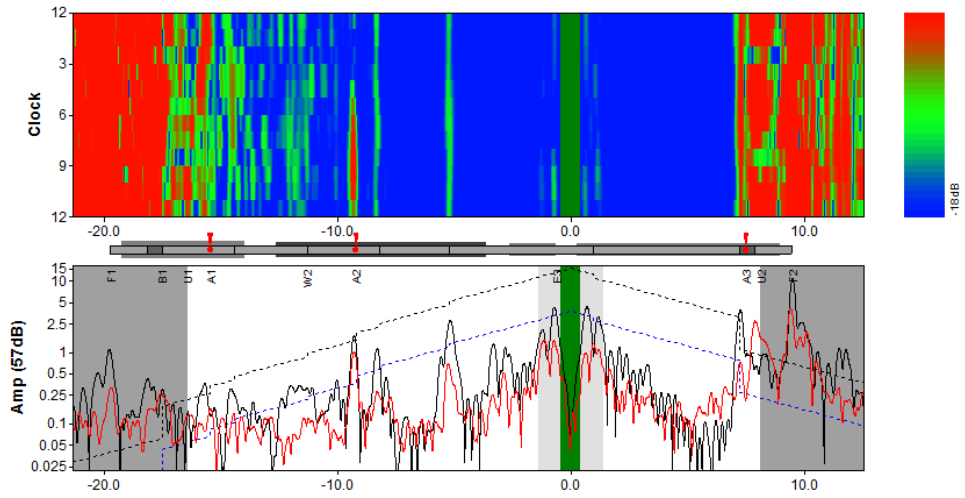
Figure 7. Inspection results with piezoelectric sensor at measuring point 4 before burial

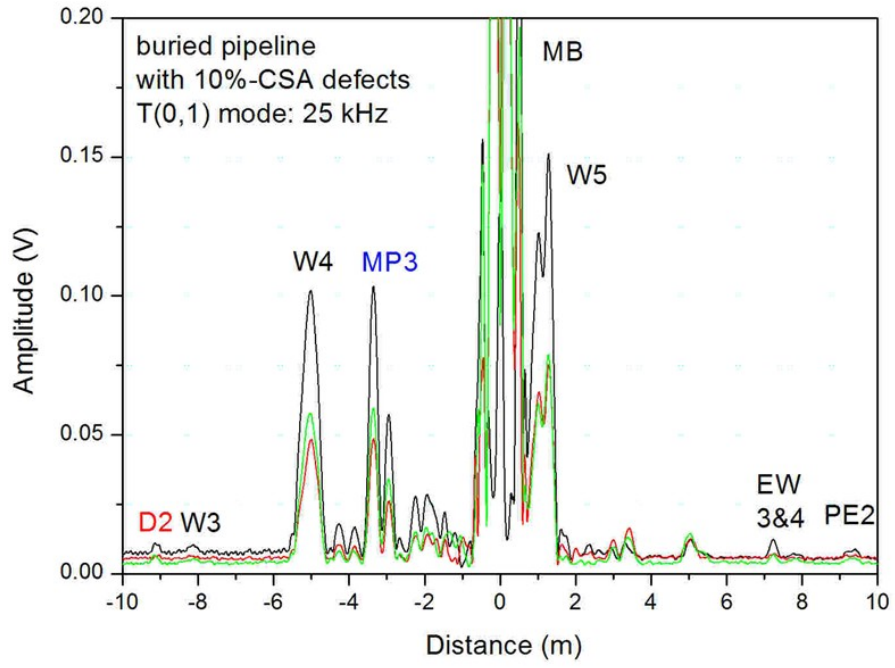
Figure 8. Inspection results with magnetostriction sensor at measuring point 4 after burial

The signal decay became more significant at the result obtained at buried pipes. The observed decay at buried pipe is around 6dB/m at 25 kHz. The attenuation rate was known to be frequency dependant. At higher frequency the coefficient became higher (3, 4). The detection ranges were identified and are summarized at Table 2, 3.

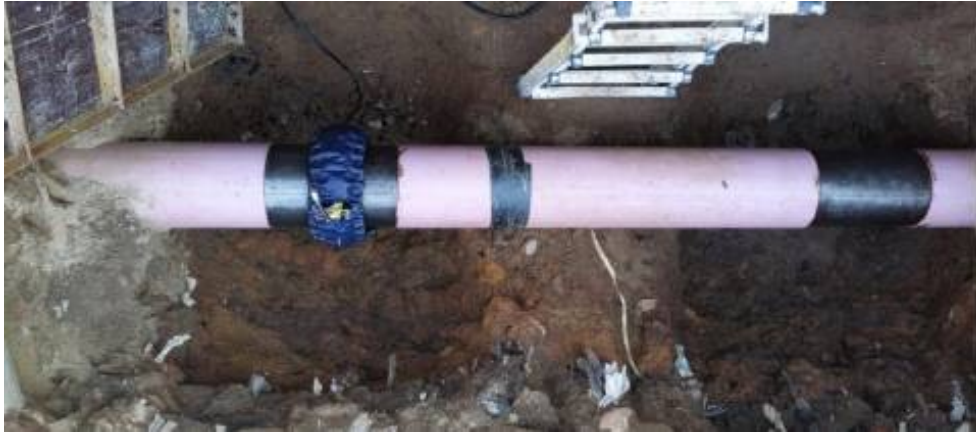
Figure 10. Inspection with piezoelectric sensor at valve station

The field applications of piezoelectric sensor were conducted at sites (figure 10). The following results show that suspected defects was identified successfully as shown in figure 11. The detection range at the field is slightly shorter than the test pipe. It is believed that uneven soil condition and coating degradation induces
