**GAS DISTRIBUTION NETWORKS: ASSESSMENT OF THE
LIFETIME OF AN INNOVATIVE SAFETY SYSTEM INSTALLED IN
EXISTING SERVICE LINE**

1. Abstract

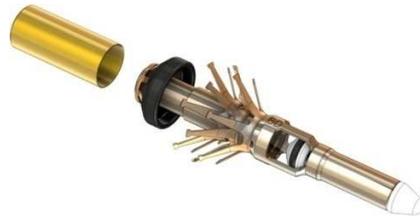
Figure 2 presents DPBE for 20 mm ($\frac{3}{4}$ ") external diameters PE service lines:

Figure 2: DPBE for 20 mm ($\frac{3}{4}$ ") external diameters PE service lines

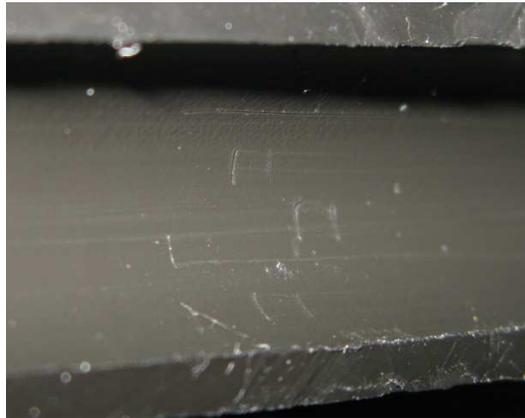
So the analysis of laboratory specimens containing a DPBE two years after its installation confirmed a very small depth. Figure 7 shows the scratches generated by the DPBE.

Figure 7: Scratches generated by the DPBE on a 20x2 mm pipe inner surface two years after its installation at 20°C

Then the geometry of such a scratch is known to have a far slighter mechanical impact on the pipe lifetime compared to the equivalent fault oriented along the pipe axis for the following reasons. Firstly the widest surface exposed to the stresses is perpendicular to the pipe axis for which the traction stress is negligible (centered fault on an infinitely long pressurized pipe) and secondly, the surface exposed to the hoop stress is extremely small. Consequently the internal pressure is supposed to have no significant effect on such a fault and the scratch is not likely to provoke a slow crack growth neither in the transverse direction nor in the longitudinal direction. The hydrostatic pressure tests in progress up to now on pipes with calibrated internal indentations confirm the poor impact of such faults on the 20x2 and 20x3 mm pipes (see the second approach presented above).
