SCC A PROBLEM IN THE INDUSTRY AND ONE WAY TO MANAGE IT

Daniel Falabella – Transportadora de Gas del Sur, Argentina
Fabián Lara - Transportadora de Gas del Sur, Argentina
Mariana Córscico - Transportadora de Gas del Sur, Argentina

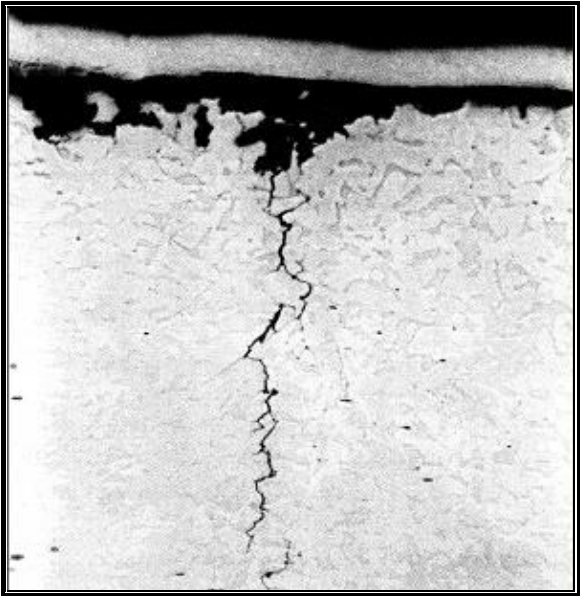
<p>High-pH SCC (electrolite pH between 8.5 and 11) <i>Intergranular</i></p>	<p>Low-pH SCC (electrolite pH between 6.0 and 8.5) <i>Transgranular</i></p>

<p>(Magnified 250 times)</p>

<p>(Magnified 250 times)</p>
<p>Figure N°1 High pH SCC</p>	<p>Figure N°2 Low pH SCC</p>

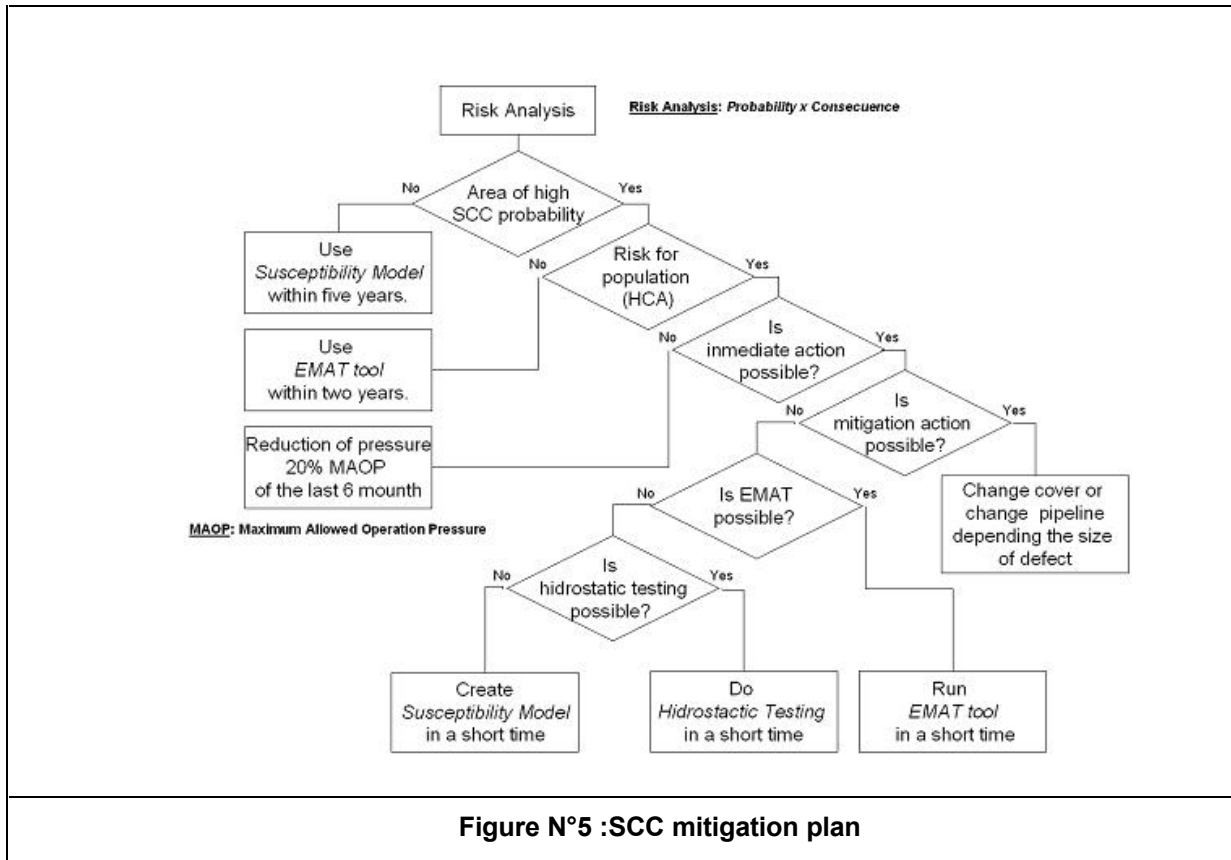
The SCC mitigation plan implemented as shown in Figure 5 uses a combination of: Internal inspection, hydrostatic test and SCC direct assessment, which (in a short time) allowed TGS to optimise technical and financial resources, to operate the pipeline system affected in a safe and reliable way.

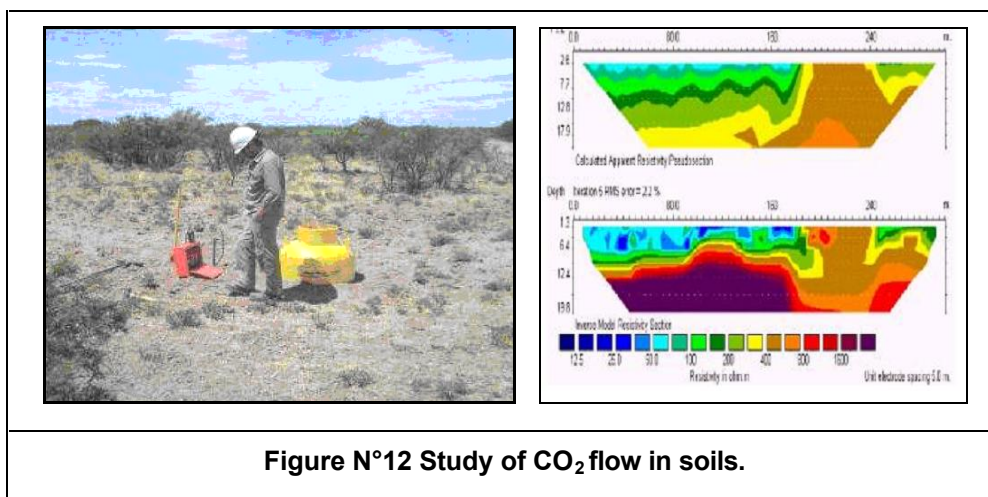
Figure N°12 Study of CO₂ flow in soils.

- ❑ Study of the abnormal presence of CO₂ flow in the place where the cracks occurred. Figure N° 12
- ❑ Measurement of the soil conductivity change and development of a specific model of soil resistivity in two-dimensions. It was possible to detect important changes of soil resistivity in SCC areas.
- ❑ Soil laboratory tests were performed to determine physical and chemical parameters which were used by AEROTERRA to construct isovalue maps
- ❑

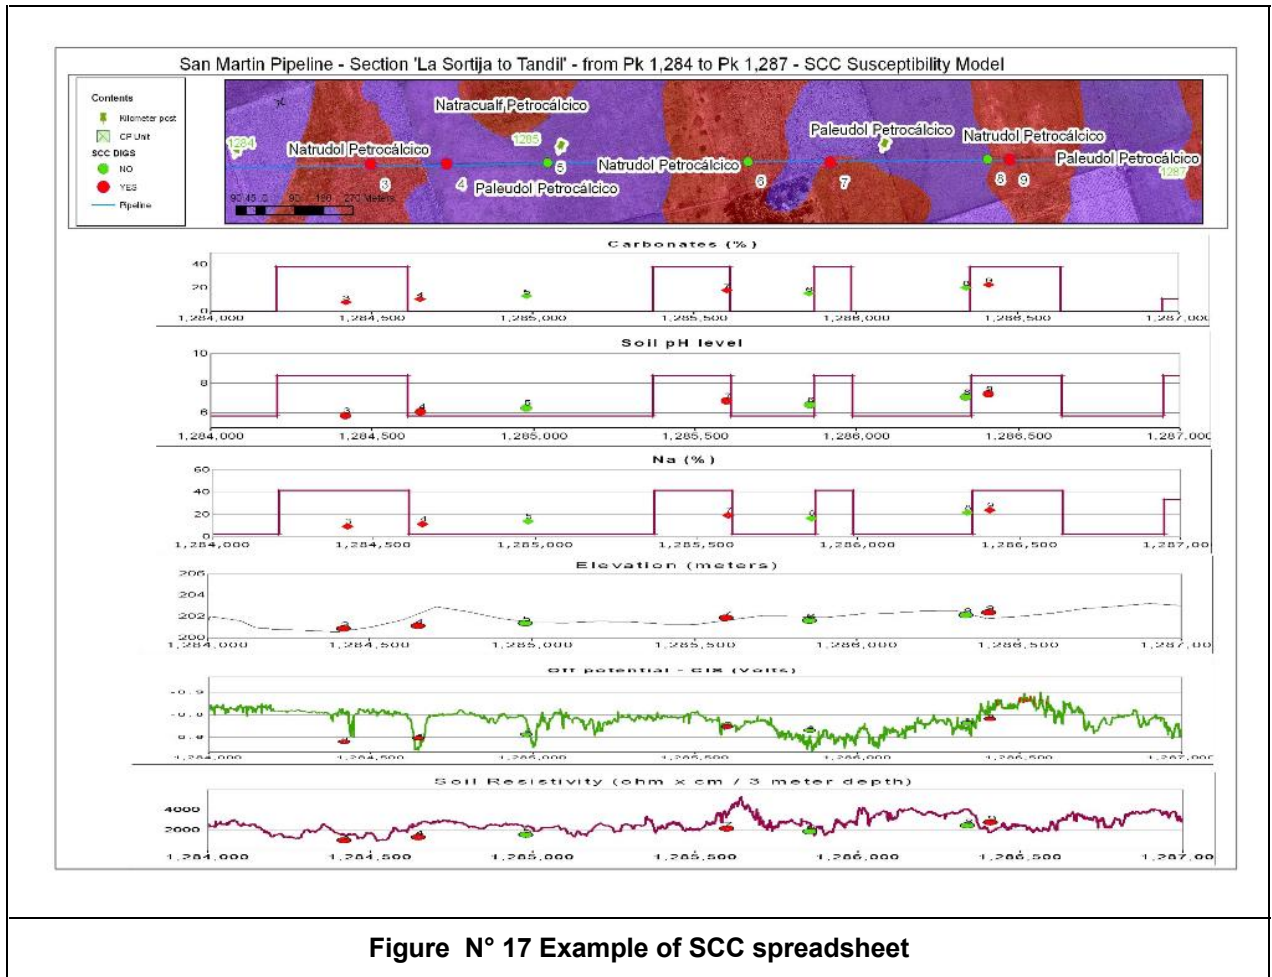
The following is an example of this SCC spreadsheet.

Figure N° 17 Example of SCC spreadsheet

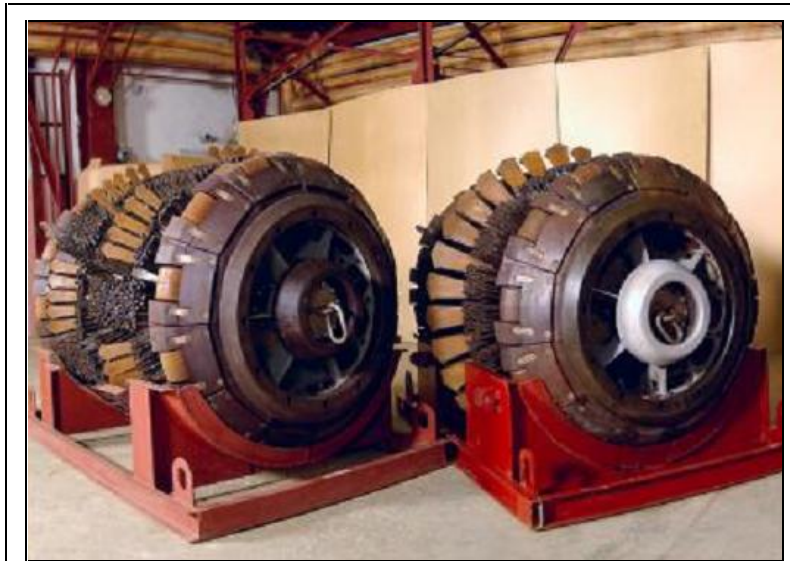
The ILI tools, that include two different techniques: magnetic flux leakage (MFL) + transverse field magnetic flux leakage (TFI), are useful to evaluate the integrity of gas line. The combination of MFL + TFI is a good one to detect low pH SCC, but not for the high pH SCC. In this case the cracks are closed and do not produce significant variation in the magnetic field. For this reason, this combination of tools is only used to detect low pH SCC.

Figure N° 20 MFL + TFI tool
