## Remote Sensing Analysis for Pipeline Incidents Risk Evaluation

Alexandre Agaian, PhD, Dmitry Vilbaum, Terra Insight Services, Inc

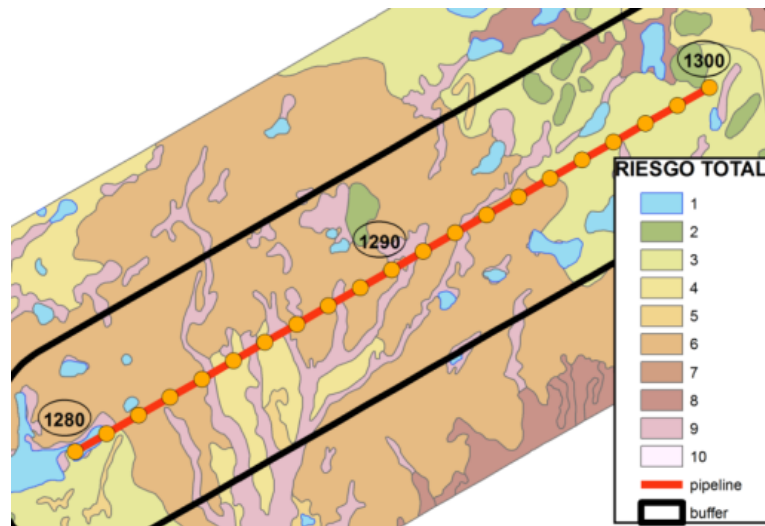
Figure 5: Map of combined risk of negative soil processes development

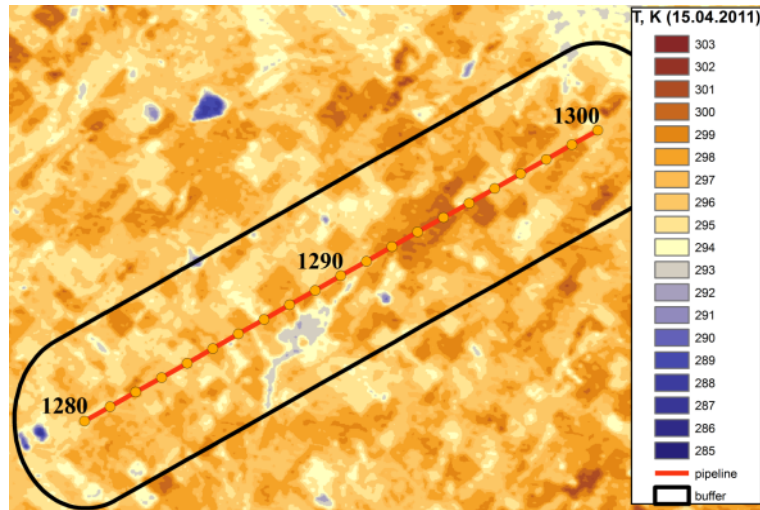
Figure 10: The temperature map based in Landsat-5™ satellite data at 04.15.2011

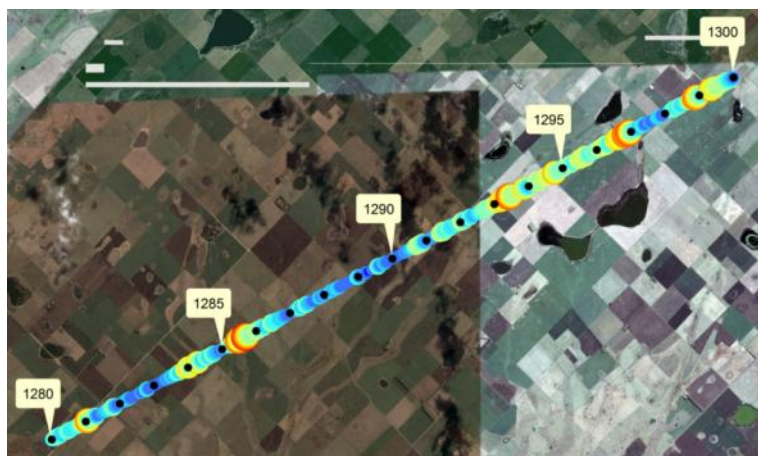
Figure 14: Map of the potential combined risk estimates. Red color – maximum risk values, blue color – minimum risk values

where  $B_{ij,n}$  is the value of the factor  $F_{ij}$  in point  $n$ . As previously stated, the calculations were performed for all of the points on the 20km Pipeline fragment with 1 meter resolution. Thus, the assessment of risk is represented as a function of the combined/correlated individual risk factors for any specific point (coordinate) on the pipeline. The map and the graph showing the results of such calculations are presented on Figure 14 and Figure 15.

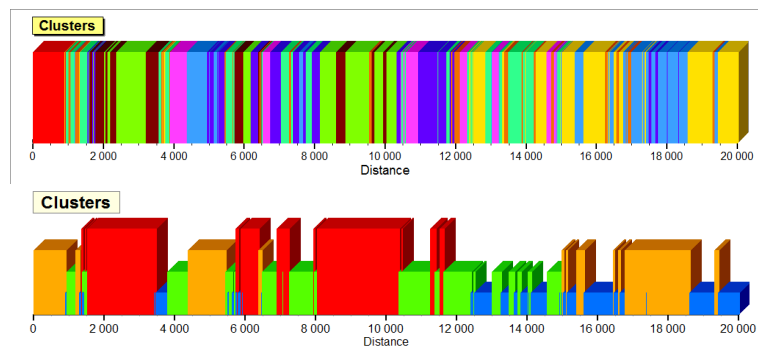
Several clustering procedures were performed for a different number of classes. The analysis revealed that the optimal number of classes was between 4 and 10. For the illustration purposes, Figure 16 shows the results of clustering for 9 and 4 classes respectively. Colors designate particular classes, spatial localization of which is determined by the distance (in meters) from the pipeline marker 1,280. Semantic content of colors for the upper and lower graphs is not the same, i.e. the same colors in the graphs (above and below) do not imply the same class. Differentiation of classes by height in the lower figure is shown for a better visual perception and has no other substantive meaning.

Figure 16: Clustering result for 9 (upper graph) and 4 (lower graph) classes.

Analyzing the results, we can notice some correlation between classes in the upper and lower figures. In particular, in the distance range 2,000-4,000 and 8,000-10,000 meters from mark 1,280, red color at the bottom of the figure are correspond to brown and green colors at the top; in the range of 15,000-20,000 meters, blue and orange colors of the lower picture correspond, respectively, to yellow and blue color of the top graph.

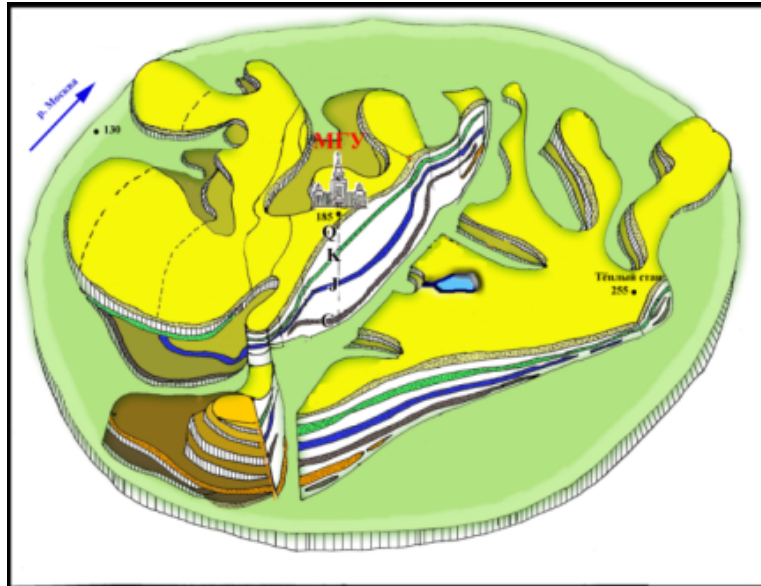
Typically, only two-dimensional geological and engineering profiles are used by the pipelines constructors. Lithodynamic analysis produces highly informative more accurate space-time (matter in motion) maps, as shown for example in Figure 18.

Figure 18: Example of the geologic-geometric model, scale 1:5,000

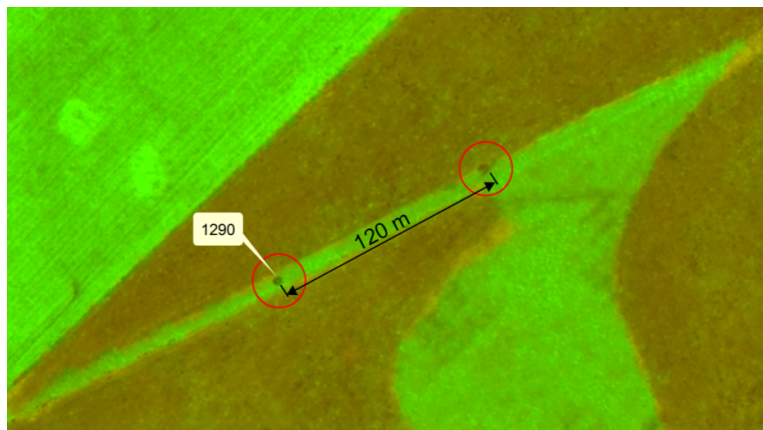
Figure 26: Color composite image (R2, G4, and B1) of the same site (dated 10.10.2010 - 4 months before the incident)

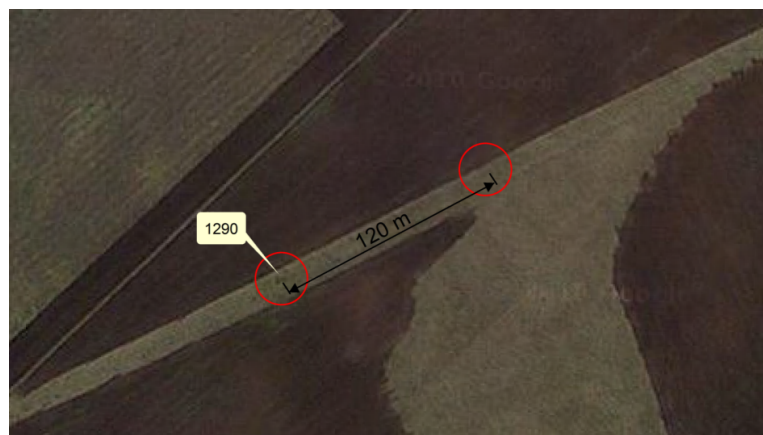
Figure 27: Image taken in 2003 (from the Google service)

Based on the visual interpretation of the space imagery materials (QuickBird-2) on 10/10/2010 (4 months before the Incident at mark 1,290), TIS discovered a clear anomaly precisely over the mark 1,290. Moreover, the presence of the same anomaly, although not as explicit, can be observed on the image hosted on the Google Earth Installer service (photo taken in 2003).

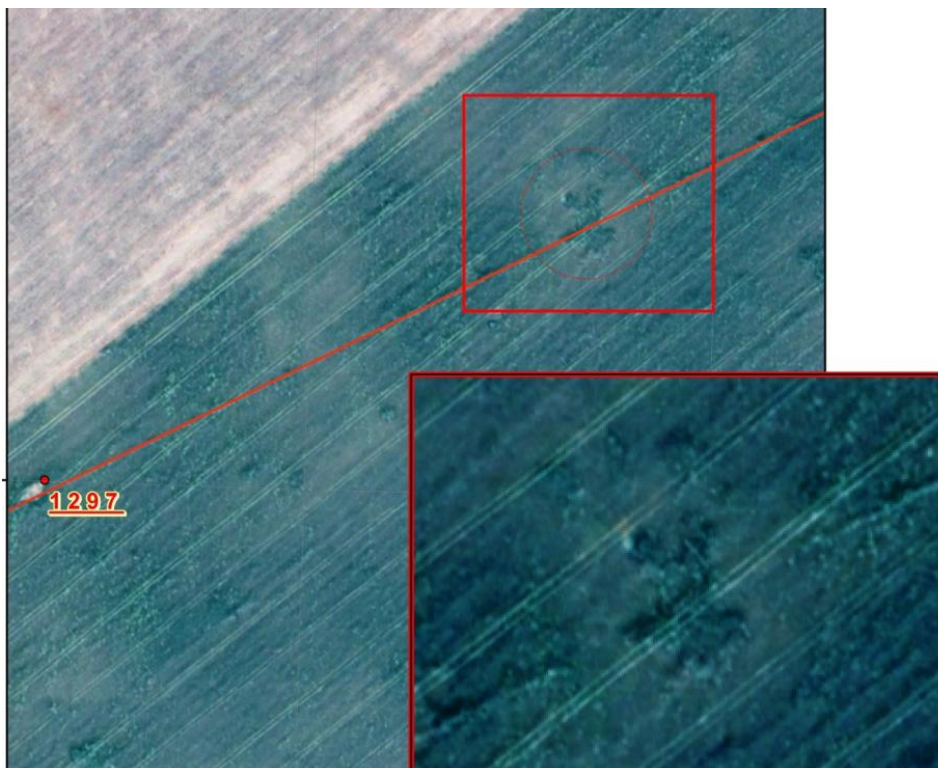
In general, in the homogeneous areas, the vegetation anomalies are sometimes observed. Figure 34 below shows a circular structure (in the middle of the square) in the center of which there is an increase in vegetation mass, while along the radius of the circle - a sharp decrease in vegetation mass. The path of the pipeline is also hardly traceable within this spot. Perhaps this is a local subsidence in the relief, the so-called micro-depression.

Figure 34: Circular structure on the pipeline with a high vegetation mass in its center and sharp drop in vegetation at its edges
