# Assessment of low-frequency Electric Resistance and Flash Welded line pipe defects by EMAT and CMFL In-Line Inspectio

Richard Kania, TransCanada Pipelines, Calgary, Canada  
Ralf Weber, ILI Consulting, Karlsruhe, Germany  
Martin Runde, ROSEN Technology & Research Center, Lingen, Germany  
Stefan Klein, Germany

**26th World Gas Conference** | 1-5 June 2015 | Paris, France

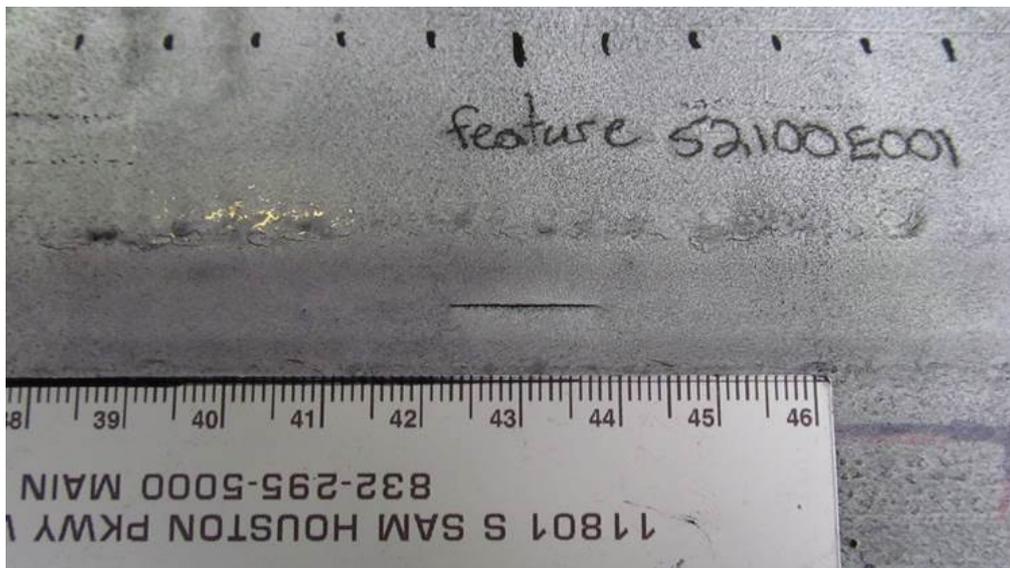
Figure 1: Photograph of verified LOF defect surface breaking on the OD after b/w MPI of the external pipe surface.

The defect shown by Fig. 1 has been identified as a LOF at the bonding line of the seam. The length of the defect of 15 mm (0.590 inch) is significantly smaller than the wall thickness of the pipe 7.2 mm (0.281 inch). For such penetrators, the lower frequency reflection clearly indicates the reported defect. The CMFL signal indicates the defect as well. An increase in the recorded magnetization is detected. MPI and PAUT confirmed the presence of the penetrator. The length of 15 mm (0.590 inch) is well below the specified minimum defect length for the EMAT and of the order of the shortest EDM notch tested upfront. The reported ILI depth matches the NDE depth and is within the specified accuracy. Although no destructive testing result is available at this point for this defect, it is assumed, that the defect depth profile is similar to that of a machined EDM notch. The ILI overestimates the length of the defects with respect to the reference MPI length. This can be explained by the extent of the measurement area of the EMAT sensor. Assuming a Gaussian EMAT sensor sensitivity distribution and a significant overlap of individual measurements in axial direction the extension of the defect is enlarged.

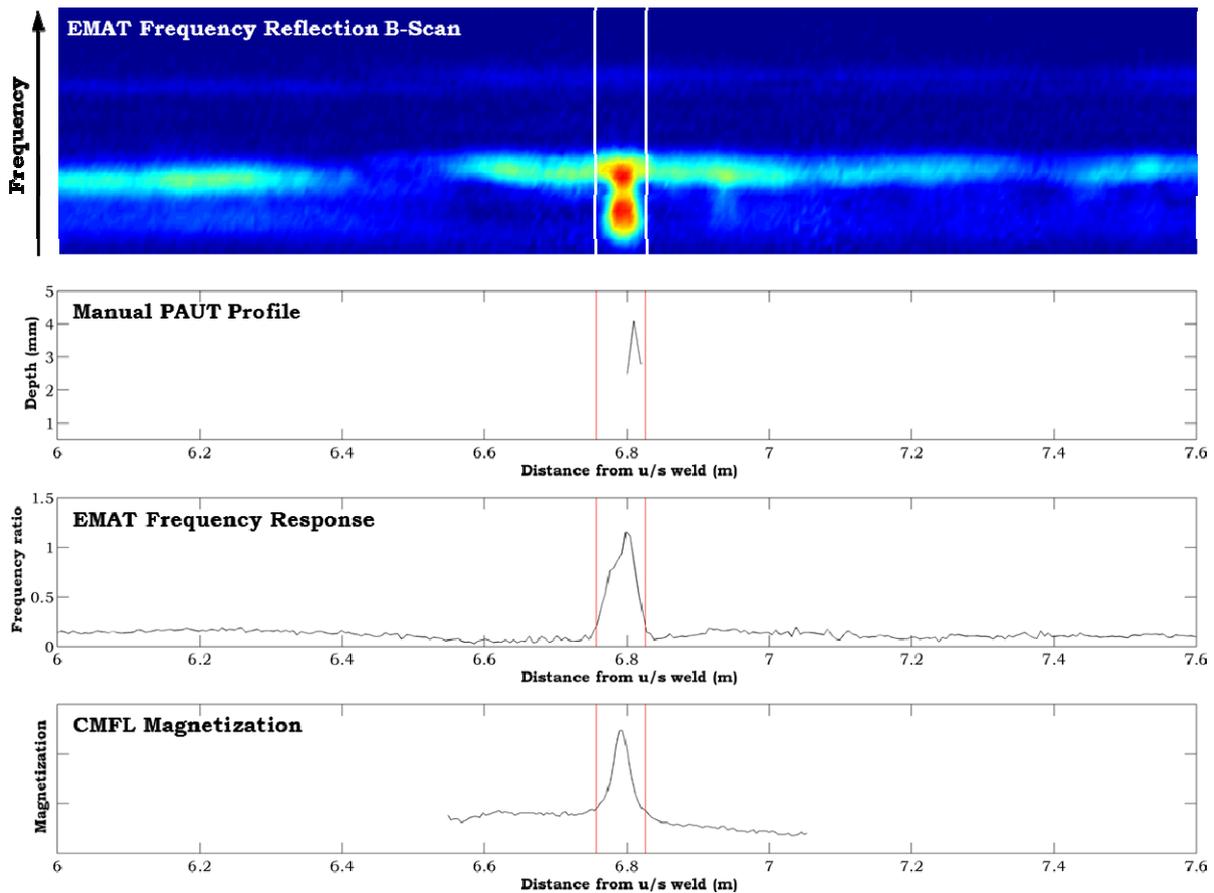
Figure 2: ILI and manual PAUT NDE data for spool No. 1. High correlation of the PAUT depth profile and EMAT frequency response is visible for defects that exceed 1mm depth. Further description is given in the text.

Manual PAUT was used as a benchmark with regards to detection and sizing capabilities for a series of similar LOF and hook crack defects. From the different dimensions in terms of lengths and depths of the investigated defects the capabilities are demonstrated and compared to destructive testing results. The applied EMAT and CMFL show high sensitivity to defects in the ERW weld. The EMAT successfully resolves different defects ranging from exemplary penetrators to continuous seam-weld anomalies of varying depths.
