26th World Gas Conference

Thematic Session (WOC 3-3)

Assessment of ERW and EFW line pipe defects by EMAT and
CMFL Inline Inspection

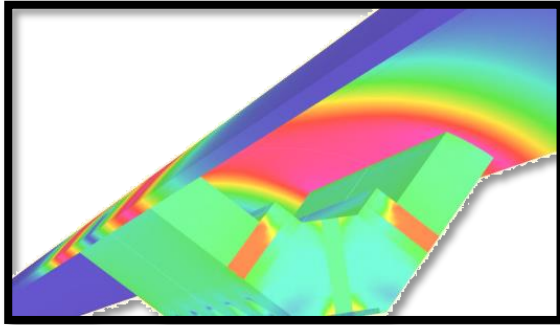
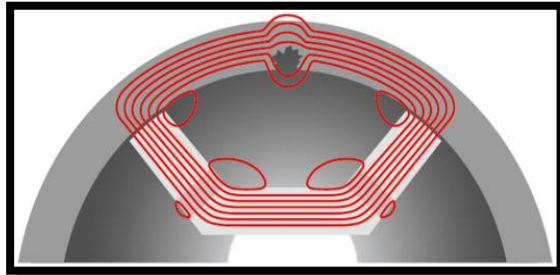
- The magnetic field is oriented in circumferential direction
- Primarily axially oriented volumetric anomalies are targeted such as corrosion.
- Axially oriented planar anomalies can be successfully detected when they exceed a minimum opening.

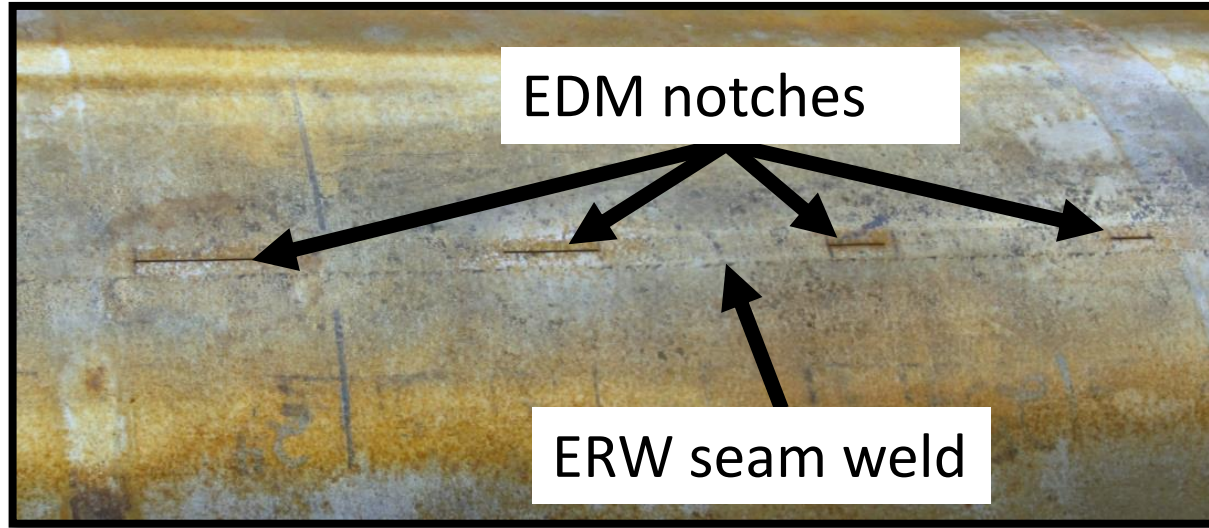
- Determine detection capabilities of machined EDM notches at centerline of the ERW seam-weld
- 22" test pipe previously removed from targeted pipeline

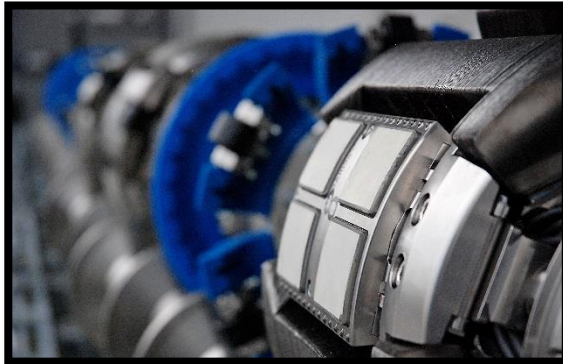
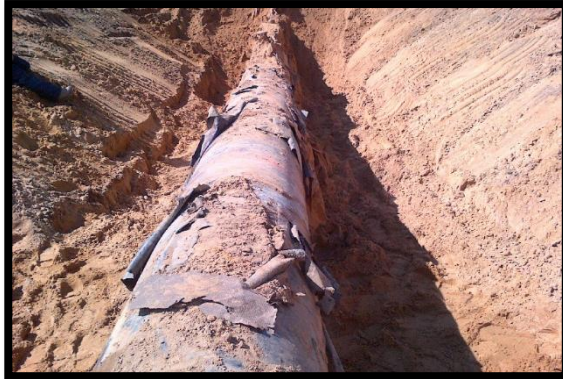
- After joint review of the pull-test data ILI tool runs have been performed and data analyzed
- After initial validation of the ILI capabilities additional joints have been selected for excavation
- Following a developed dig prioritization process to further assess the ILI capabilities 11 spools have been cut-out and verified to date

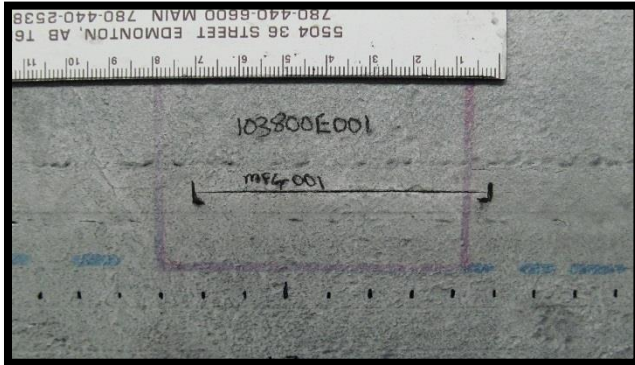
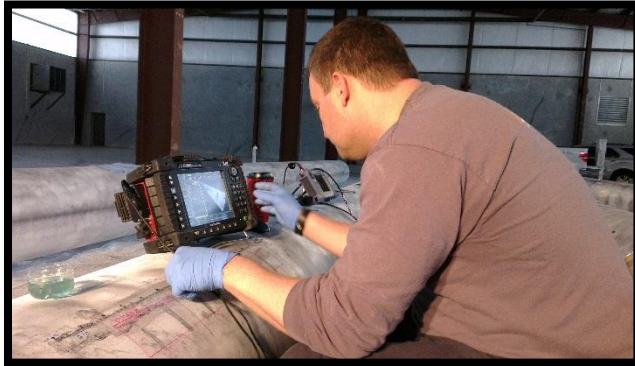
- Spools have been sandblasted and investigated using b/w MPI for the entire pipe surface
- PAUT depth profiles have been recoded for the entire seam-welds (10mm grid)
- Anomalies have been verified internally and externally
