Assessment of the condition of underground collector lines

situated inside the technological complexes of
underground storage facilities

Underground gas storage Lab

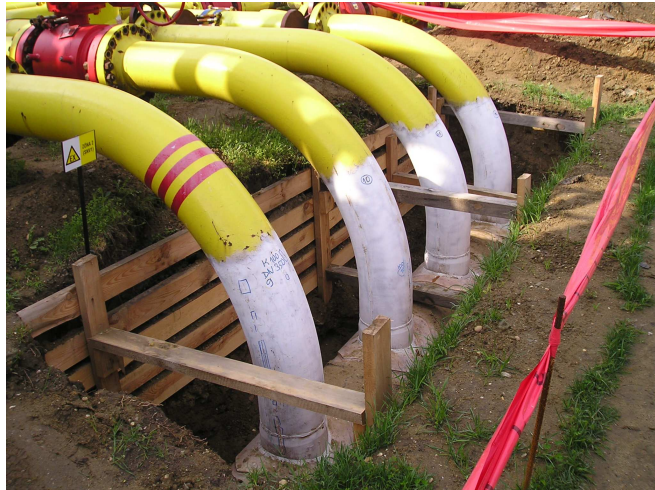
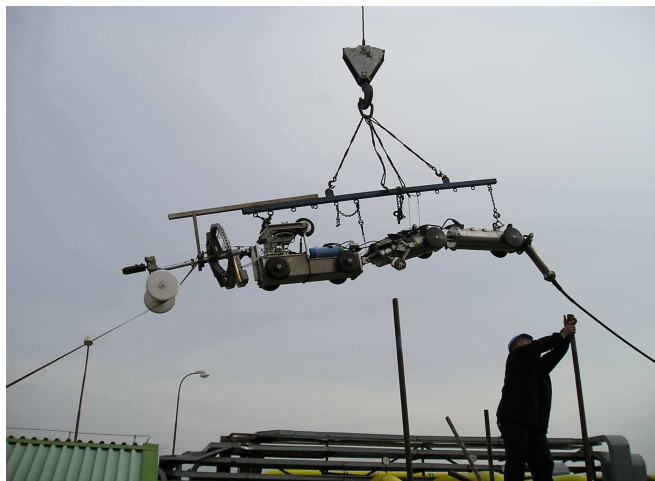
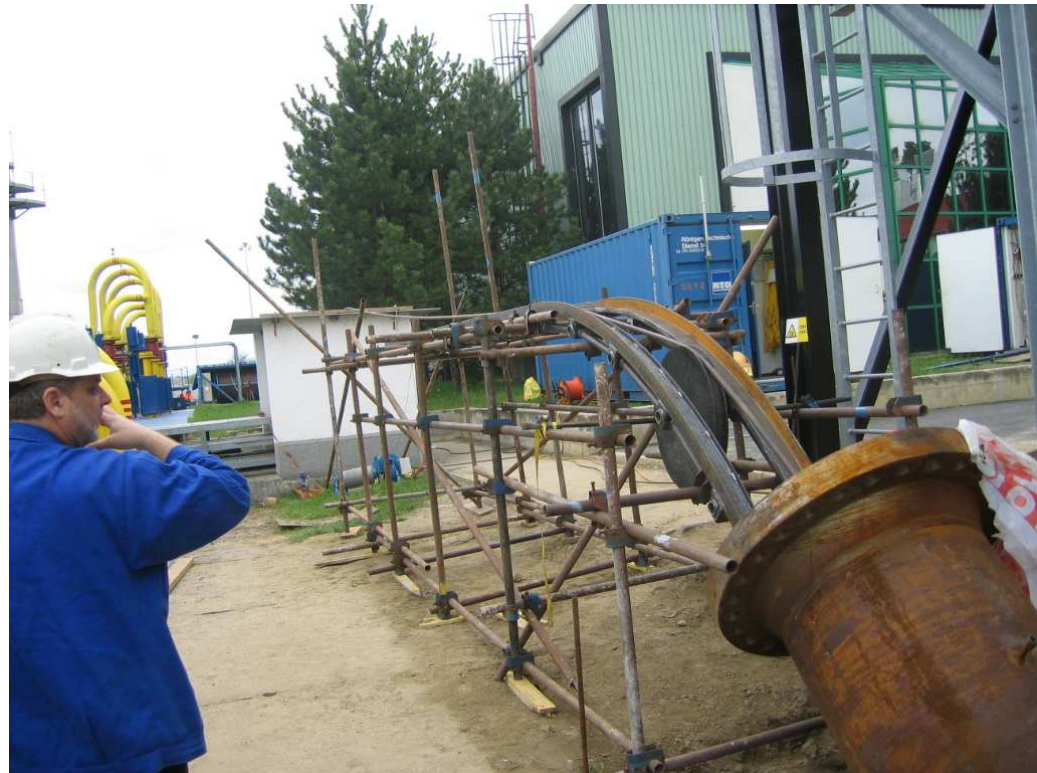
Inspection of collectors K 100, K 101

- Excavation and preparation for bends' installation
- Inspection of all off-takes
- Material shop preparation
- Modifications of collectors' entries
- Ultrasonic in-line inspection by an external company

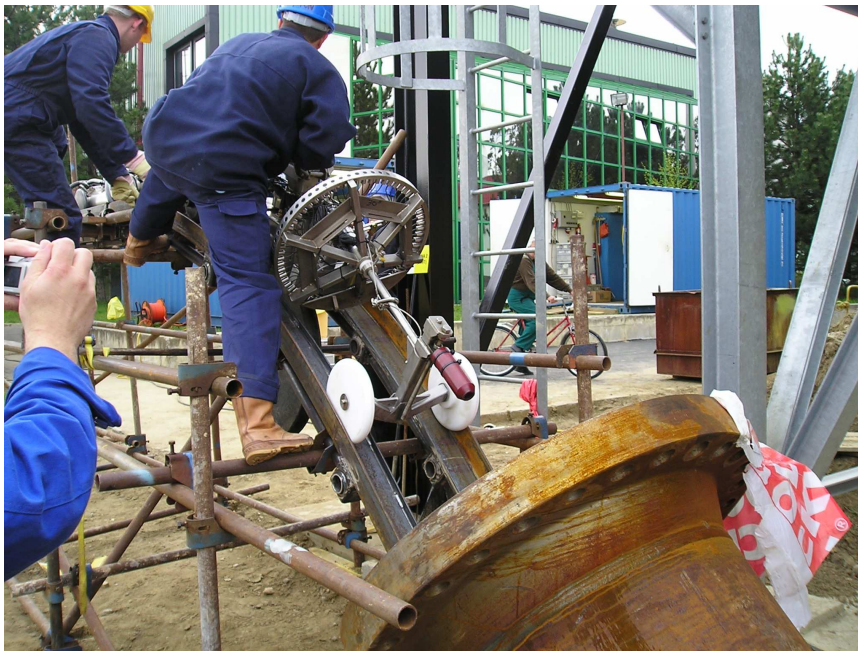
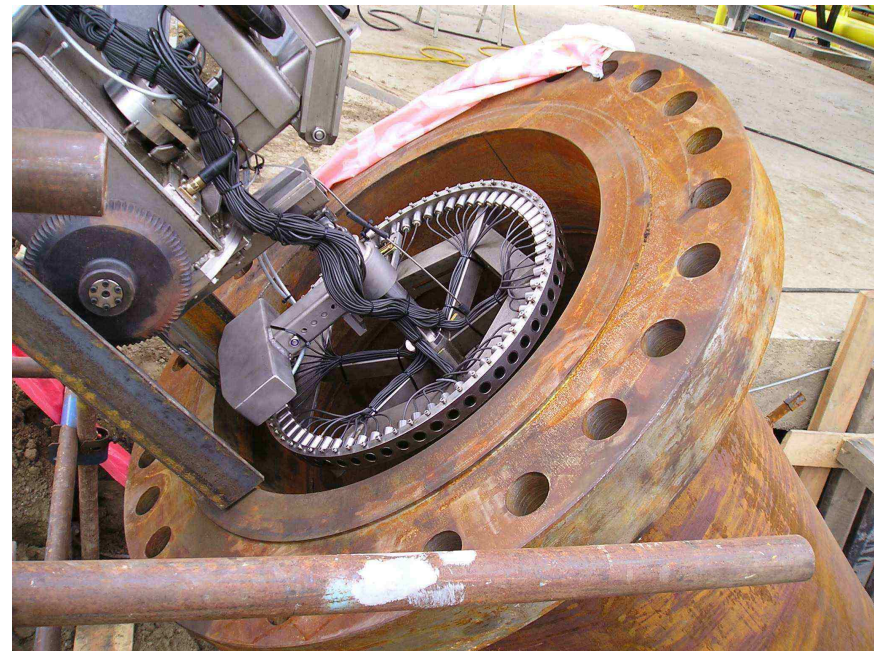
Inspection of collectors K 100, K 101

- **No serious defects were revealed**
- Only lamination defects (mill defects), originating from manufacturing process were found
- Lamination parts were reinforced by installation of ‘hot sleeves’
- **Based on simulation, safe operation forecasted until year 2015, the next inspection with assessment planned 2015**
