# **Failure Analysis and design modification of stack spool bolts under mechanical/thermal loading using finite element model and experimental data: A case study**

## **Abstract:**

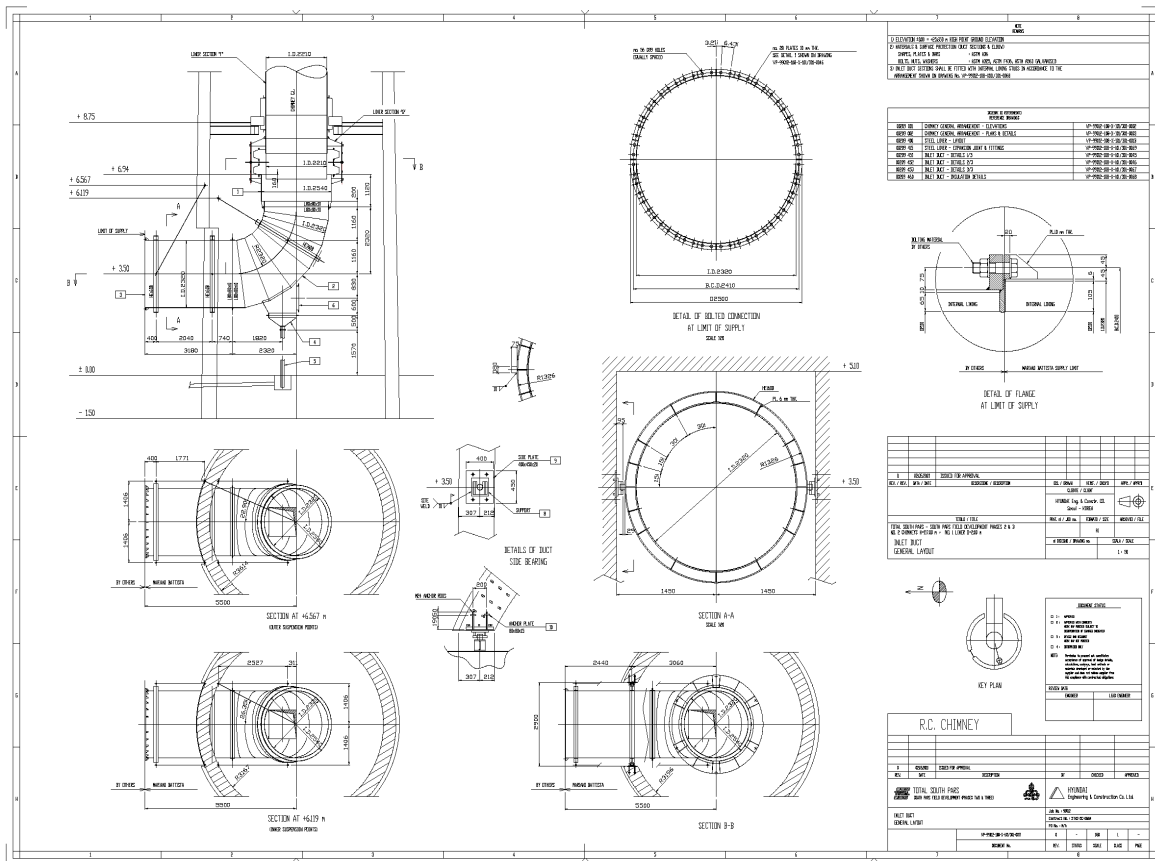
Figure 3. CHEMNEY DETAIL DRAWING

A few years after the stack was erected the bolts began to fail with replacement required approximately every 3 years. Failure happened on the 19 & 20 spools and when top spools fail, lower spools lose their connections and their weights suppress guided supports and expansion joint at the bottom of stack structure damaging them. An investigation was carried out and the main results are presented below.

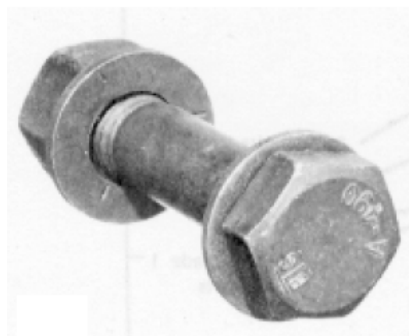
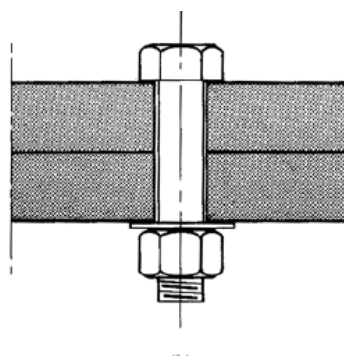
Figure 16.standard hexagonal head bolt

The bolts which used to connect chimney flanges are hexagonal head high strange structure bolt according ASTM A325, bolt size is 12 and this connection thigh with 60 bolts per flange. Failures occurs every 3 or 4 years at the flange NO 19 or 20 which higher load exist at this point. Bolt stress and load shown in table.3

This stress concentration effect was severe on two points: 1- bolt head 2- at the beginning of the tread part where we have cross section area alterations. To overcome the limitations the material and type of bolts have been changed. Current bolt material (A-325) changed to higher strength material (A-193 B16) and machine bolt changed to stud bolt with double nut configuration. Using stud bolt instead of machine bolt reduce stress concentration points.

Besides, using double nut with pre load 100 (N.m) guaranty the appropriate strength for the structure.

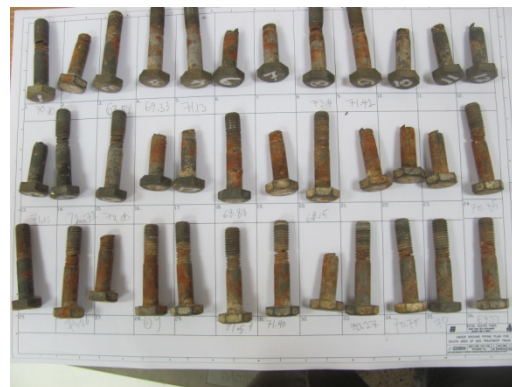
Figure 20.bolt analysis

Type of broken and Location of bolt fail and broken was shown in picture 15 to 20
