International Gas Union Research Conference 2011

Failure of Field Joint Coating under Soil Stress

YoungGeun Kim

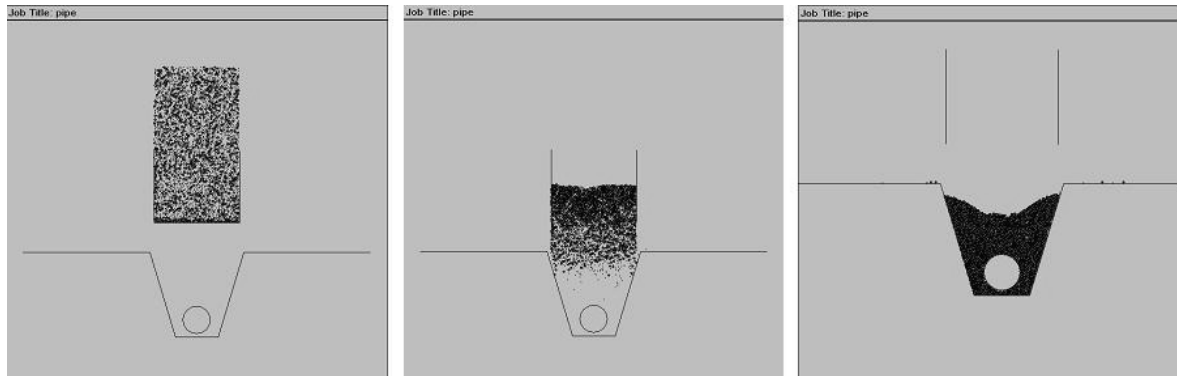
Figure 4. Simulation of Back-filling with Particle Flow Code

sometimes disobeyed by the contractor. It is very common to back-fill the trench in a single step. The initial density of soil was analyzed using particle flow code in 2 dimensions (PFC2D of ITASCA). Following results shows the typical calculation results of the analysis. The particles falling from the above will fill the space around the pipe in the trench.(Figure 4)

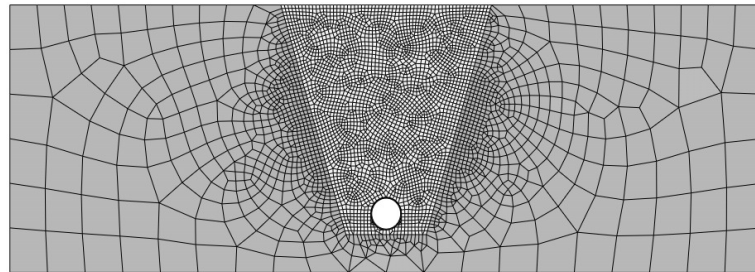
Figure 6. Grid for FEM analysis

Based on the observed results softer soil at underneath the pipe was assumed for the calculation. Next figure shows the grid for the calculations.(Figure 6)

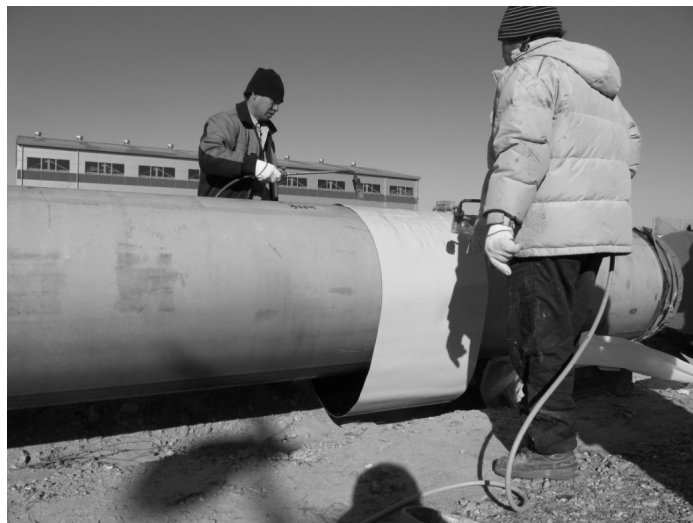
Figure 9. Coating Application for Field Test of Coating Performance

All of the application was done above ground.(Figure9) It means that the condition for the working were very good to apply and to inspect every surface of the coating. The heating of the surface was uniform. After application of the coating the pipes were buried to the depth of 1.5 m to the top of the pipe. The typical value of the commercial mastic heat shrinkable sleeve is about 200 kPa.
