Effects of the Large-scale Earthquake and Tsunami on an LNG Receiving Terminal

Nobuhiko Takei (The Japan Gas Association)
Minoru Makino (Gas Bureau, City of Sendai)
Toshihiro Meguro (Tokyo Gas Co., Ltd.)
Shohei Nishida (Osaka Gas Co., Ltd.)
Hidetoshi Osajima (Saibu Gas Co., Ltd.)

This paper presents a detailed report of the damages to this LNG receiving terminal (the Sendai City Gas Bureau Minato Works) from the earthquake and massive tsunami of a scale beyond all expectations, describes the emergency recovery and restoration efforts, and notes what can be learned from this experience.

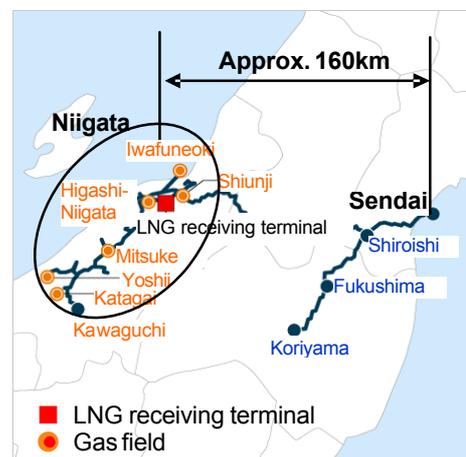
Fig. 12 High-pressure gas pipeline

It was determined that the complete recovery (restoration) of the Minato Works would take a substantial amount of time for the replacement and repair of equipment that was flooded and damaged. So a high-pressure natural gas pipeline (Fig. 12) and temporary LNG regasification equipment were used for the early restoration (emergency restoration) of supply.

Since the natural gas high-pressure pipeline and the facilities required for emergency restoration of supply within the Minato Works (piping, odorization equipment, etc.) were confirmed to be sound, while conducting safety measures within the Minato Works and implementing emergency measures for the minimum necessary monitoring from the control room, which was undamaged, gas supply was resumed using gas from the natural gas high-pressure pipeline. This took place on March 23, 12 days after the Minato Works were damaged. It took 35 days, until April 16, to resume supply to all of the approximately 300,000 users whose gas had been cut interrupted by the earthquake.

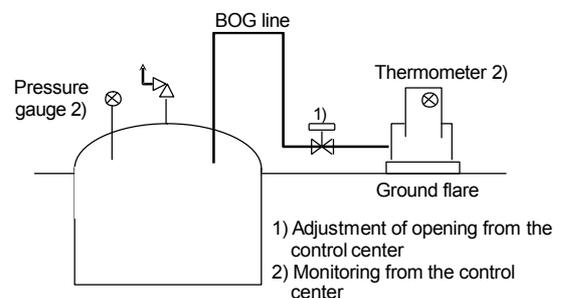
Fig. 13 LNG Storage Tank BOG Apparatus

To prevent the BOG generated in the LNG storage tank from mixing and being delivered together with regular gas supply, the gas was burned off using ground flare equipment while monitoring the pressure inside the tank at the control center. To confirm sound combustion (continuous combustion), equipment was installed so that the ground flare exhaust temperature could be monitored at the control center.

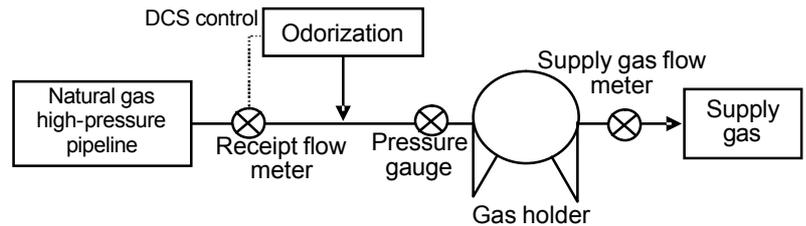
Fig. 14 Control of Natural Gas High-pressure Pipeline

In arranging emergency recovery with gas from the natural gas high-pressure pipeline, the measuring instruments required for monitoring and control from the control center (receipt volumetric flow, delivery gas volumetric flow, pressure gauges, odorant input volume, etc.) were

installed or restored (Fig. 14). A temporary electricity source that can operate continuously for long time periods was installed to provide the electric power required for emergency recovery safety measures and for monitoring and control from the control center (DCS control, power source for instruments).

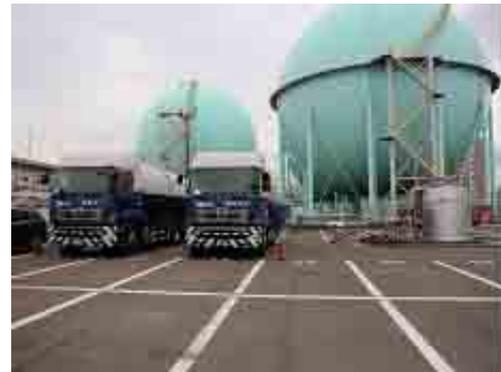
Fig. 15 Temporary LNG regasification equipment

The medium-pressure gas pipes within the Sendai City Gas Bureau's supply area were not damaged by the earthquake and tsunami. For that reason, it was possible to maintain supply to users with a public nature (such as hospitals and communications companies) that receive their gas directly from medium-pressure gas pipes using the gas stored in gas holders. Since the amount stored was limited, LNG gas trucks, temporary LNG regasification equipment and odorization equipment were brought in from Tokyo (Fig. 15), set up outside the Minato Works, and gas supply was maintained.
