Managing Integrity of High Pressure Gas Pipeline: Root Cause Analysis and Hydrogen Induced Crack (HIC) Direct Assessment of Weldment Crack on 30" Gas Pipeline

- Constructed in 1989 and commissioned in 1991. It has been in operation for 20 years.
- 209 km length from SOC to Pasir Gudang MS.
- On 15 Feb 2009, pipe cracked at KP 69.2, Bekok along the circumferential weld from about 5-to-7 o'clock positions.

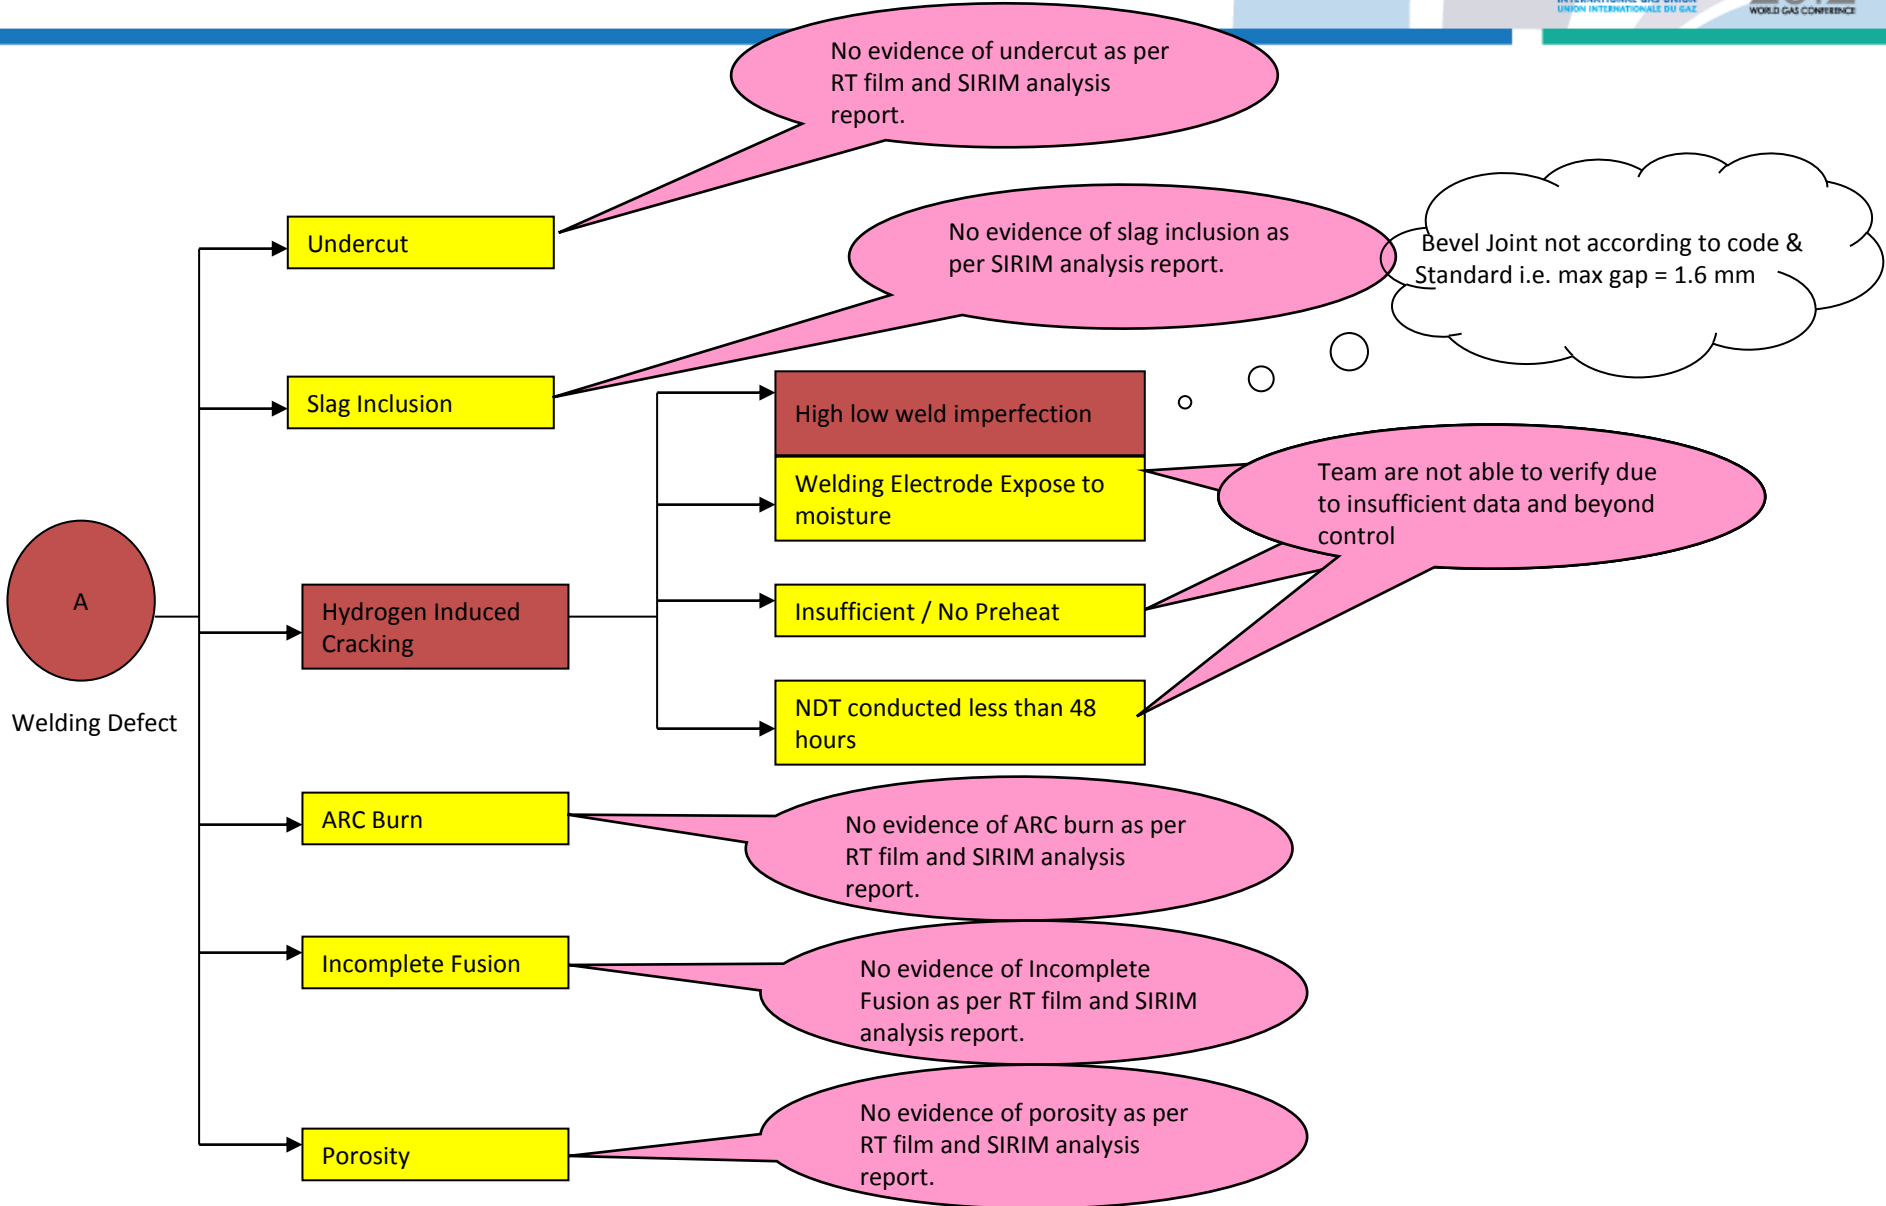
Root Cause Analysis of Welding Joint Crack (2/4)

Pipe adjacent to welding joint (HAZ) at KP 69.2, PGU 2, Sector 3 crack and lead to leak and resulted estimated PONC of RM 4 M.

- Cracks initiated at weld toes due to hydrogen induced cracking mechanism leading to the formation of dark fracture surface filled with oxides.

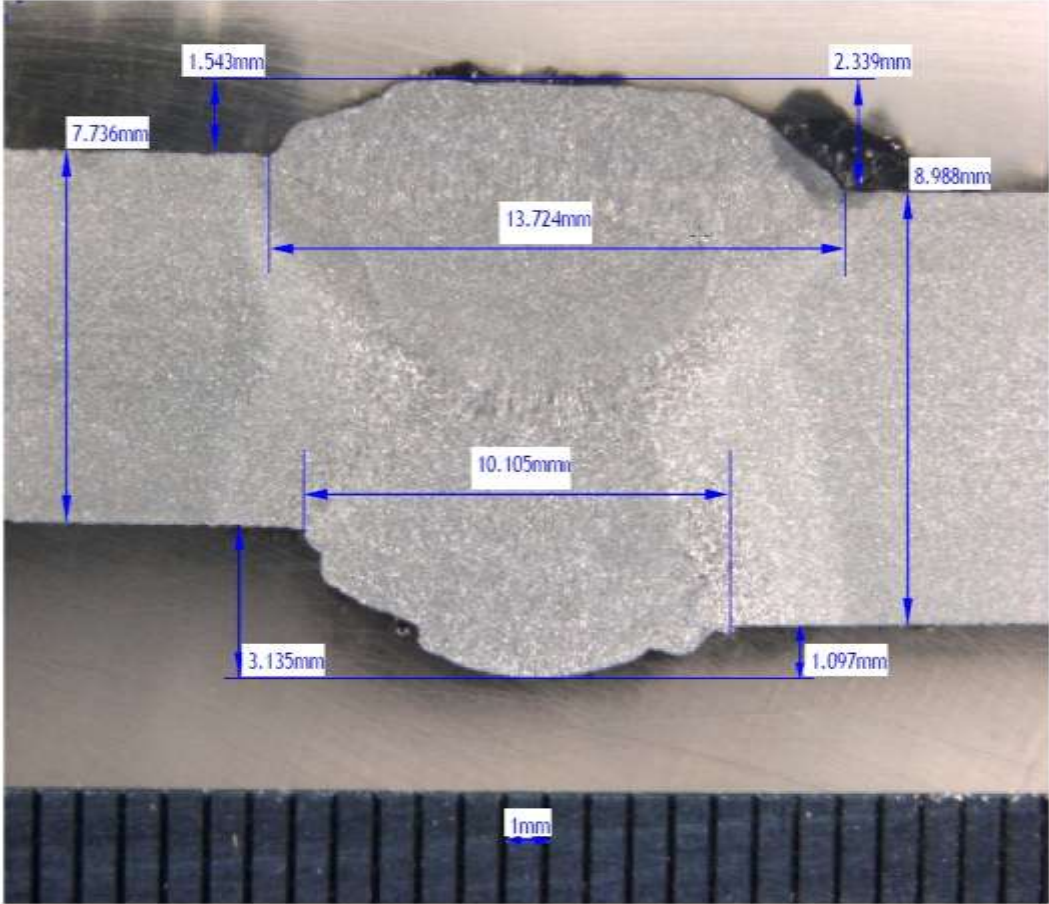
Root Cause Analysis of Welding Joint Crack (4/4)

- ✓ High-low weld imperfection
- ✓ Insufficient (or no) preheat
- ✓ Welding electrodes exposed to moisture in hot and humid conditions.
- ✓ NDT inspection conducted in less than 48 hours after the welding might miss any sign of HIC which might occur after a period of several hours.

- ✓ The contributing factor highly possibly due to the welding process i.e. joint design incompliance with API 1104 standard
 - ✓ The defect/crack was not detected in the radiographic testing during the project/construction of the pipeline
