25th world gas conference  
“Gas: Sustaining Future Global Growth”

# Effects of the Large-scale Earthquake and Tsunami on an LNG Receiving Terminal

Nobuhiko Takei,  
The Japan Gas Association  
6th JUN 2012

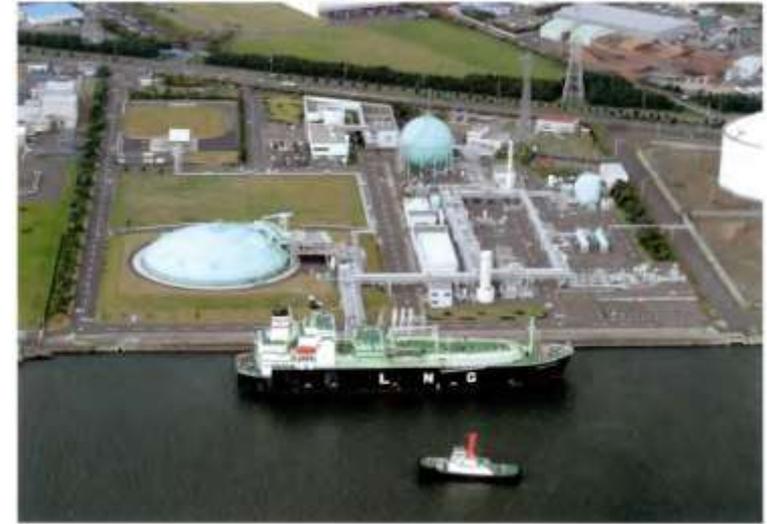
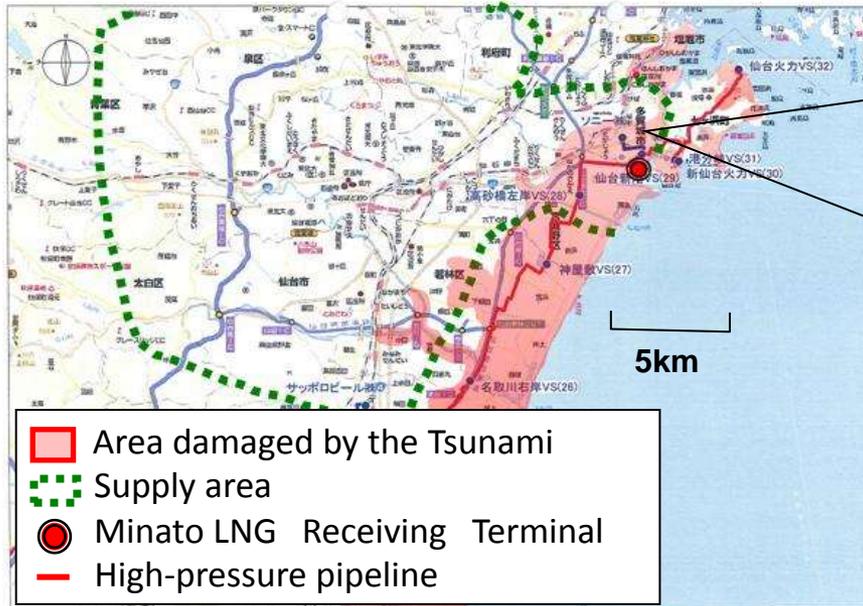
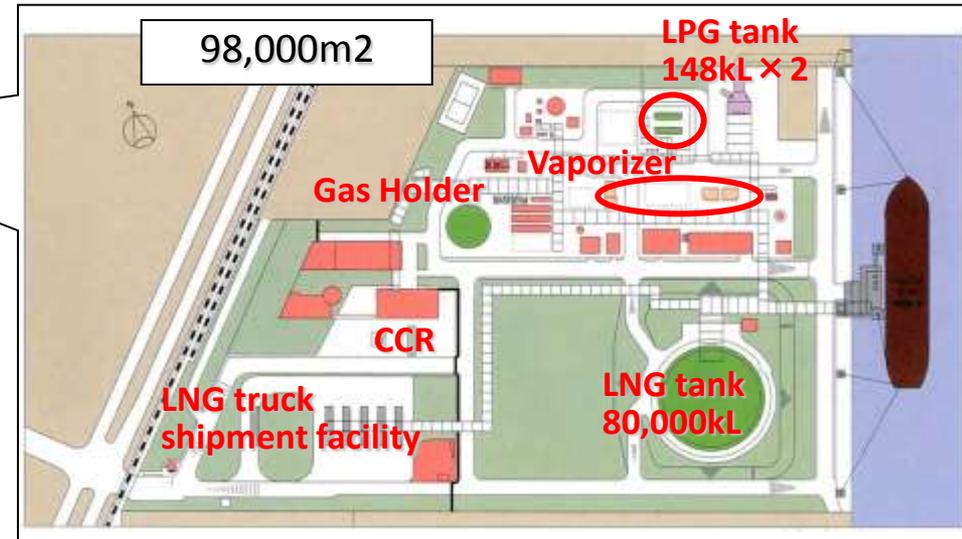
- Earthquake caused almost no damage.
- Tsunami (maximum 4 meters height from the ground) struck 1 hour after the earthquake.
- The operationability of LNG terminal was lost, however there was no loss of life, LNG leaks, or any other secondary disasters.

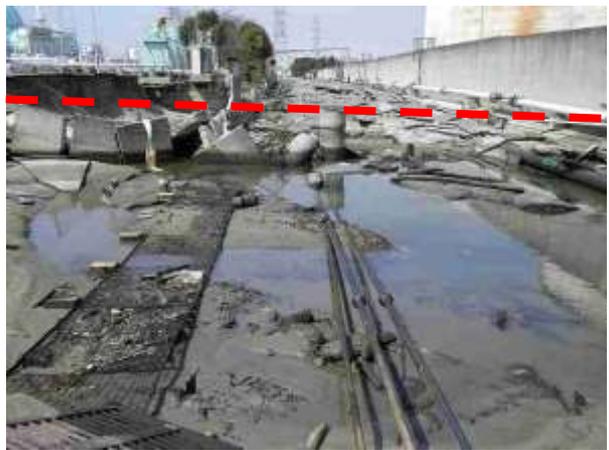
Near the sea water sluice gate

- The area where flow was concentrated was seriously damaged.
- Drifting objects didn't cause serious damage.
- The slab foundation was damaged.
- Equipment with pile foundations were not seriously damaged.
- Erosion was quick to occur around unpaved locations.

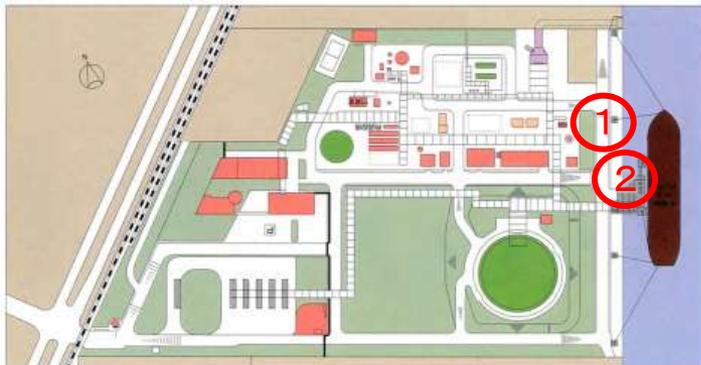
Only some scouring on the surface of the ground which did not effect it's operationability.

There was some partial scouring on the surface. However, there was no damage to the sheet-pile and the bank remained intact.

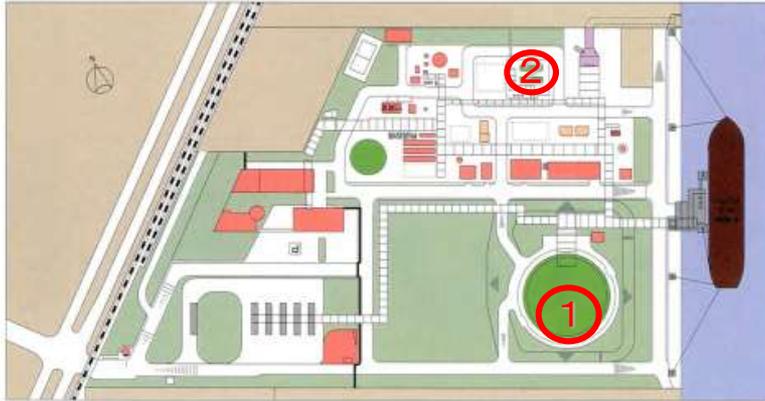
A part of it was flooded, some of the soil around the foundation was washed away, but there was no damage.

Luckily being on the top of a 4 meter banking hill spared it from being flooded.

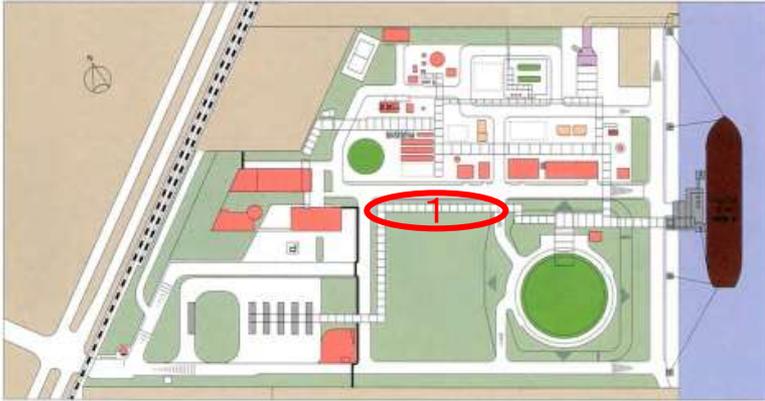
- Framework collapsed due to being washed away around the foundation which were quite shallow.
- Although the piping was deformed there were no LNG leaks.

■ The foundation of piping framework was changed from slab type to pile type.

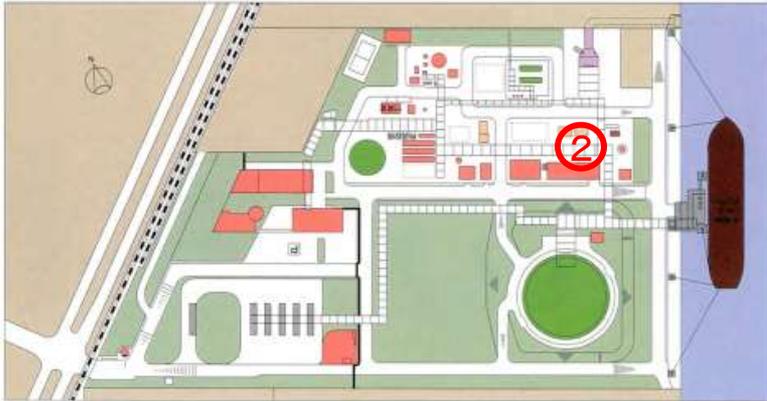
- End of branch piping for future additional piping was not completely fixed to any framework and as such suffered severe deformation.
- Emergency shut down was carried out quickly, and there were no LNG leaks.

Secure pipes to prevent floating

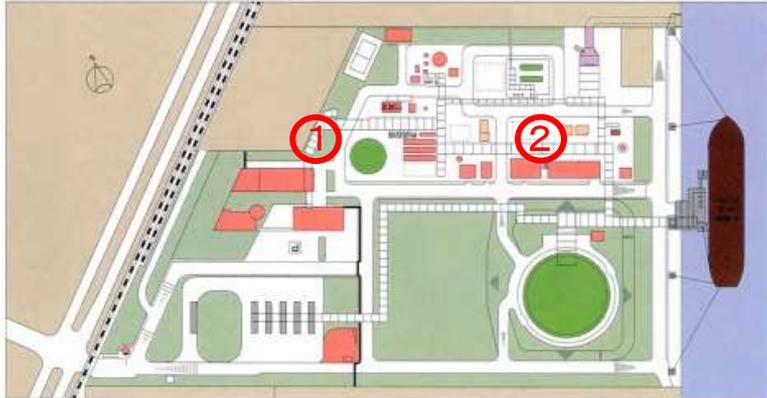
Although these were suffered severe water flooding, there was no damage and the operationability was maintained.

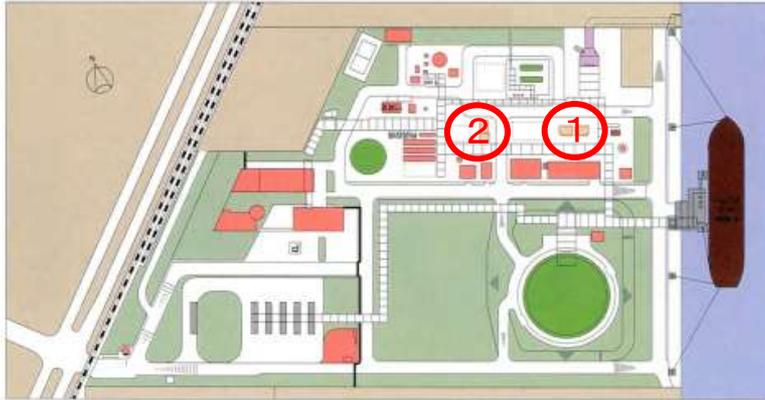
- ◆ 1. Open rack vaporizer  
It was not damaged.

- ◆ 2. Submerged combustion vaporizer  
Control board and combustion air blower were flooded and the operationability was lost.

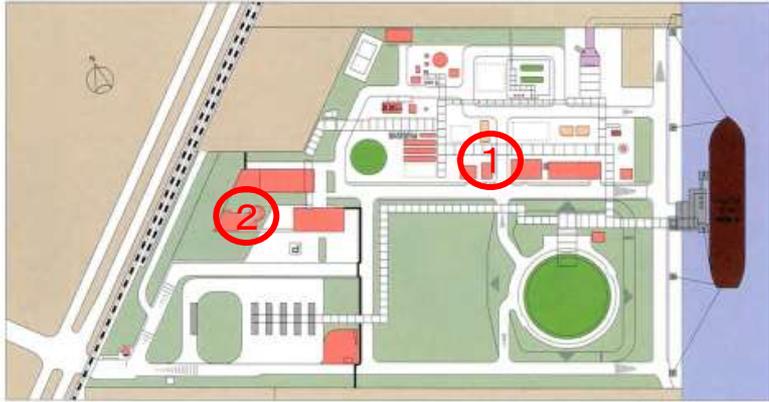
Tsunami damaged non watertight doors allowing internal flooding.

The equipment operations failed.

Outside installation was flooded and equipment failed.

- Replacing doors of important buildings with watertight (airtight) doors like those in the odorization building.

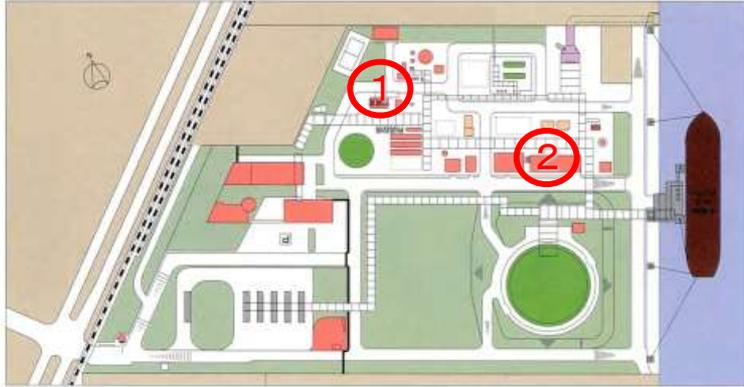
It was installed on the second floor and not damaged.

It had highly airtight doors with no aperture, no flooding occurred.

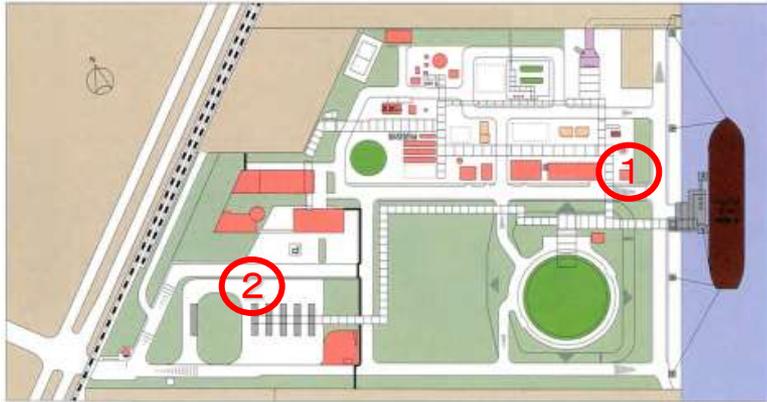
- ◆ 2. LNG truck loading building  
A lightweight building was swept away.

- ◆ 1. Berth control center building  
The wall and windows at the first floor were damaged.

- The LNG receipt and truck loading monitoring facilities, which had been on the first floor and suffered damage, were relocated to the second floor.
