International Gas Union - 23rd World Gas Conference

INTEGRITY MANAGEMENT FOR OLD PIPELINE SYSTEM

Company: **TRANSPORTADORA DE GAS DEL SUR**

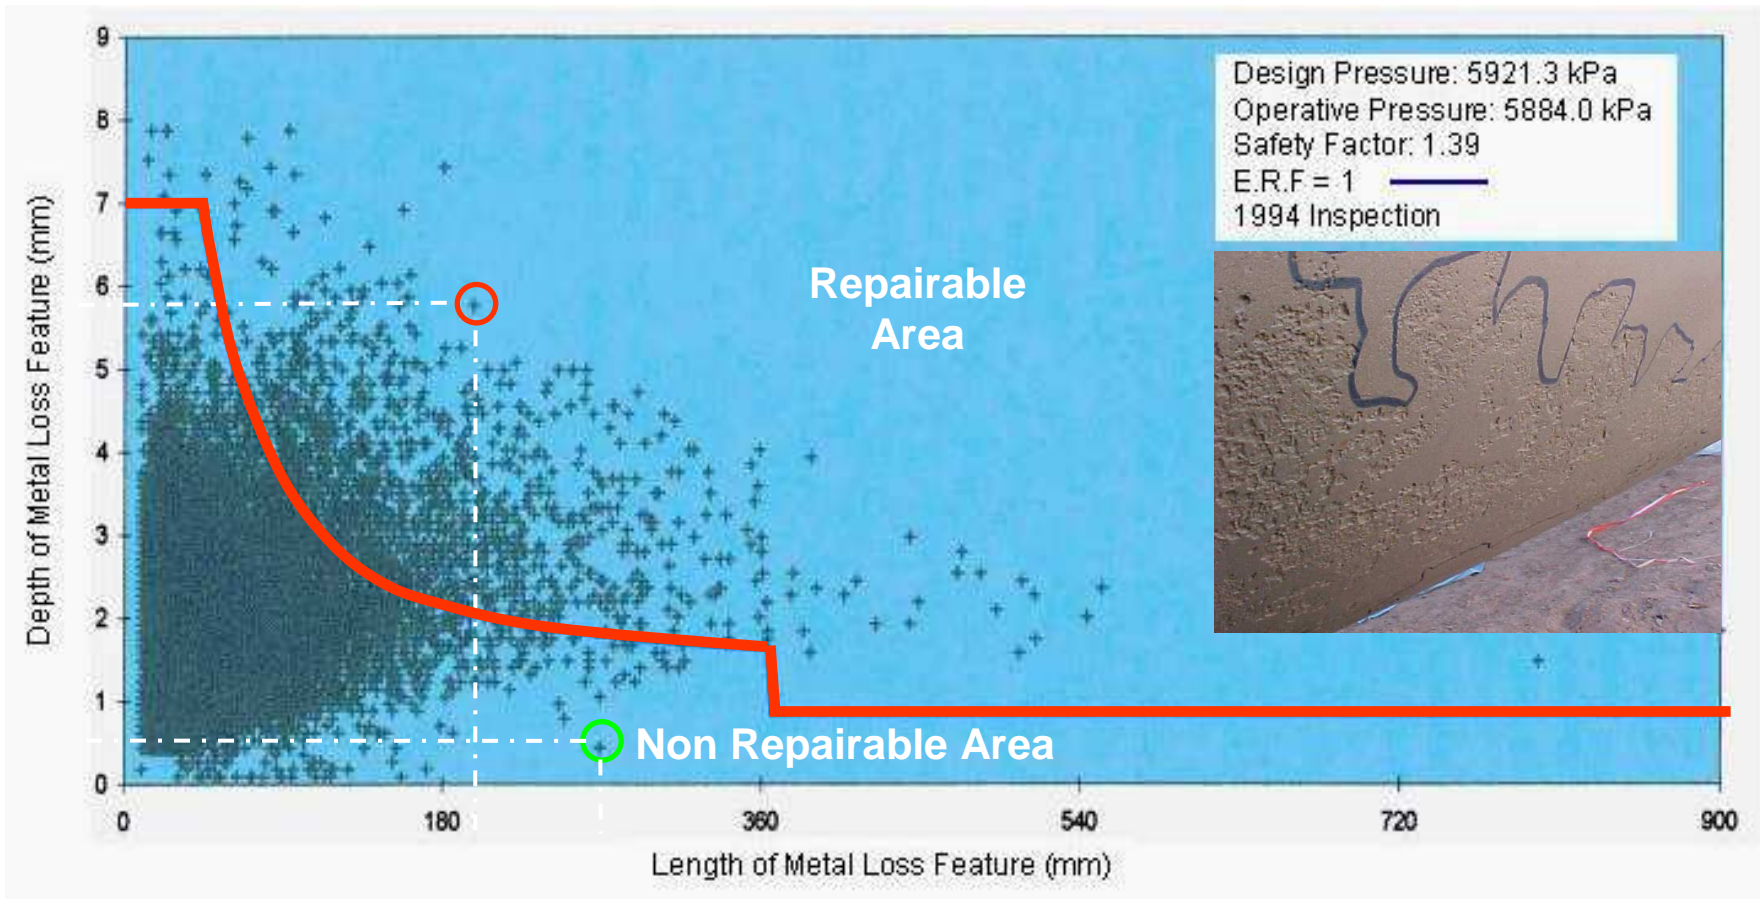
Corrosion Defects - In Line Inspection – 1994

ILI result of a section in our system

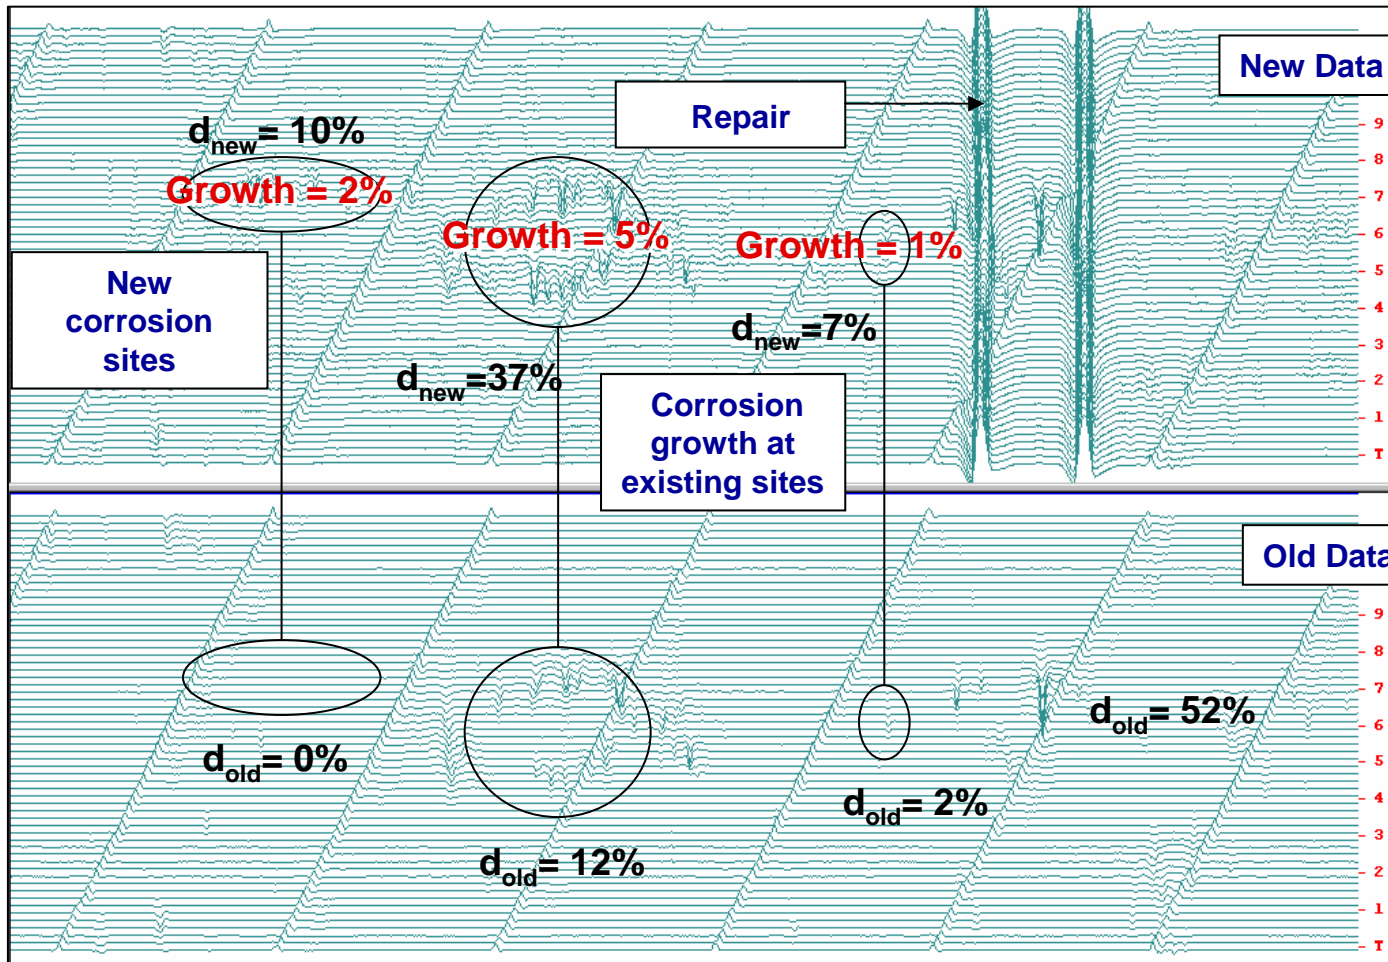
Determination of Corrosion Growth Rates

$$Growth = \frac{depth_{new} - depth_{old}}{Time}$$

Time (between Inspections): 5 years

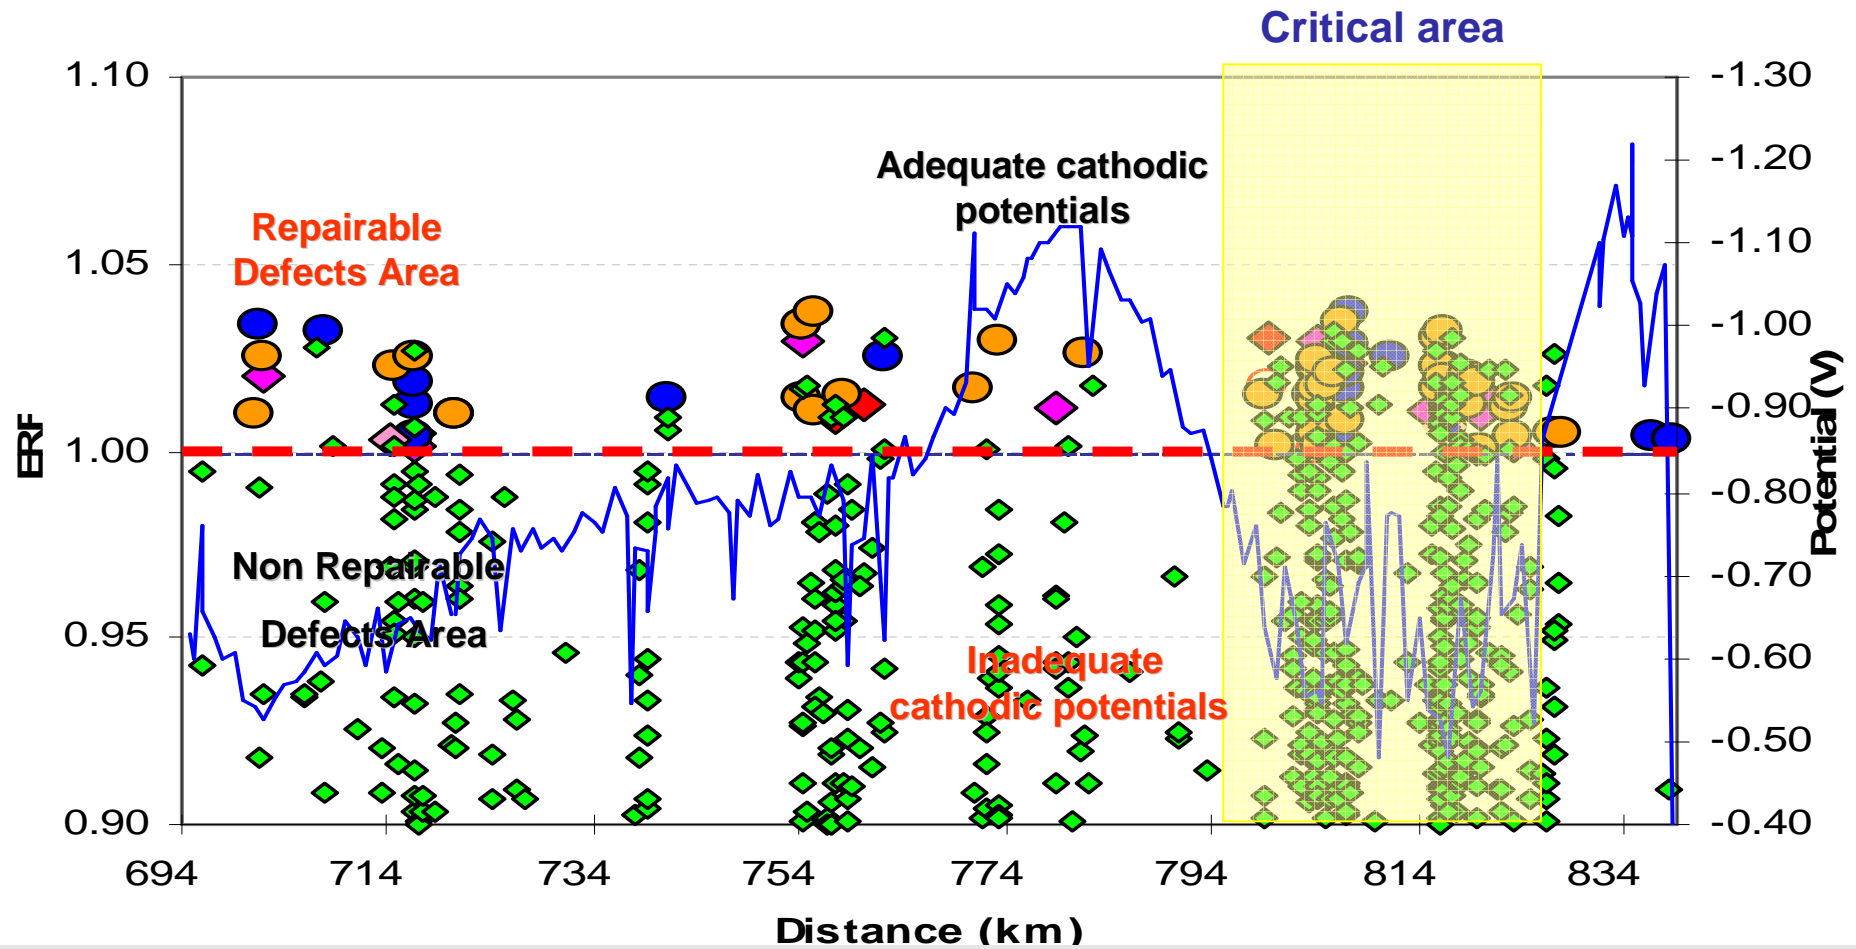
REPAIR PLAN

Corrosion Growth Rates + Cathodic Potentials

◆ 2006 ● 2007 ◆ 2008 ● 2009 ◆ 2010

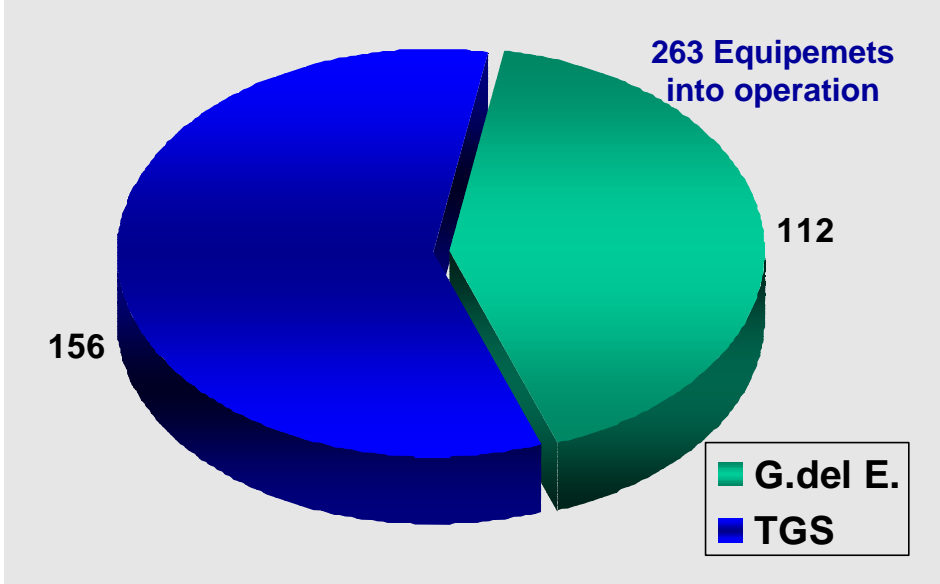
CP Units Evolution

Year	Pipeline (km)	Total CP Units	Protected Pipeline (%)	Km /CP Units
1993	5,899	112	55	52
2005	8,000	263	100	30

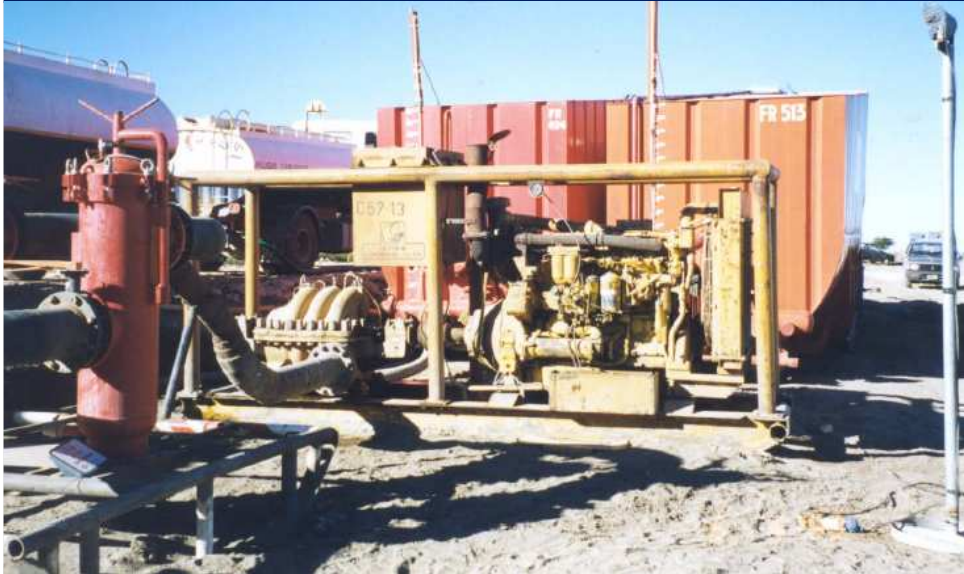
Hydraulic Test

- Hydrostatic Test: 134 km
- 460 m of pipeline were replaced from service
