24<sup>th</sup> World Gas Conference  
ARGENTINA | 2009  
5-9 October

## PROGRESS IN THE DEVELOPMENT OF THE MODEL FOR FINDING HIGH pH SCC IN ARGENTINA

## PIPELINE SYSTEM OF NATURAL GAS TRANSPORTATION IN ARGENTINA

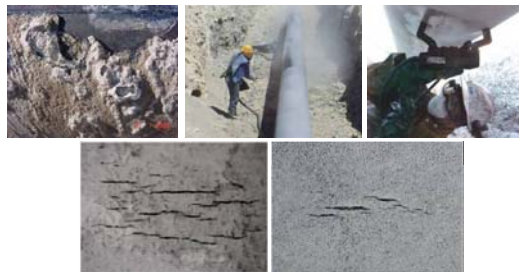
## FIELD WORK

Based on the results of the research, soil studies, and considering all the variables, it is possible to outline and delimit the areas of highest susceptibility for carrying out direct field assessment

Through the application of this model in TGS 10 SCC sites were found and over 100 SCC colonies

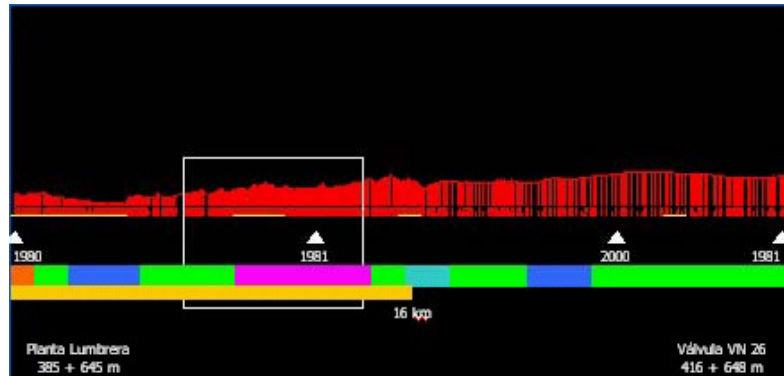
### TGN's ORIGINAL SOIL MODEL

TGN was developing a soil model to locate SCC when the 2002's rupture happened. The failure was about 12 km downstream a compressor plant, in an area with good drainage, foot hill pattern with a strong dry season.

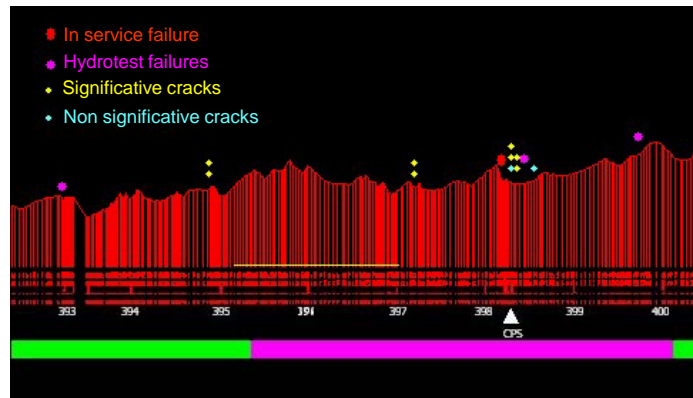
### TGN's ORIGINAL SOIL MODEL

There seemed to be a good agreement between soil description and area where SCC failures in service, or in hydrotest (3) happened, or SCC colonies were found.
