Joint Stock Company  
Scientific & Production Association  
**Spetsneftegaz**

## EMAT TECHNOLOGIES

DETECTION OF PIPELINE CRACKS  
CHECK UP OF COATING QUALITY

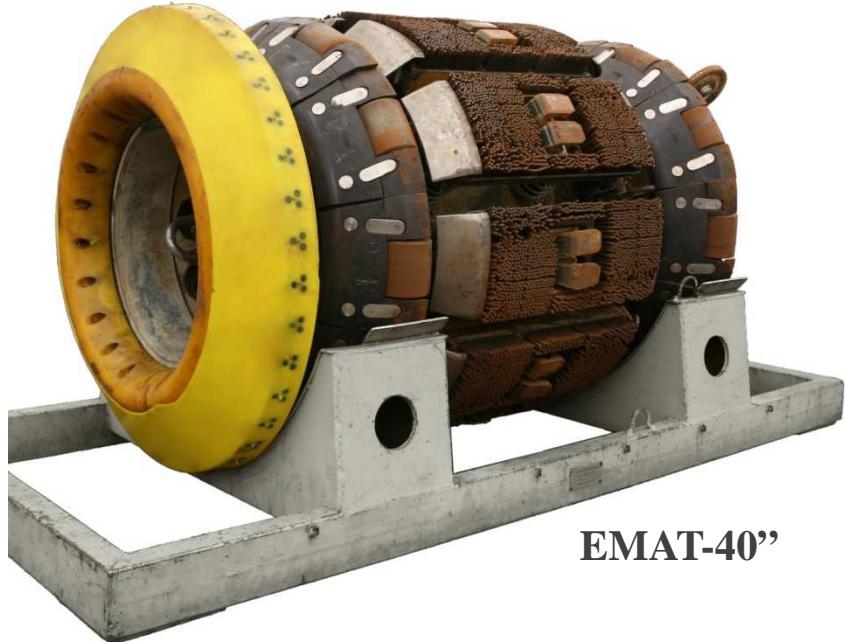
**EMAT-40"**

# EMAT in-line inspection tools of big diameters

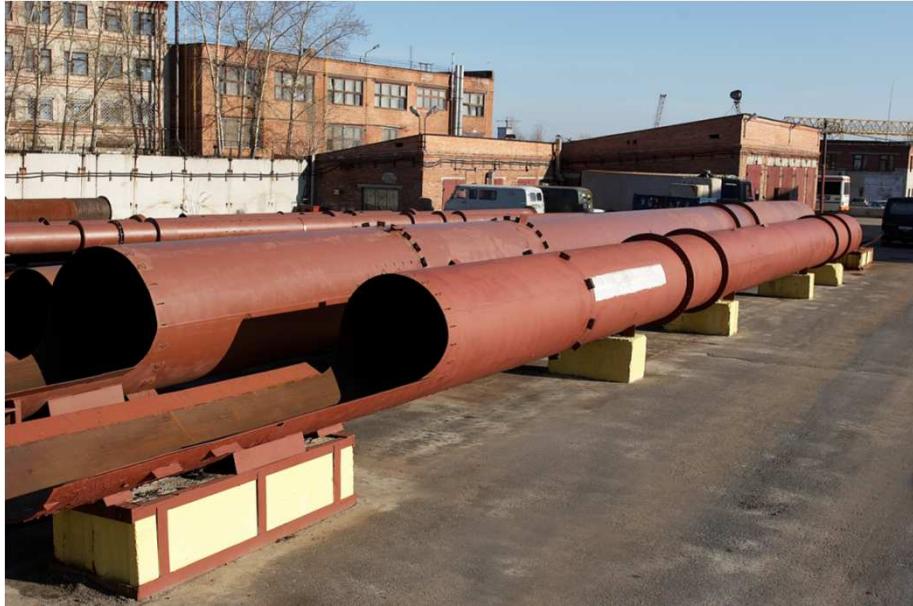
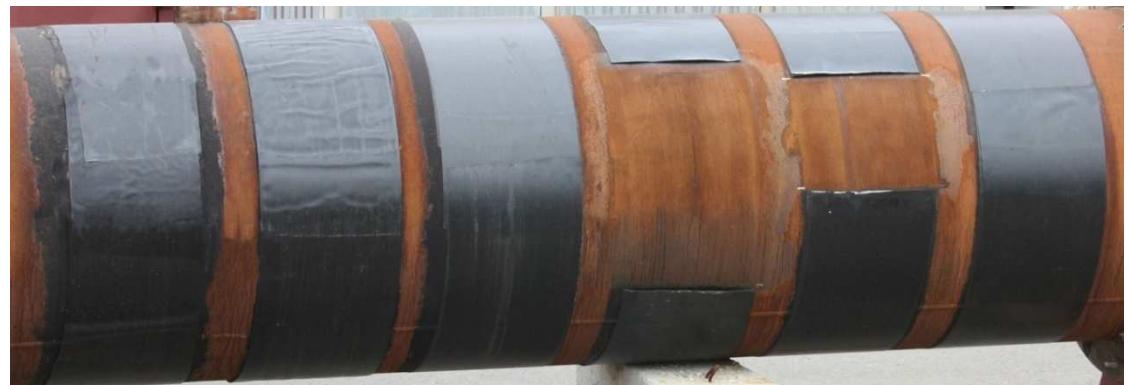
# Pipe Pull-through Test Stands at Spetsneftegaz Production Base

Check up of disbanded coating zones  
In pipe pull-through test stands with  
various types of coatings

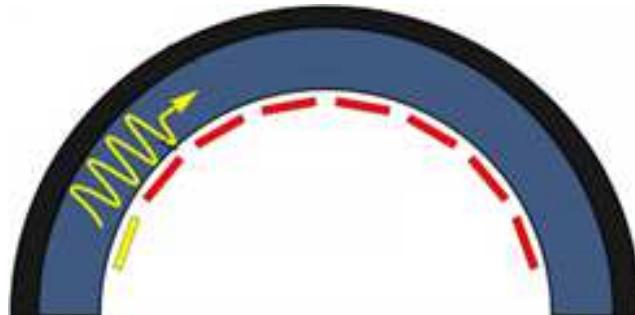
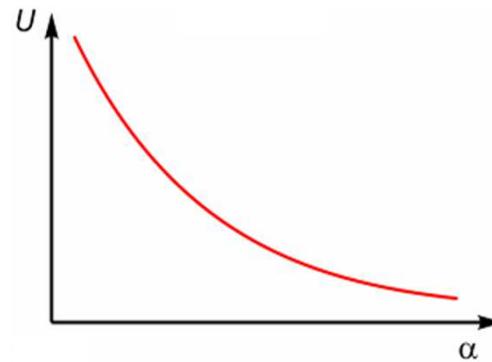
# Physical Principles of Pipe Disbonded Coating Check-up

Well bonded pipe coating

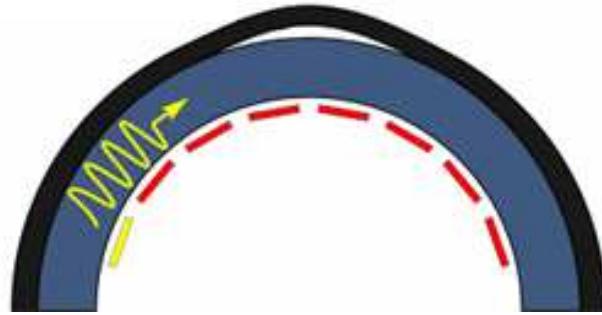
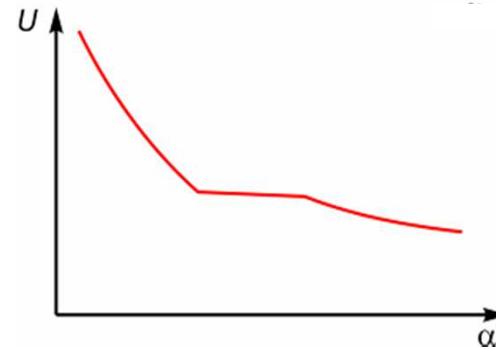
Disbonded coating

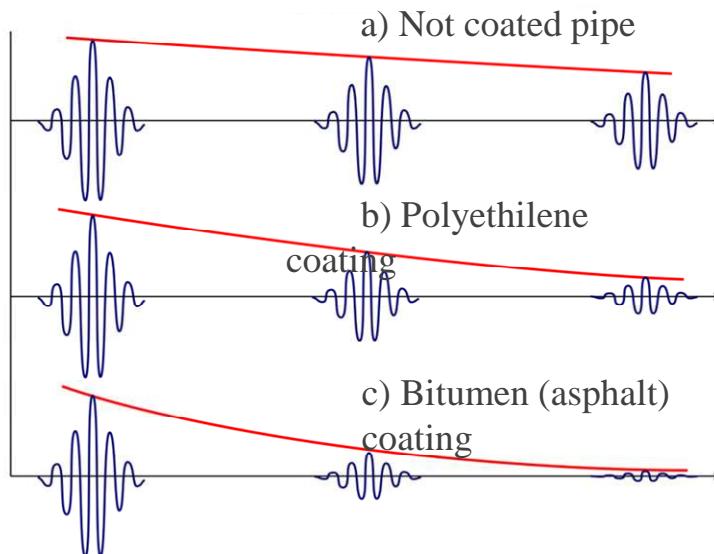
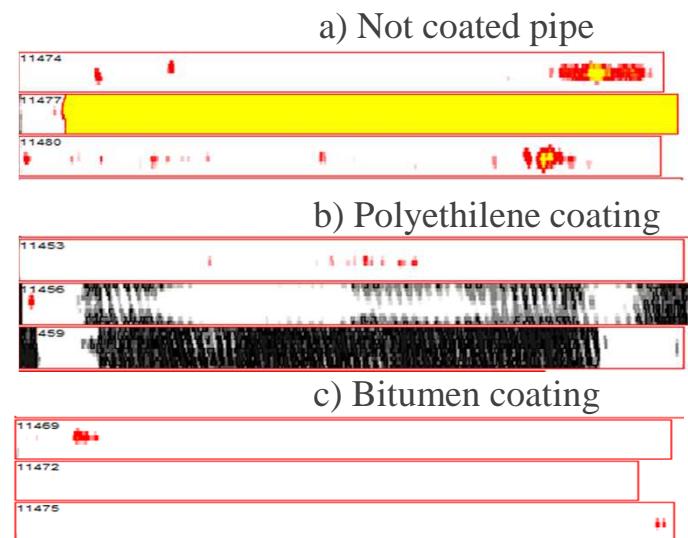
# Types of pipeline coatings

Absorption factors of acoustic waves in various types of pipeline coatings:

- a) Weak attenuation of acoustic wave in uncoated pipe. Maximum (yellow color) on EMAT inspection plot.
- b) Intermediate attenuation of acoustic wave in a pipe with polyethylene coating (black and red colors on EMAT inspection plot).
- c) Strong attenuation of acoustic wave in a pipe with bitumen (asphalt) coating. Minimum signal (white color) on EMAT inspection plot.

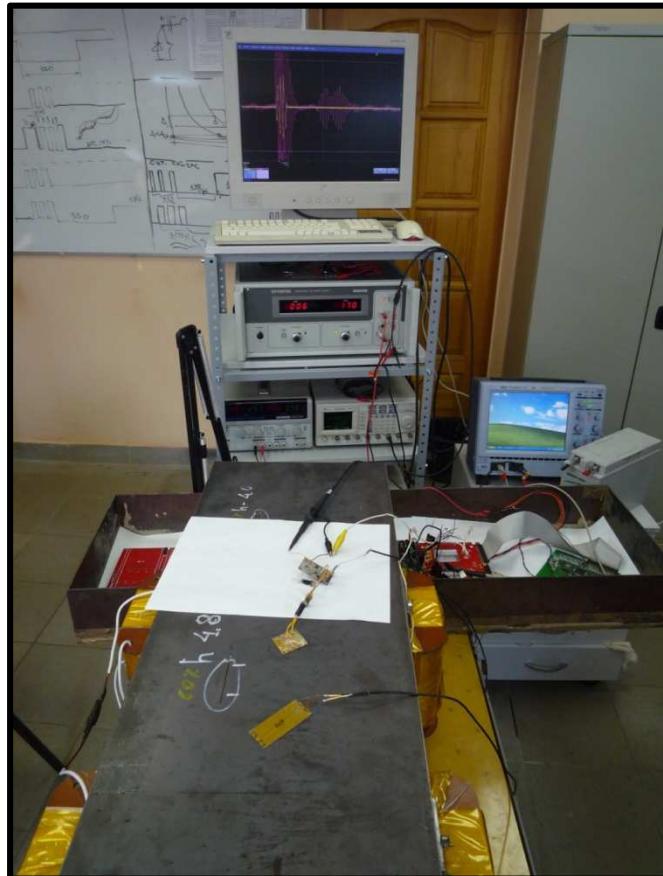
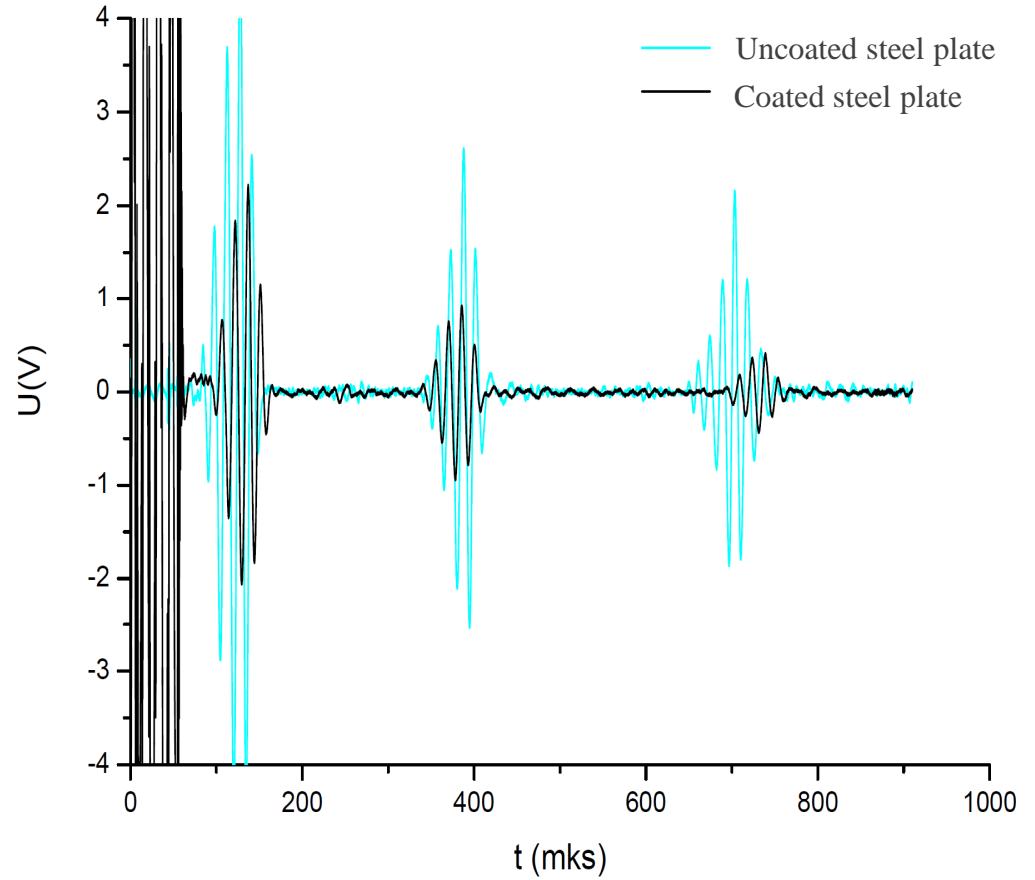
# Laboratory tests of EMAT signals

Assessment of acoustic wave attenuation (absorption)

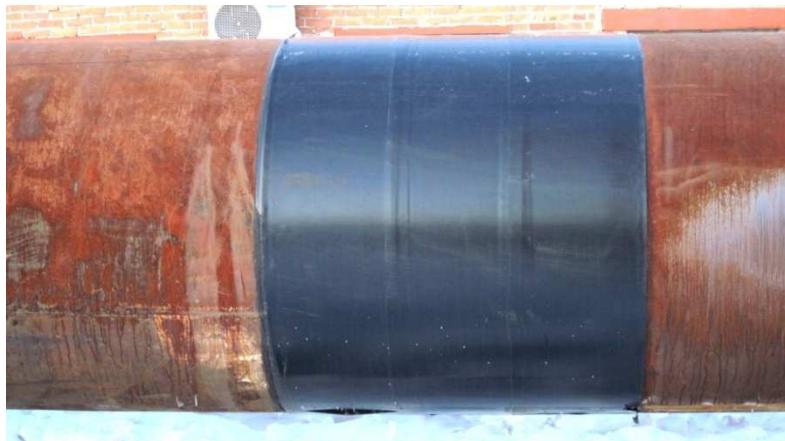
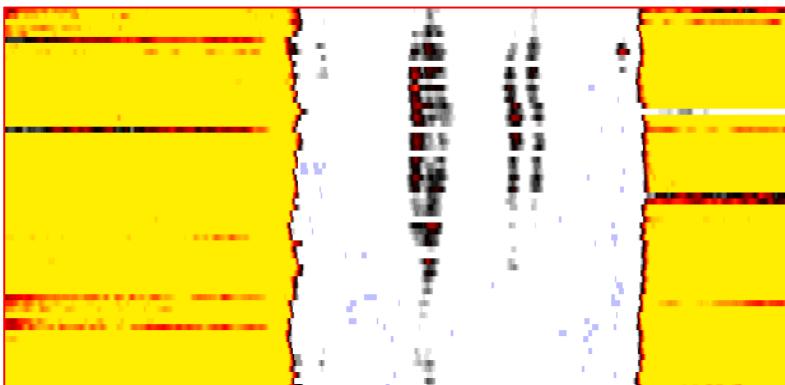
# Tests of Spetsneftegaz EMAT-56" ILI tool

Detection of a coated pipe on the background of uncoated pipes

Yellow color on EMAT inspection plot shows an uncoated pipe.

White color shows coated pipe.

Black stripes on EMAT inspection plot testify to not compactly bonded overlapping coating edges.

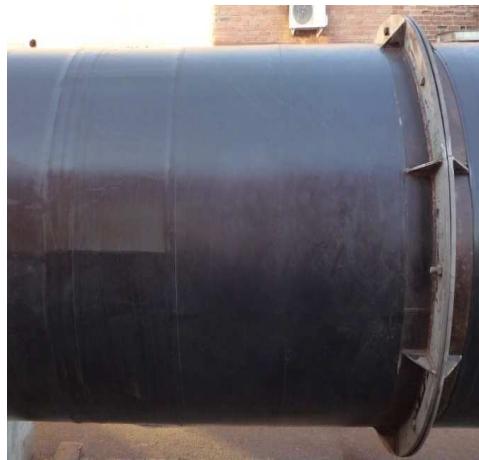
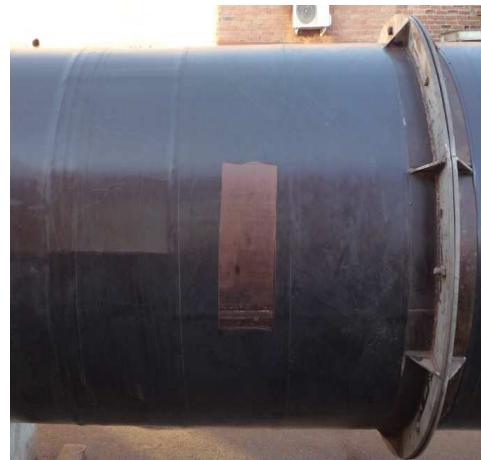
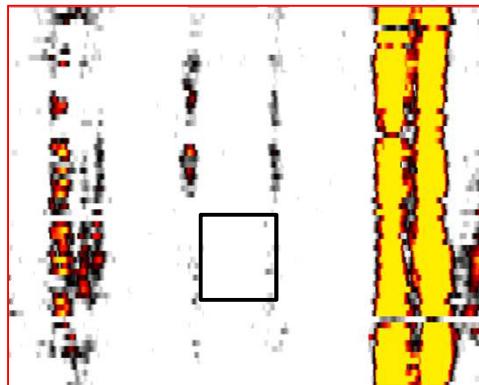
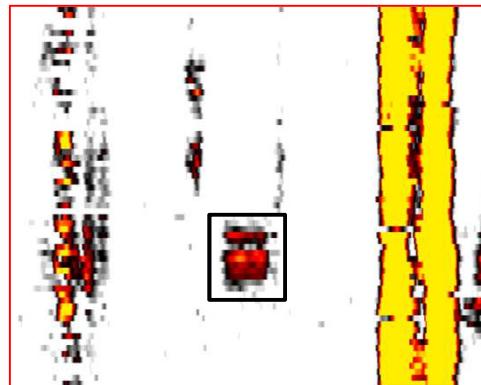
# Tests of EMAT-56" ILI tool

## Assessment of minimum disbonded coating defect

EMAT inspection plots of pipe pull through test stand

a) with full pipe coating

b) with cut out coating piece.

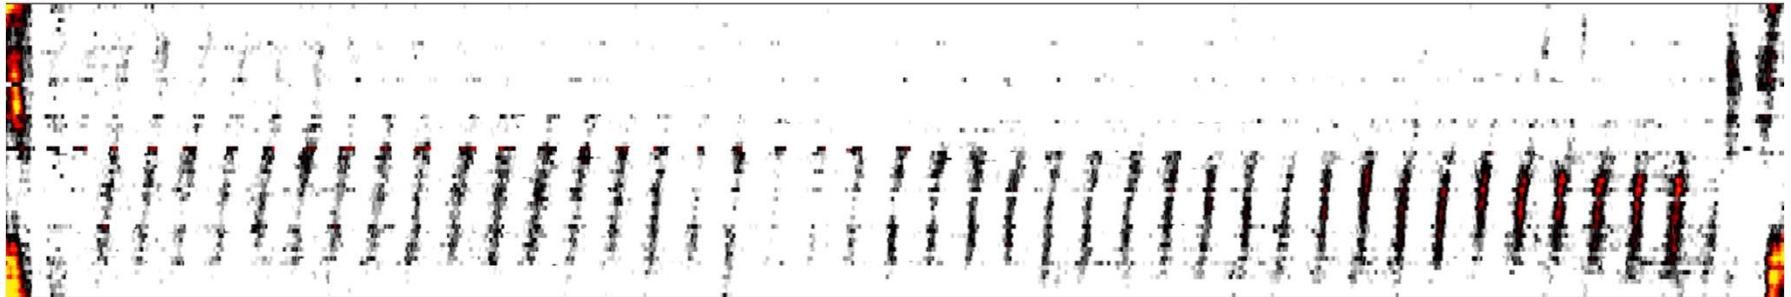
Good coating

# EMAT inspection in Urengoi – Novopskov Trunk Gas Pipeline in Russia

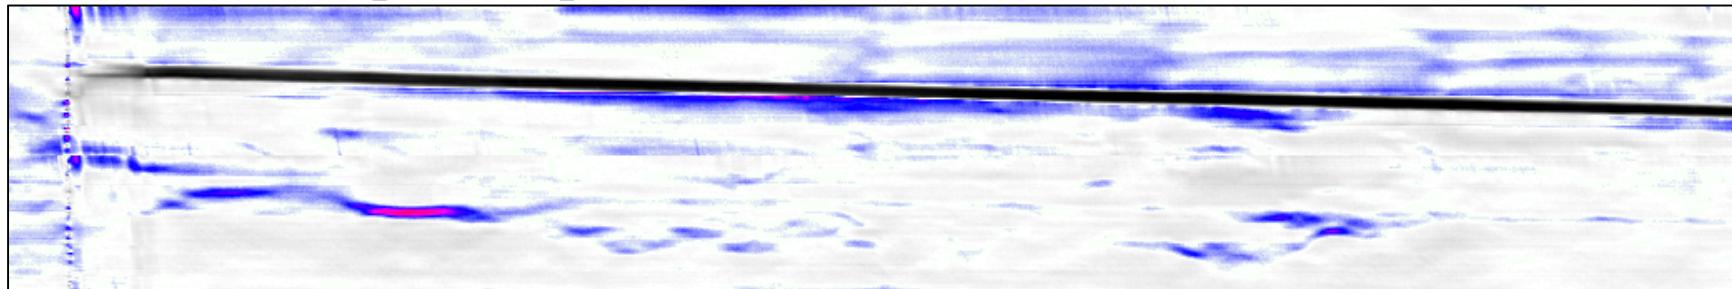
EMAT-56" inspection plot

## Crack detection by EMAT-56" ILI tool in Urengoi – Novopskov Trunk Gas Pipeline Section in Russia

Total 531 zones of stress corrosion cracks were detected:

245 SCC zones 10-20% p.w.t. deep

104 SCC zones 20-30% p.w.t. deep

113 SCC zones 30-40% p.w.t. deep

44 SCC zones 40% p.w.t. deep

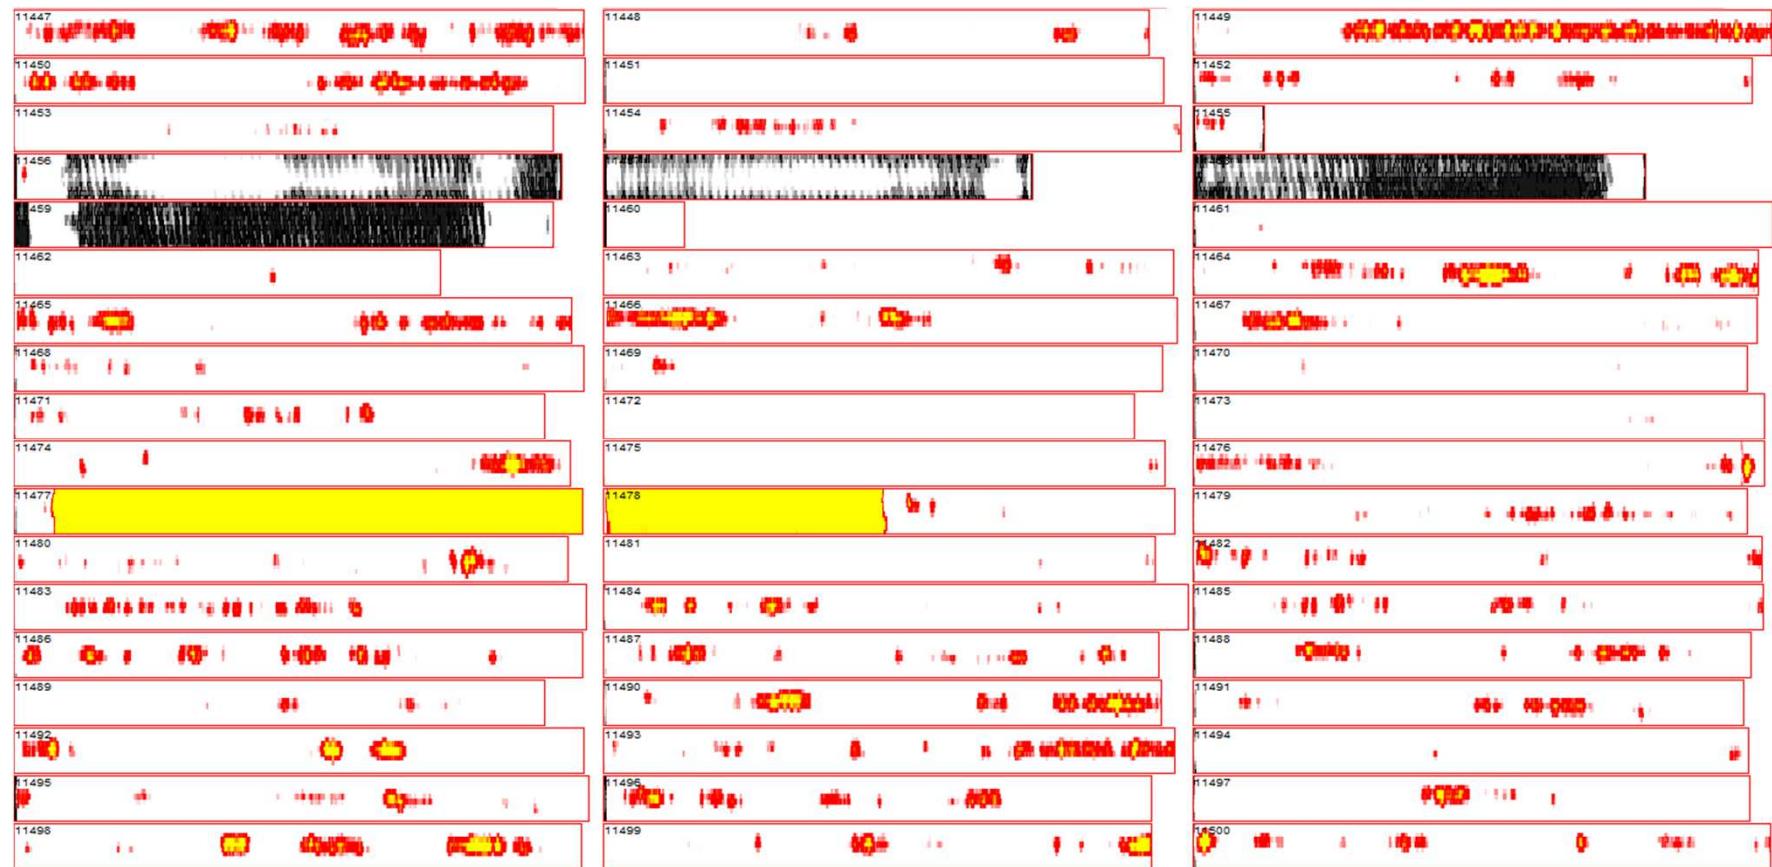
## Pipe Tally

# EMAT inspection in 40" trunk gas pipeline in the Middle East

Bitumen coating, polyethylene coating, uncoated pipe

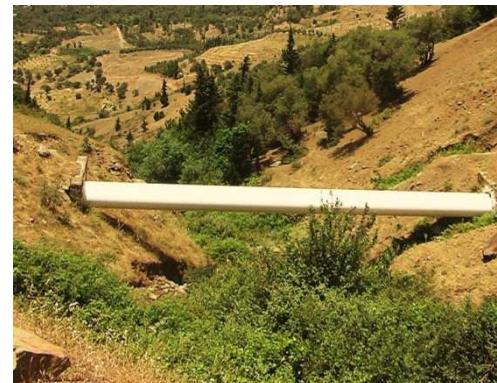
Photo of uncoated pipeline air crossing.

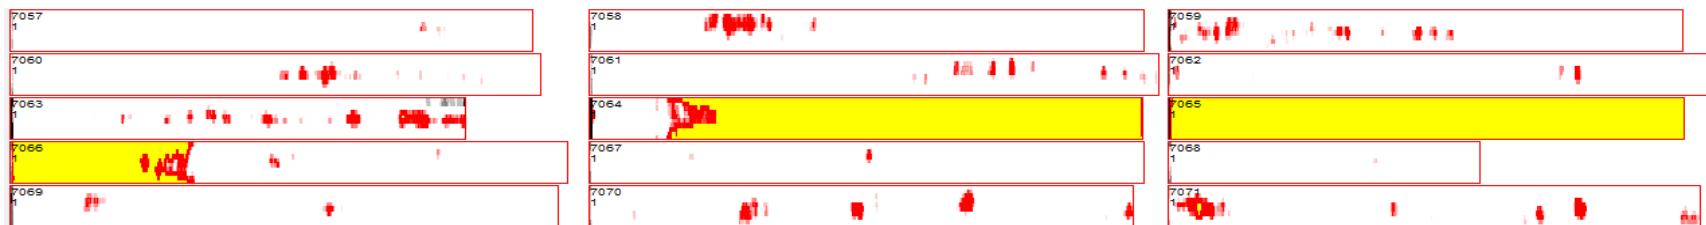
## Air crossing of uncoated pipeline

EMAT data.

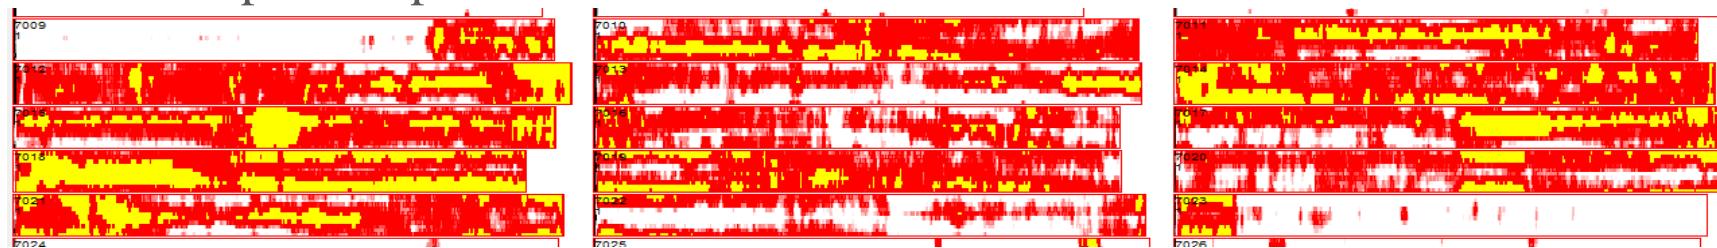
EMAT inspection plot

# EMAT-40" inspection plot. Disbonded coating of the gas pipeline in river valley.

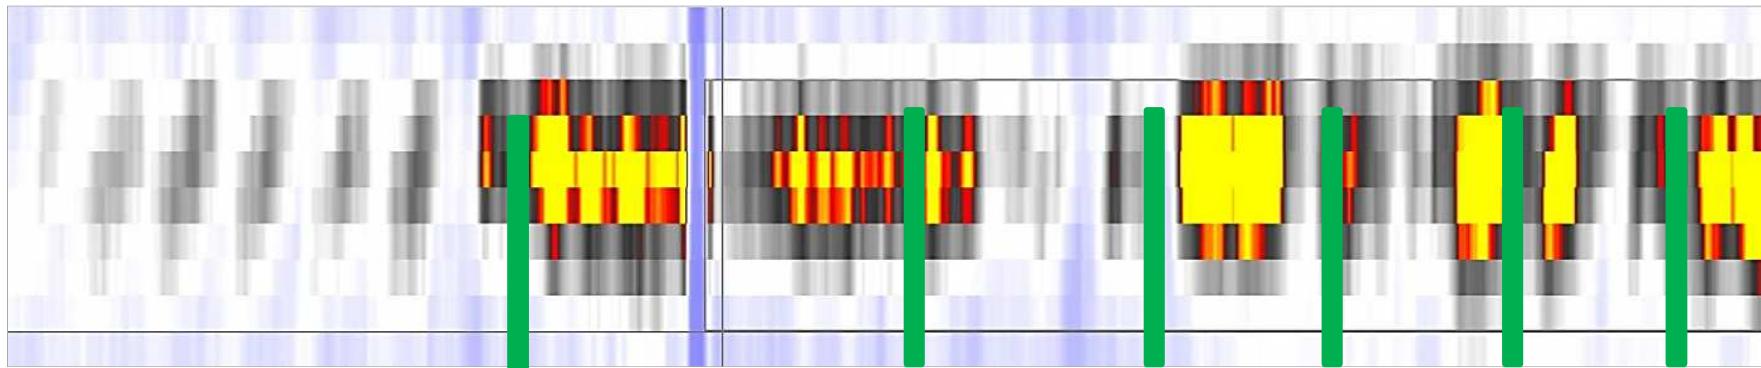
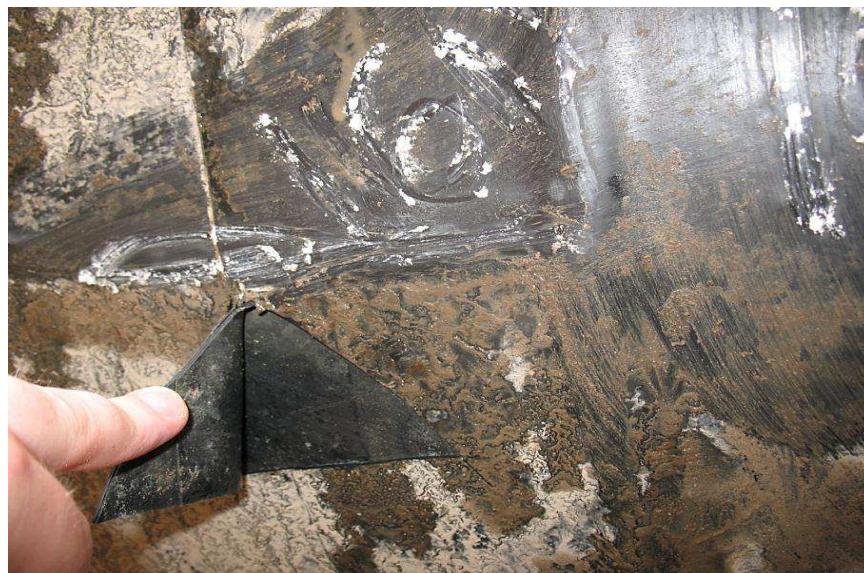
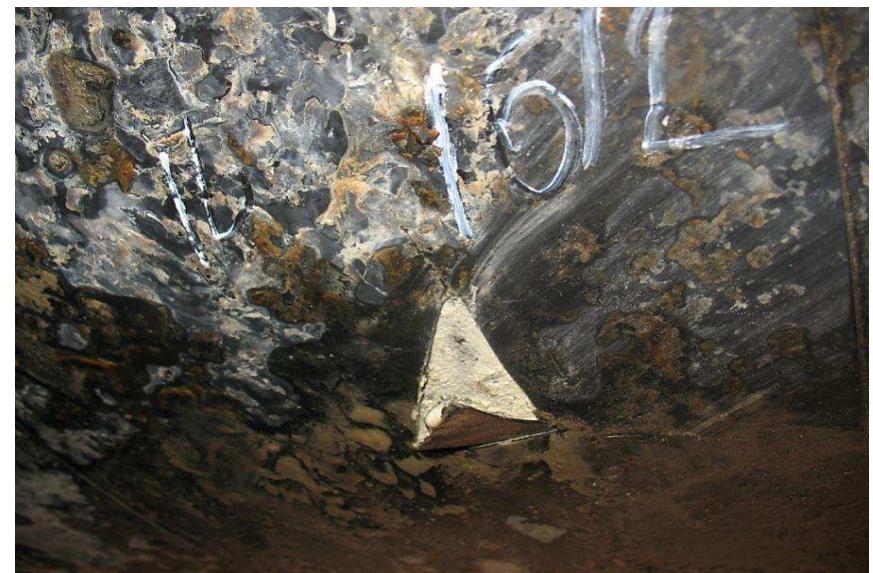
# Results of check-up digging excavations of 40" trunk gas pipeline in vicinity of Saint – Petersburg, Russia

## Disbonded coating zones
